ORE DRESSING AND METALLURGICAL LABORATORIES.

Investigation No. 1385.

Examination of Failed SAE X4130 Aircraft Tubing.

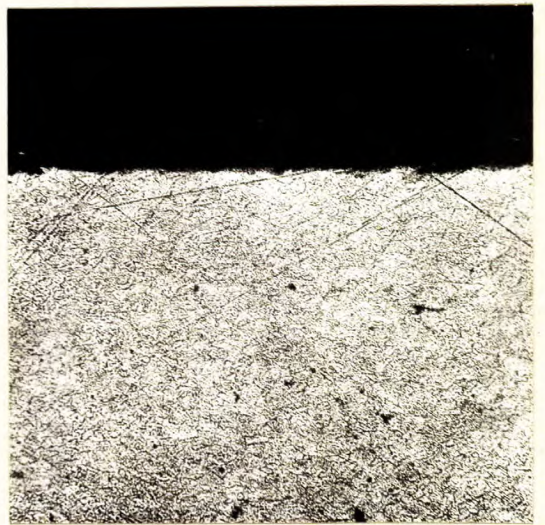
Figure 2.

Sections of the tubes were mounted in bakelite, given a metallographic polish, and then examined under the microscope in the unetched condition. Both steels were found to be fairly clean. The steels were then etched in a solution of 2 per cent nitric acid in alcohol and re-examined. Figures 1 and 2 are photomicrographs, at X100 magnification, showing respectively the structure of the heavy-wall and thin-wall tubing. Next to the bakelite (the dark area at the top of the picture in Figure 1) is a broad white band of ferrite, the iron constituent. It will be noted, in Figure 2, that this band is lacking in the thin-walled tube.

X100, etched in
2 per cent nital.
THIN-WALLED TUBING.

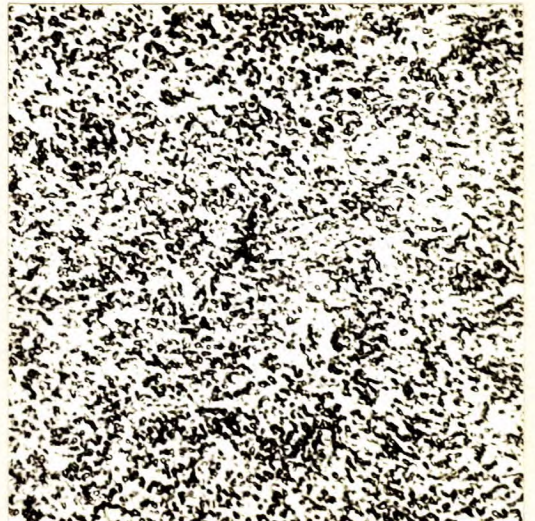
Figure 4.

steels at X1000 magnification. Figure 3 shows that the structure of the heavy-walled tubing consists of fine pearlite (the iron-iron carbide; dark etching areas) and ferrite (the white etching iron constituent). Figure 4 shows the structure of the steel in the thin-walled tubing to consist of spheroidized carbides (the round globular constituent) and ferrite (the white material).

X1000, etched in
2 per cent nital.
THIN-WALLED TUBING.

The ferrite at the outer surface of the heavy-walled tubing indicates a bad state of decarburization. The ratio of ferrite to pearlite and the finely lamellar nature of the pearlite show that this tube had been given a normalizing heat treatment, i.e., it was heated above the upper critical range and cooled in air. No decarburization was observed in the thin-walled tubing. The spheroidized structure shown in Figure 4 indicates that it was held for a considerable time at a temperature slightly under the lower critical ranges. Steel in this condition has lower tensile properties than in the normalized condition. This, then, explains the lower ultimate strength of this tube.
