Investigation No. 1397.

Examination of a Scored Cheetah Aircraft Cylinder
Sleeve and an Aluminium Alloy Piston.

BUREAU OF MINES
DIVISION OF METALLIC MINERALS
ORE DRESSING AND
METALLURGICAL LABORATORIES

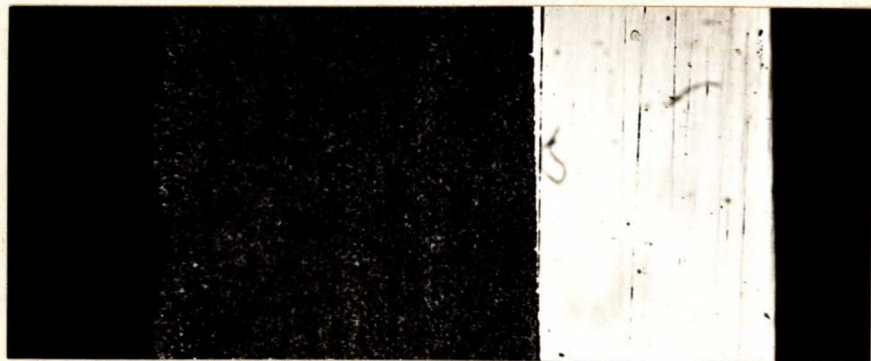
Figure 1.

Specimens of the piston, cylinder sleeve, and shot were mounted in bakelite, polished, and examined under the microscope. Figure 1 is a photomicrograph, at X40 magnification, of a section of the cylinder sleeve after etching in a solution of 4 per cent picric acid in alcohol. The outer black area is bakelite, the dark etching material is the steel cylinder, and the white area is the chromium metal plate on the cylinder wall.

X40, etched 4 per cent picral.

PHOTOMICROGRAPH SHOWING CHROMIUM
PLATE ON STEEL CYLINDER SLEEVE.

The chromium plate on the Chestah cylinder sleeve was observed to be quite uniform and was not of the porous type of plate produced by the Van der Horst process. The thickness of the chromium plate was approximately 0.025 inch.

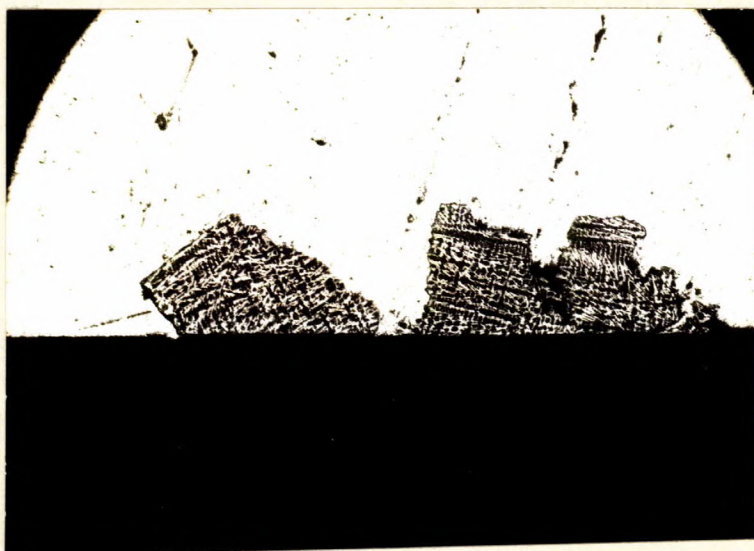
Figure 3 is a photomicrograph, at X100 magnification, obtained from a location which showed a shiny spot area. Several particles of white iron shot may be seen embedded in the aluminium alloy piston.

X100, etched in 2 per cent nital.
PHOTOMICROGRAPH SHOWING PARTICLES OF WHITE IRON
SHOT EMBEDDED IN ALUMINIUM ALLOY PISTON.

The shot examined was found to be of white iron (which has a Brinell hardness of approximately 450). This hard substance, when used for cleaning the cylinder head, apparently became embedded in the piston, as shown in Figure 3. It is concluded, from this examination, that the seizure of the piston was probably due to the presence of this material in the piston.

If shotblasting of the cylinder head is necessary, malleable iron shot should be used in place of the white iron shot. J. O. Almen, a leading U.S. authority on shotblasting, states that shot size should be between 0.040 and 0.060 inch. It is his opinion, however, that shotblasting the cylinder head does not effect much improvement, other than cleaning, if the engine is air cooled but is of value for liquid-cooled engines.
