ORE DRESSING AND METALLURGICAL LABORATORIES.

Investigation No. 1398.

An Investigation of the Effect of Overheating on
the Impact Strength of "S-80" Stainless Steel.

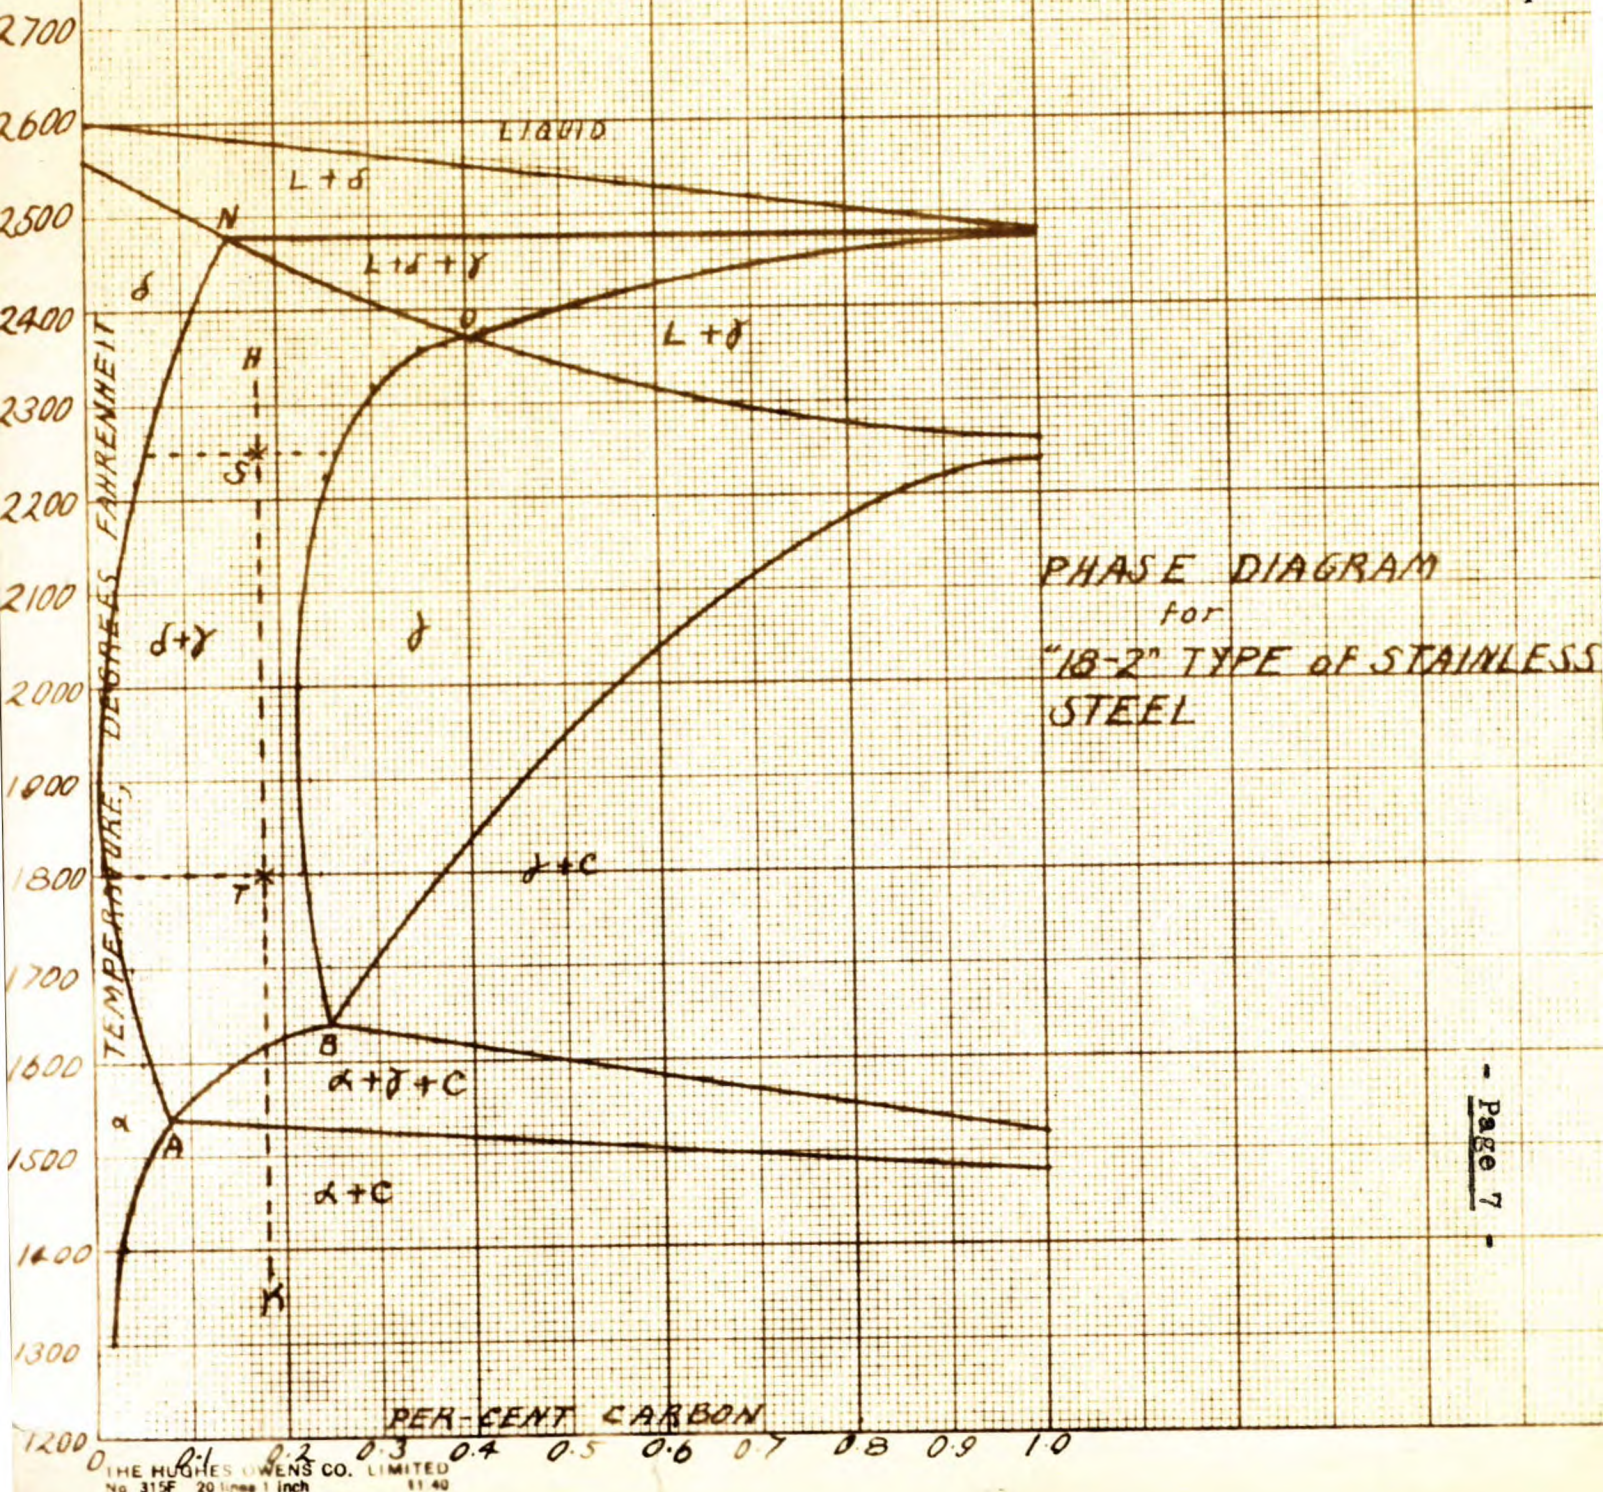
(Page 7 is a phase-diagram)
(chart, referred to in the)
("Discussion of Results".)

It is not held that this diagram is absolutely accurate. However, it is thought to be a close approximation to the phase diagram. For steel in the range being investigated it agrees fairly well with the findings. At all temperatures above, about 1650° F., both delta and gamma iron exist. At 2250° F. more delta iron exists than at 1800° F. This is evident from an examination of Figure 12 and is also evident from the phase diagram. The ratio of the distance between the line HK and OB to the distance between lines NA and OB at any given temperature gives an estimate of the amount of delta iron present at equilibrium. The nearer HK approaches OB the greater will be the amount of gamma phase (or its transformation product) present.

Line NA represents the solubility of the alpha or delta iron for carbon. It will be noted that this solubility is rather low at 1800° F. but is quite appreciable at 2250° F. According to the phase diagram, delta iron formed at 2250° F. contains about 0.05 per cent carbon. At 1800° F. it can hold only 0.01 per cent carbon in solid solution. The excess will be precipitated as carbide, as is shown in Figures 6 and 10. The slower the cooling the greater is the amount of carbide formed. This is also illustrated in Figures 6 and 10.

To facilitate a discussion of the results of this investigation, a phase diagram for this type of steel is given (Page 7). This is made up from information obtained from the following articles:

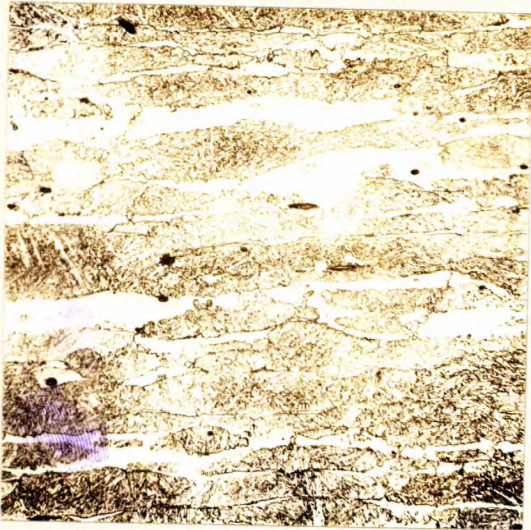
Figure 1.

Photomicrograph, X100.
Electro-polish, etched in 5% HCl
1% picric acid, solution in alcohol.

STRUCTURE AS RECEIVED.

A comparison of Figures 1, 4 and 7 reveals that phase redistribution has taken place on heating up to 2250° F. The long continuous stringers of the ferritic phase have been broken up but there is still some evidence of a banded structure. It is not possible, from these photomicrographs, to get any clear idea of the grain size of the steel. However, it does not have the appearance of being excessively coarse-grained and on comparing Figures 4, 7, 14, 16, and 18 there does not appear to be much grain refinement resulting from re-heat treatment after high-temperature treatment. About the most striking effect of the high-temperature treatment has been to partly break up the ferrite bands.

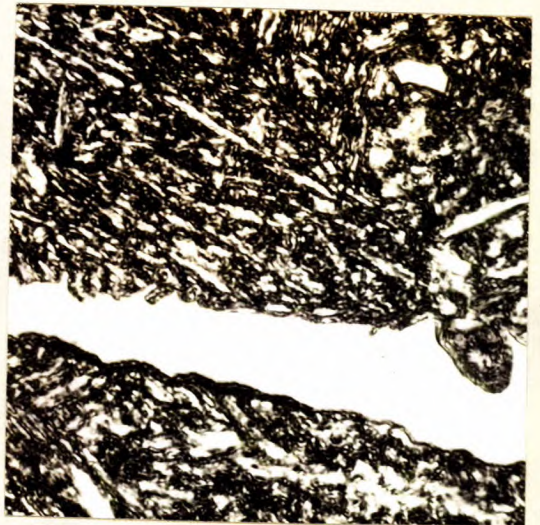
Figure 2.

Photomicrograph, X1000.
Electro-polish, etched in alcoholic
solution of 5% HCl and
1% picric acid.

"AS RECEIVED" CONDITION.

Figures 2, 11, 13, 15, 17, and 19 are presented to show that the structure of the martensitic phase in the metal in its final quenched-and-drawn condition is about the same as in the steel in its original condition. This fact, combined with the hardness values, would tend to indicate that the final tempering temperature chosen was about the same as that used for the original heat treatment.

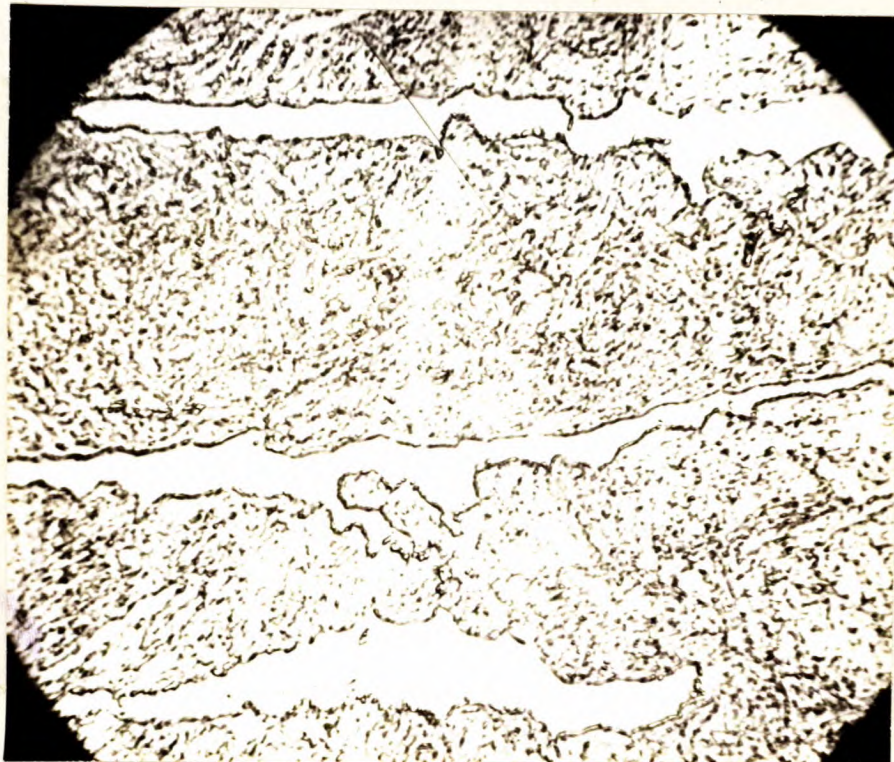
Figure 3.

X1000. Hand polish, electrolytic etch in
10% aqueous tartaric acid solution, 6V, 0.15A, 8 minutes.

STRUCTURE IN STEEL AS RECEIVED.

It is evident from Figure 3 that carbides also exist at the martensite-ferrite interface in the steel in the "as received" condition.

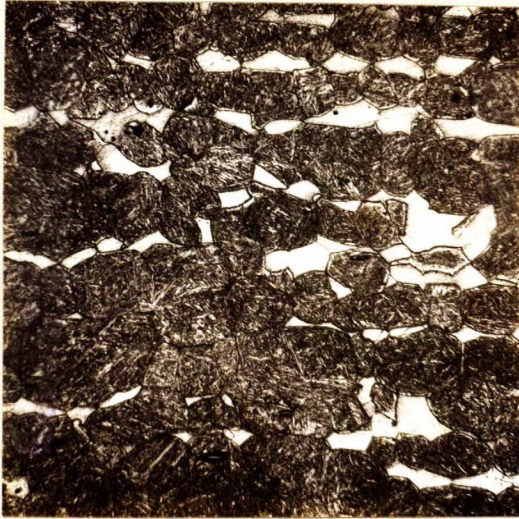
Figure 4.

X100. Electro-polish,
etch in alcoholic solution
of 5% HCl and 1% picric acid.

STRUCTURE WHEN HEATED TO 2250° F.,
HELD FOR 5 HOURS, AND AIR COOLED.

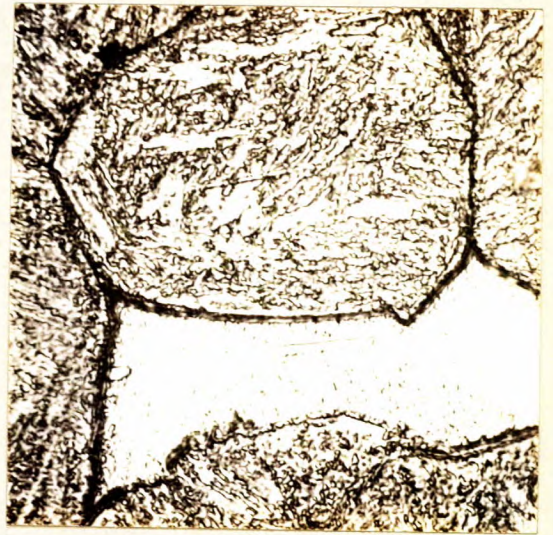
Figure 5.

X1000. Electro-polish,
etch in alcoholic solution
of 5% HCl and 1% picric acid.

STRUCTURE WHEN HEATED TO 2250° F.,
HELD FOR 5 HOURS, AND AIR COOLED.

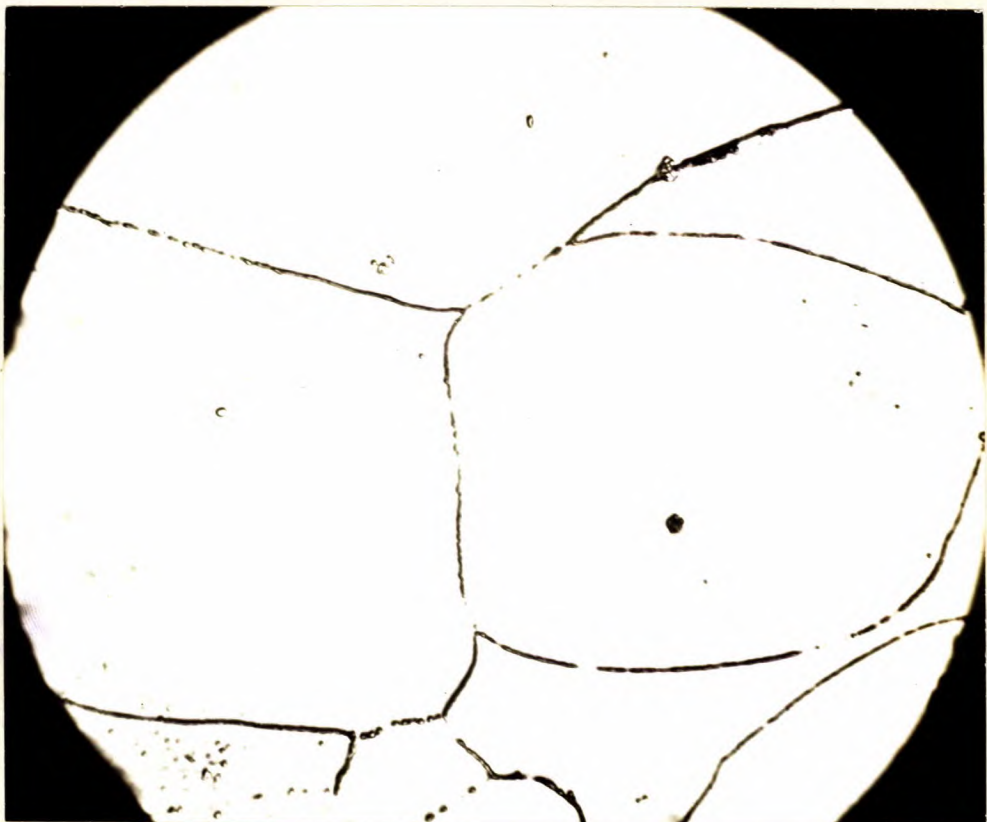
Figure 6.

X1000. Hand polish, electrolytic etch in
10% aqueous tartaric acid solution, 6V, 0.15A, 8 minutes.

CARBIDE NETWORK CREATED BY HEATING TO 2250° F.,
HOLDING FOR 5 HOURS, AND AIR COOLING.

One of the reasons for the low impact is evident from studying Figures 6, 9, and 10. It will be noted that a carbide network has been formed. This network is more general in occurrence at the martensite-ferrite interface but also exists at some of the grain boundaries in the martensite. When cooled very slowly, as in Test B, this carbide evidently even precipitates within the ferrite. This can be seen from a study of both Figure 9 and Figure 10. The large grains in Figures 6 and 10 are martensite. These did not etch because they were not tempered.

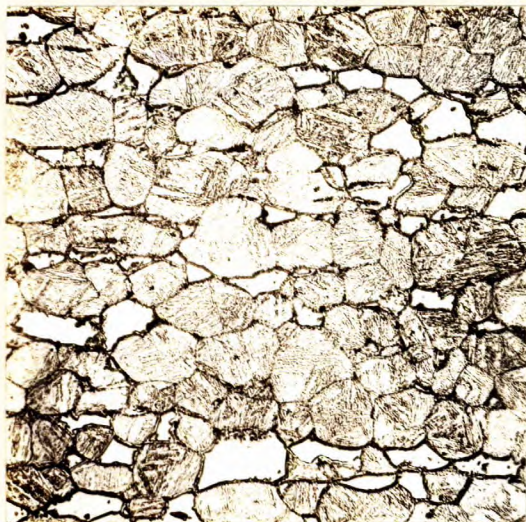
Figure 7.

X100. Electro-polish,
etch in alcoholic solution
of 5% HCl and 1% picric acid.

STRUCTURE WHEN HEATED TO 2250° F.,
HELD FOR 5 HOURS, COOLED TO 1300° F.,
HELD FOR 5 HOURS, AIR COOLED.

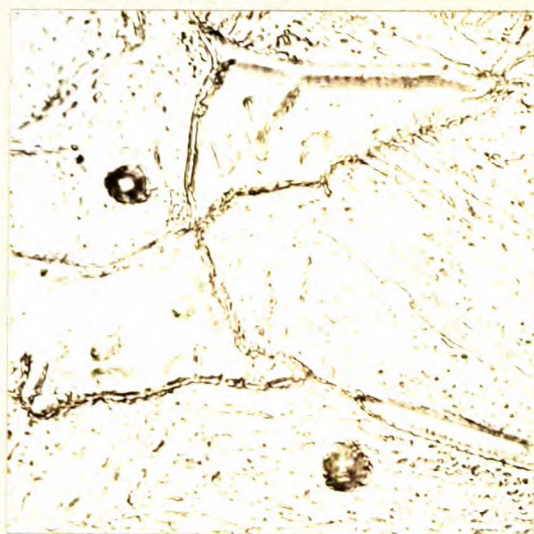
Figure 8.

X1000. Electro-polish,
Etch in alcoholic solution
of 5% HCl and 1% picric acid.

STRUCTURE WHEN HEATED TO 2250° F.,
HELD FOR 5 HOURS, COOLED TO 1300° F.,
HELD FOR 5 HOURS, AIR COOLED.

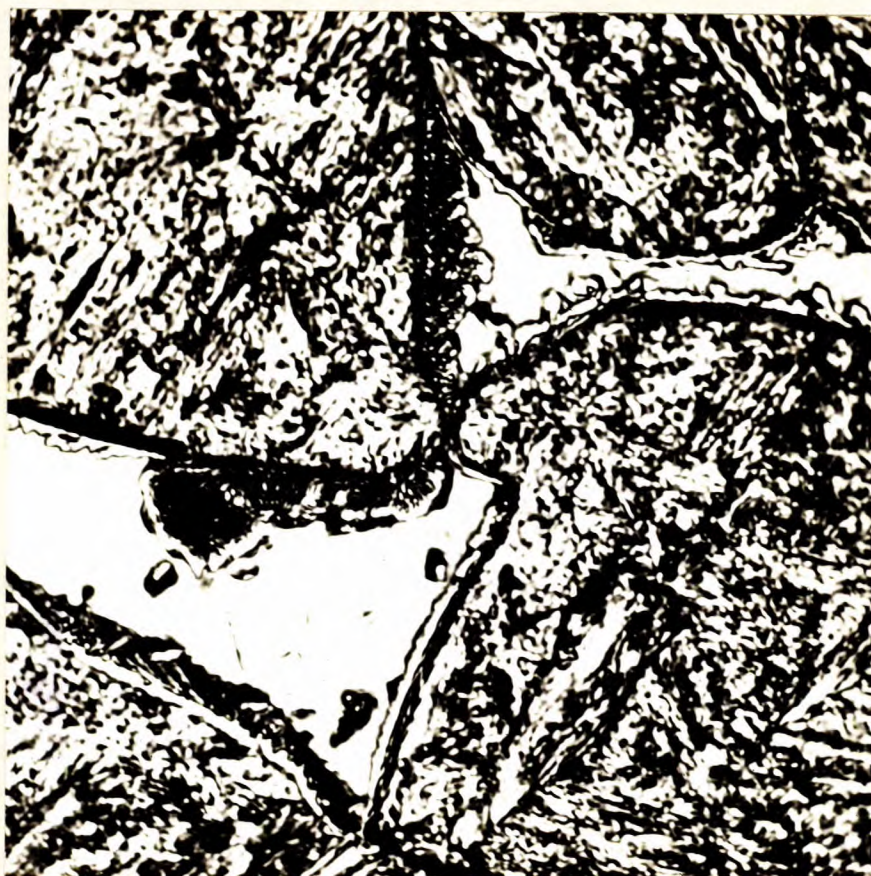
Figure 9.

X2000. Hand polish, electrolytic etch in
10% alcoholic hydrochloric acid solution, 4V, 0.4A, 10 seconds.

STRUCTURE WHEN HEATED TO 2250° F., HELD FOR 5 HOURS,
COOLED TO 1300° F., HELD FOR 5 HOURS, AIR COOLED.

Reveals carbide phase (clear white) around areas of ferrite.

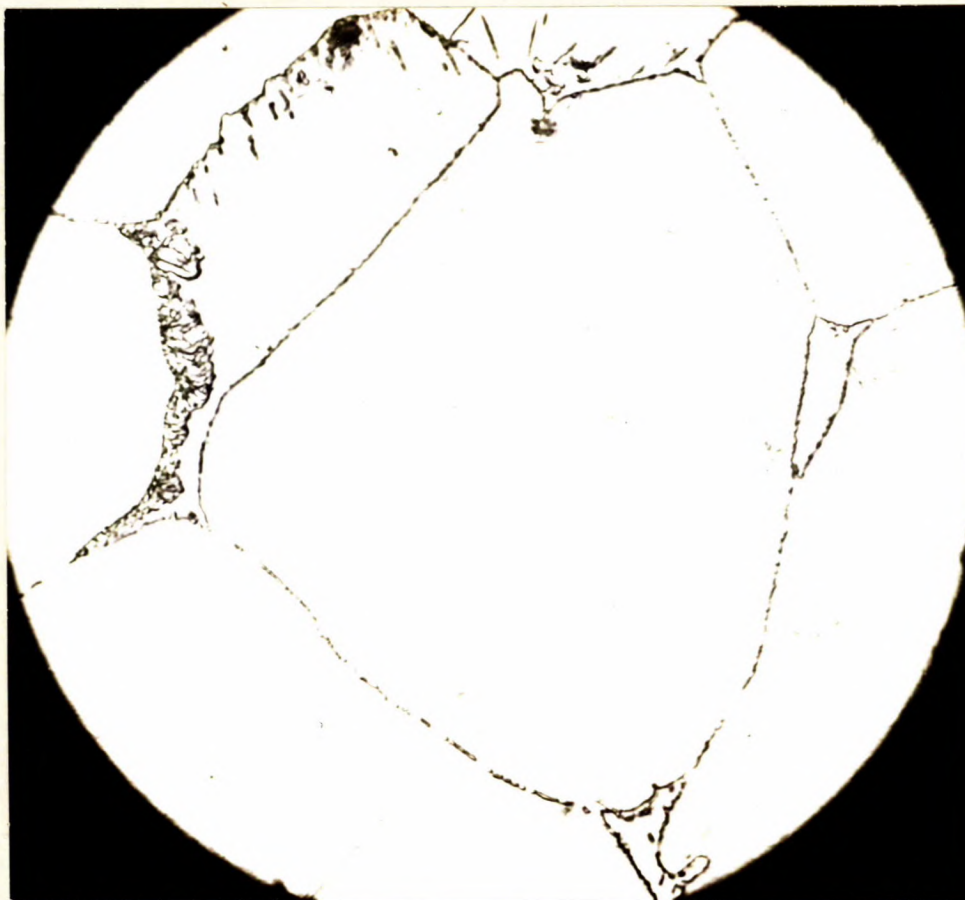
Figure 10.

X1000. Hand polish, electrolytic etch in 10% aqueous solution of tartaric acid, 6V, 0.15A, 8 minutes.

STRUCTURE WHEN HEATED TO 2250° F., HELD FOR 5 HOURS, COOLED TO 1300° F., HELD FOR 5 HOURS, AIR COOLED.

Note carbide at grain boundaries and also in ferrite. Large grains are martensite.

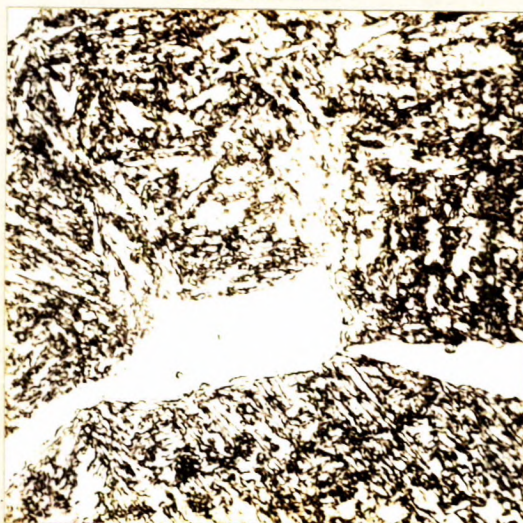
Figure 11.

X1000. Electro-polish, etch in alcoholic solution of 5% HCl, 1% picric acid.

STRUCTURE WHEN HEATED TO 2250° F., HELD FOR 5 HOURS, AIR COOLED; HEATED TO 1800° F., HELD FOR 2 HOURS, OIL QUENCHED; AND HEATED TO 1200° F., HELD FOR 1 HOUR, OIL QUENCHED.

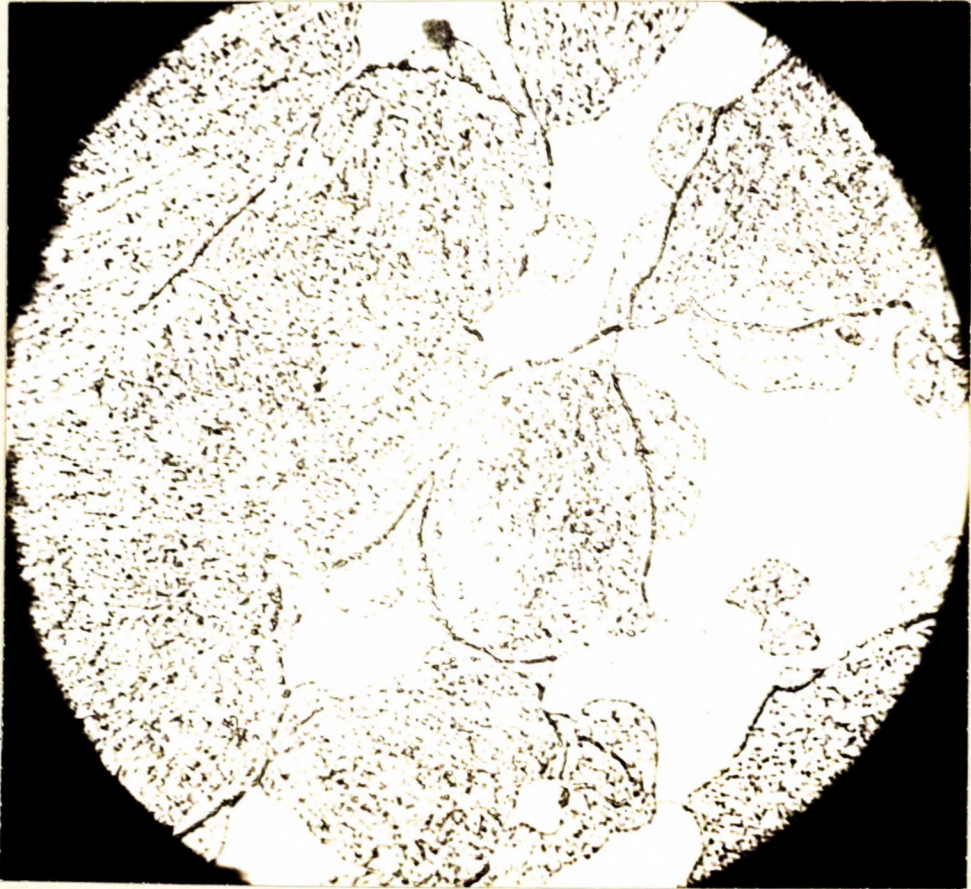
X1000. Hand polish, electrolytic etch in 10% aqueous tartaric acid solution, 6V, 0.15A, 8 minutes.

STRUCTURE WHEN HELD AT 2250° F. FOR 5 HOURS,
AIR COOLED; HEATED TO 1800° F., HELD FOR 2 HOURS
OIL QUENCHED; AND HEATED TO 1200° F., HELD FOR
1 HOUR, OIL QUENCHED.

Note persistence of carbide network formed by 2250° F. treatment. This exists at the old boundary between ferrite and martensite. Note that amount of ferrite has decreased.

Evidence that these carbides are not eliminated after 2 hours at 1800° F. is given in Figure 12. The impact strength after this treatment is 6 foot pounds for A₁ and 4 foot pounds for B₁. This is probably because more carbides were formed in Treatment B than in Treatment A. It will be noted that the martensite in these two specimens etched because they were tempered. The original boundaries of the ferrite that existed after Treatments A and B are still outlined by carbides in Figure 12. Note that some of the ferrite has been converted through the delta-to-gamma reaction to martensite.

Owing to the very slow rate of solution of this carbide at 1800° F., as is evident in Figures 12 and 20, a normal heat treatment could not be expected to remedy this situation.

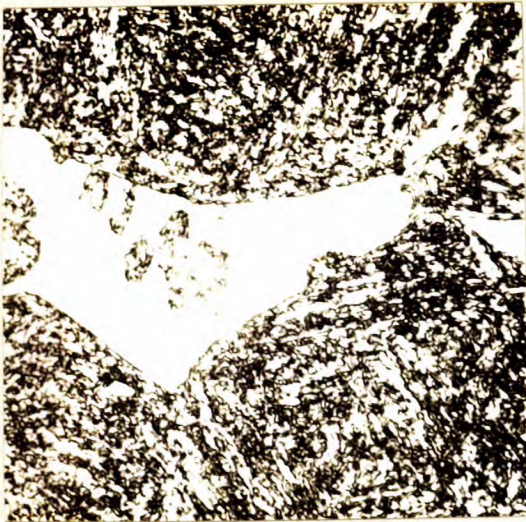
Figure 13.

X1000. Electro-polish, etch
in alcoholic solution of 5% HCl,
1% picric acid.

STRUCTURE WHEN HEATED TO 2250° F.,
HELD FOR 5 HOURS, COOLED TO 1300° F.,
HELD FOR 5 HOURS, AIR COOLED; HEATED
TO 1800° F., HELD FOR 2 HOURS, OIL
QUENCHED; HEATED TO 1200° F., HELD
FOR 1 HOUR, OIL QUENCHED.

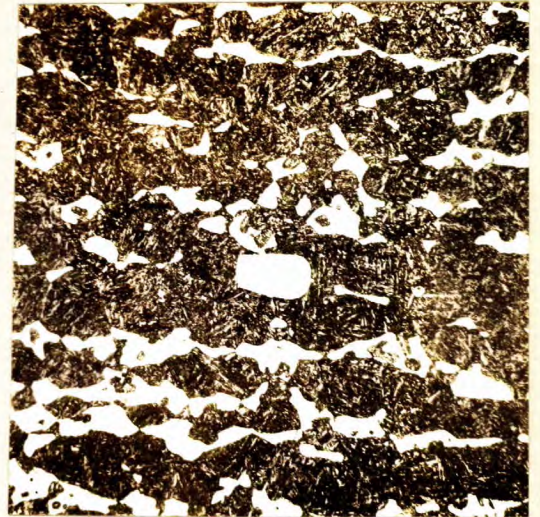
Figure 14.

X100. Electro-polish, etch
in alcoholic solution of 5% HCl
and 1% picric acid.

STRUCTURE WHEN HEATED TO 2250° F.,
HELD FOR 5 HOURS, AIR COOLED;
HEATED TO 1850° F., HELD FOR
3 HOURS, AIR COOLED; HEATED TO
1800° F., HELD FOR 2 HOURS, OIL
QUENCHED; HEATED TO 1200° F.,
HELD FOR 1 HOUR, OIL QUENCHED.

However, when the ferrite is arranged as shown in Figures 14 and 15, the more or less random arrangement of the ferrite might have the effect of quite markedly reducing the impact strength.

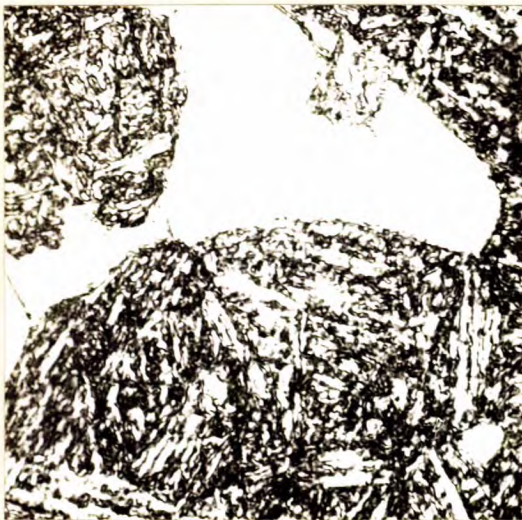
Figure 15.

Photomicrograph, X1000.

SAME AS FIGURE 14.

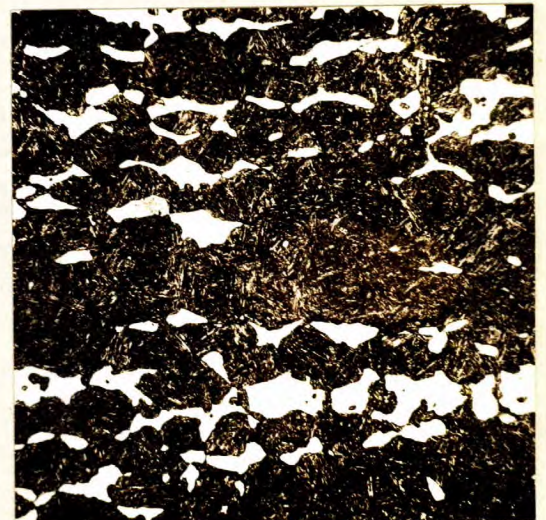
Figure 16.

X100. Electro-polish, etch
in alcoholic solution of 5% HCl
and 1% picric acid.

STRUCTURE AFTER HEATING TO 2250° F.,
HELD 5 HOURS, COOL TO 1300° F., HELD 5
HOURS, AIR COOLED; HEATED TO 1850° F.,
HELD 3 HOURS, A.C., HEATED TO 1800° F.,
HELD 2 HOURS, O.Q.; AND HEATED TO
1200° F., HELD 1 HOUR, O.Q.

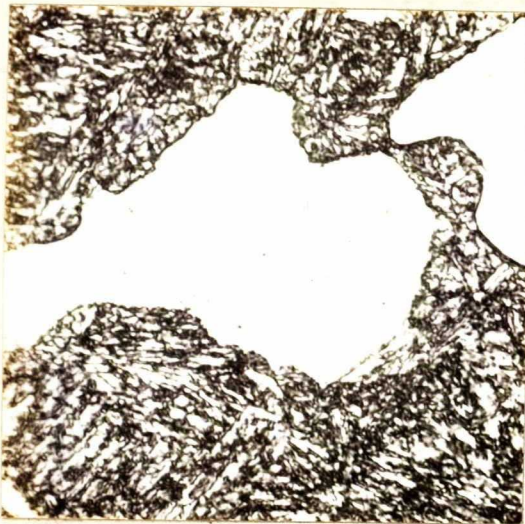
Figure 17.

Photomicrograph, X1000.

SAME AS FIGURE 16.

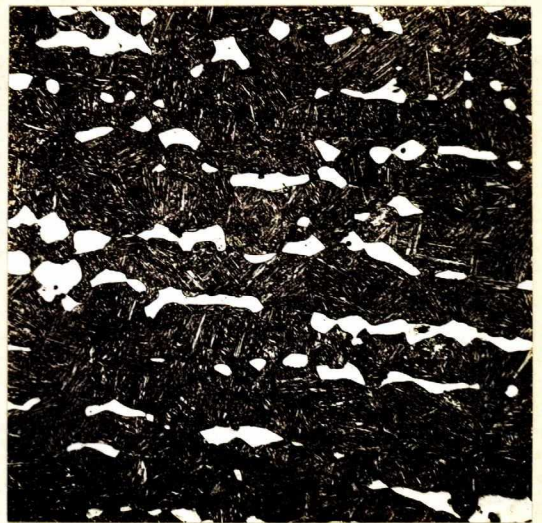
Figure 18.

X100. Electro-polish, etch
in alcoholic solution of 10% HCl
and 1% picric acid.

STRUCTURE AFTER HEATING TO 2250° F
5 HOURS, AIR COOLED; 1800° F.,
10 HOURS, O.Q.; 1200° F., 1 HOUR,
O.Q.

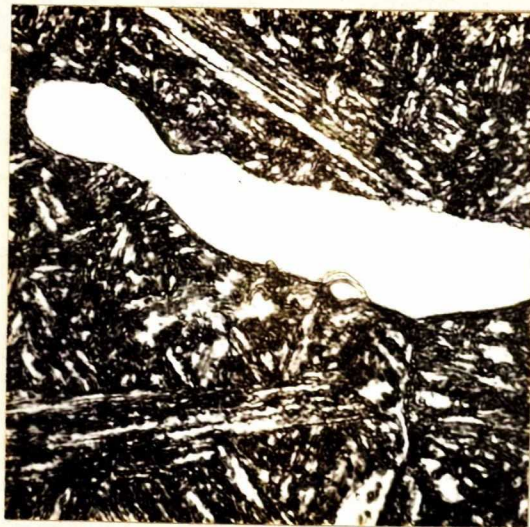
Figure 19.

X1000. Same as Figure 18, except
electrolytically etched in 10%
alcoholic solution of HCl for
10 seconds at 4V and 0.4A.

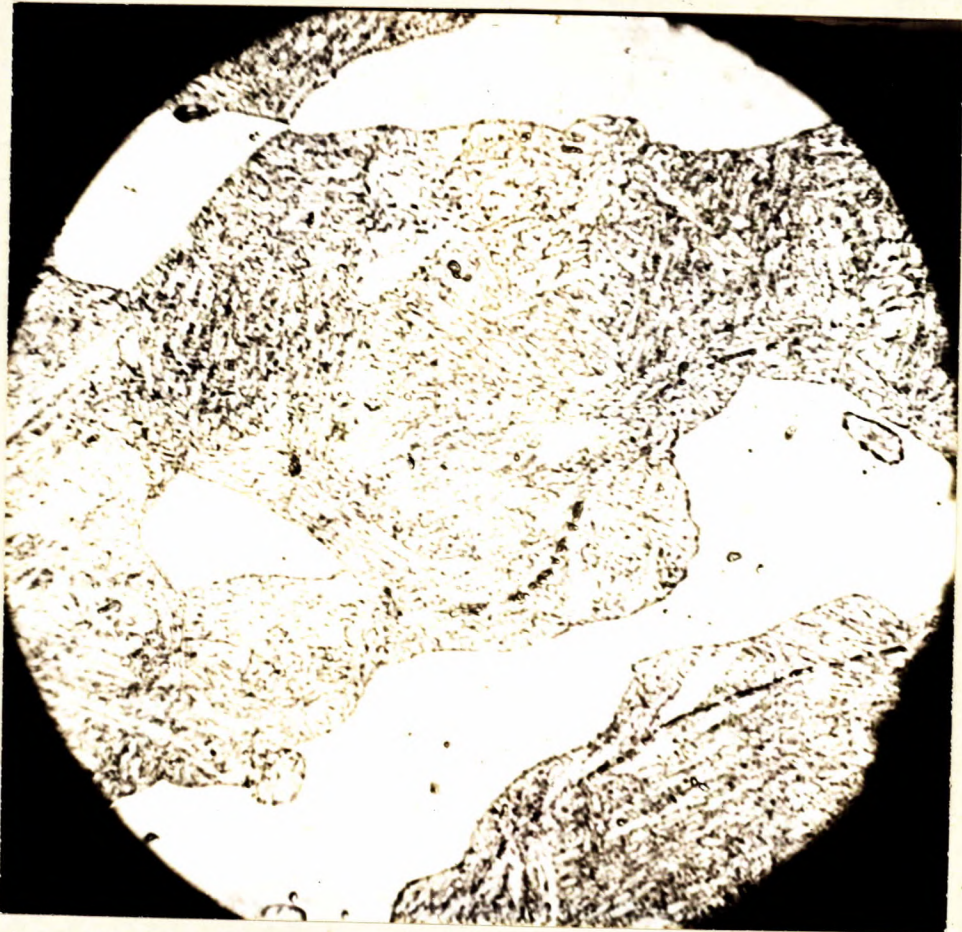
Figure 20.

X1000. Hand polish, electrolytic etch in 10% aqueous tartaric acid solution, 6V, 0.15A, 8 minutes.

STRUCTURE AFTER HEATING TO 2250° F.,
5 HOURS AND AIR COOLED; 1800° F., 10 HOURS,
OIL QUENCH; 1200° F., 1 HOUR, OIL QUENCHED.

Note that much of the carbide network has been
dissolved by the 10-hour treatment at 1800° F.

Figure 20 shows that even after 10 hours at 1800° F. some of these carbides still persist. The improvement in impact strength is attributed to the elimination of most of this carbide network.
