ORE DRESSING AND METALLURGICAL LABORATORIES.

Investigation No. 1425.

Examination of Three Broken Manganese
Steel Jaw Crusher Plates.

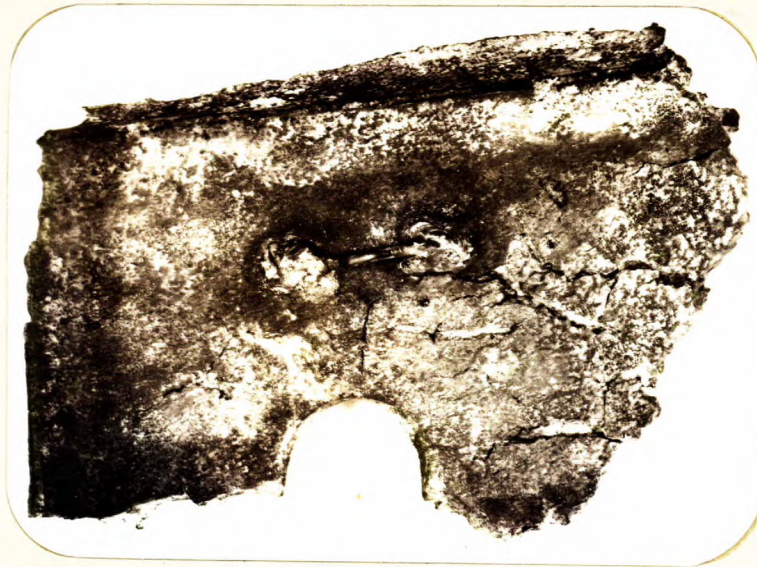
Sample marked 1, in the "as received" condition, was severely cracked and covered with rust (Figure 1).

SAMPLE MARKED 1, IN THE 'AS RECEIVED' CONDITION.

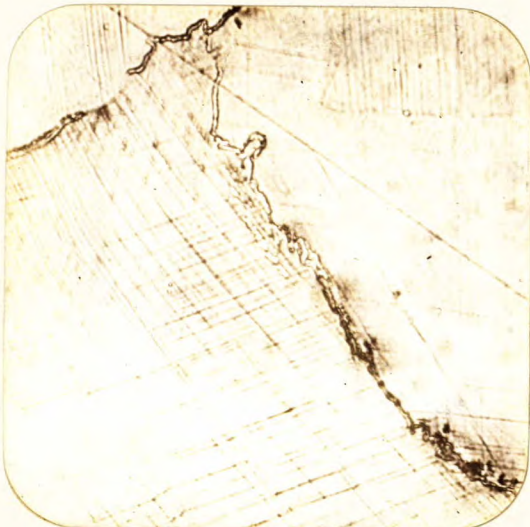
Figure 2.

Figure 2 (X500) shows the free carbides on the grain boundaries of the twinned austenite (sample marked 1).

X500, nital etch.
FREE CARBIDES ON GRAIN
BOUNDARIES OF TWINNED AUSTENITE
IN SAMPLE MARKED 1.

The photomicrographic examination of the three samples has revealed that all three of them contained free carbides. The latter are especially objectionable when they are present at the grain boundaries of the steel. Their presence might be caused either by a too low quenching temperature or by a too short soaking period at this temperature. The temperature of quenching should be 1950° F. to 2000° F. The

soaking time should be long enough to allow all the carbides to go into solution.

The detrimental influence of these carbides might have been the cause of failure of the material.

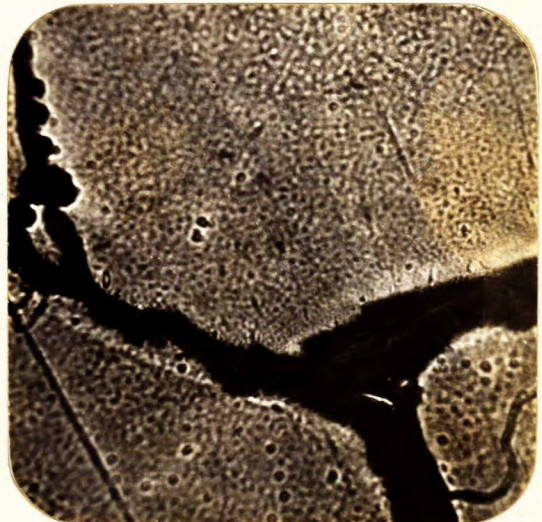
Figure 3.

Figure 3 (X500) shows an intercrystalline fracture

in the same sample.

X500, nital etch.
INTERCRYSTALLINE FRACTURE OF
SAMPLE MARKED 1.

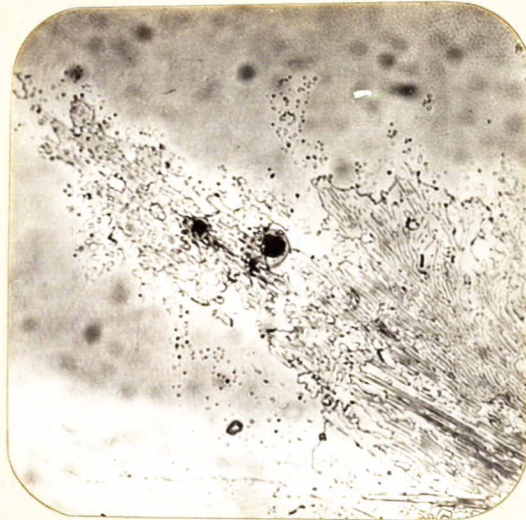
Figure 6.

Figures 5 (X100) and 6 (X500) show the lamellar distribution of carbides in austenite in the sample marked 3.

X500, nital etch.

SHOWING DISTRIBUTION OF CARBIDES
IN AUSTENITE (IN SAMPLE MARKED 3).
