Investigation No. 1442.

Examination of Samples from Airscrew Retaining
Mechanism Thrust Washers.

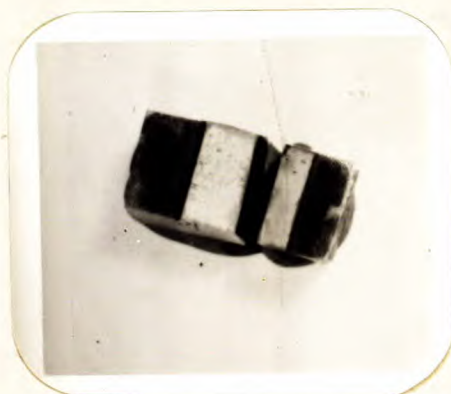
The "as received" specimens were notched and then fractured. Marked differences in the appearance of fractures of different samples were observed. Samples 1 and 2 showed excellent glassy fractures. Samples 3 and 12 exhibited good fractures. The other samples fractured badly, Samples 5 to 9 inclusive showing particularly poor breaks. A comparison between the fractures of Samples 2 and 9 is given in Figure 1.

COMPARING THE FRACTURES OF
SAMPLES 2 and 9.

Although the small size of the samples prohibited actual measurement of the impact strength, a rough estimate made from the severeness of the blow needed to fracture the different materials showed that the samples exhibiting poor fractures were more brittle than those which broke with fine silky fractures.

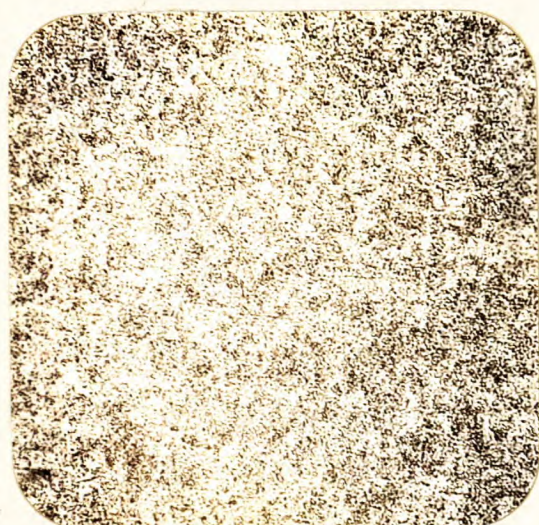
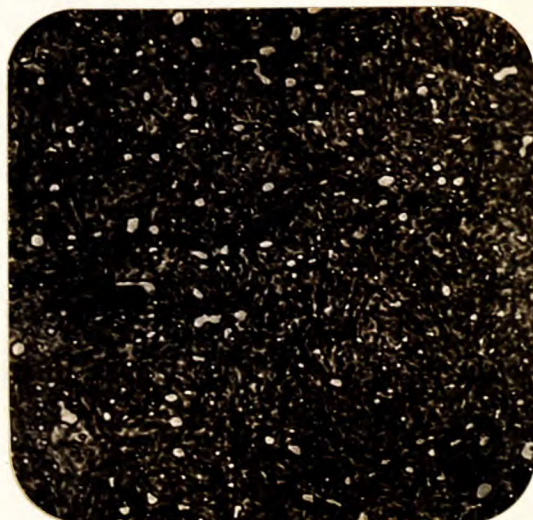
Figure 2.

Reproduction of two photomicrographs of each of these three groups is given in Figures 2 to 7. The representative samples of the three groups are, respectively, Nos. 1, 12, and 9. Within a same group, the structures of all samples are quite similar.

Microstructures shown in Figures 2 to 7 are all finely troostite-martensitic, containing free embedded carbide. Carbide envelopes were found in the nine samples of the third group. In the first and second groups these carbide envelopes can be detected only by a close examination.

X200, nital etch.

X1500, nital etch.

MICROSTRUCTURE OF SAMPLE 1, REPRESENTATIVE
OF GROUP 1.

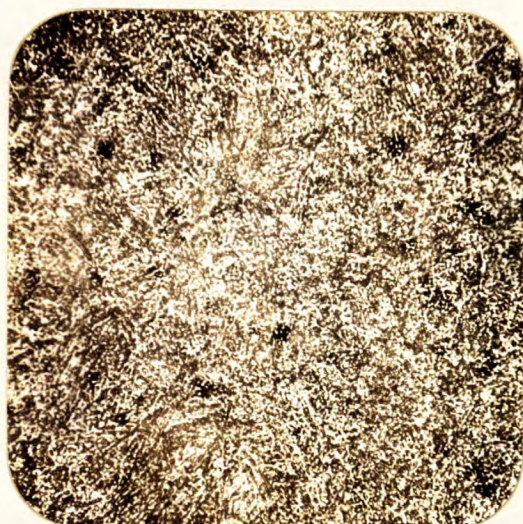
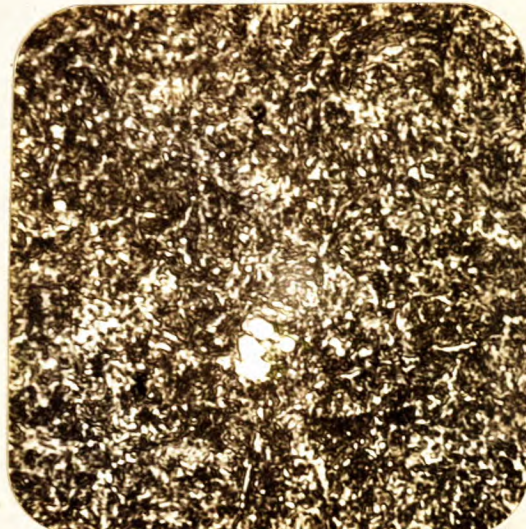
Figure 3.

X200, nital etch.

X1500, nital etch.

MICROSTRUCTURE OF SAMPLE 12, REPRESENTATIVE
OF GROUP 2.

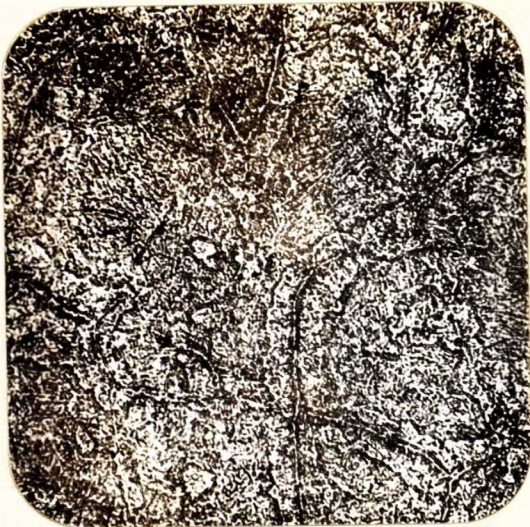
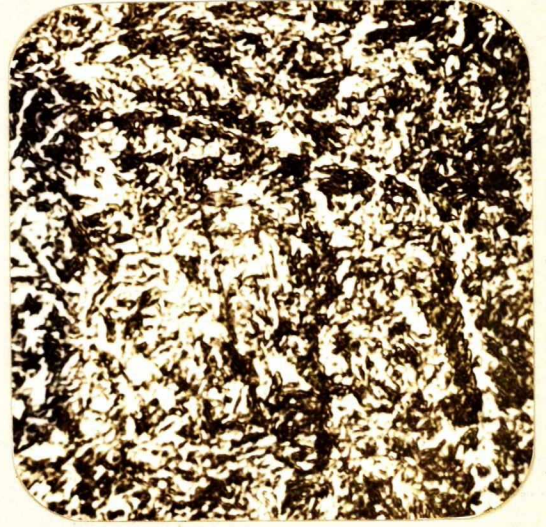
Figure 6.

X200, nital etch.

X1500, nital etch.

MICROSTRUCTURE OF SAMPLE 9, REPRESENTATIVE OF GROUP 3.

This investigation has shown that the recommended annealing operation spheroidizes the carbides uniformly although the steel still shows slight evidence of carbide envelopes. If the annealing operation had been properly carried out on the forgings which had been finished at high temperature, these would not show carbide networks such as the one exhibited by Sample 9 (see Figures 6 and 8) unless

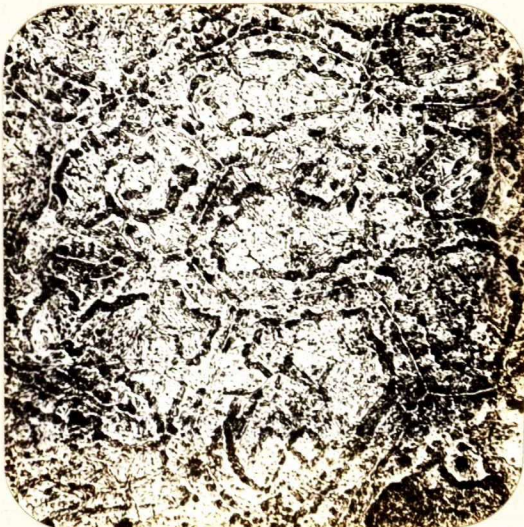
Figure 8.

Figure 8 is a photomicrograph of the structure of Sample 9 after quenching from 2000° F. Note the remaining carbide envelopes and the marked coring from the first solidified product.

X200, nital etch.
SAMPLE 9, AS QUENCHED FROM
2000° F.
Note presence of coring.

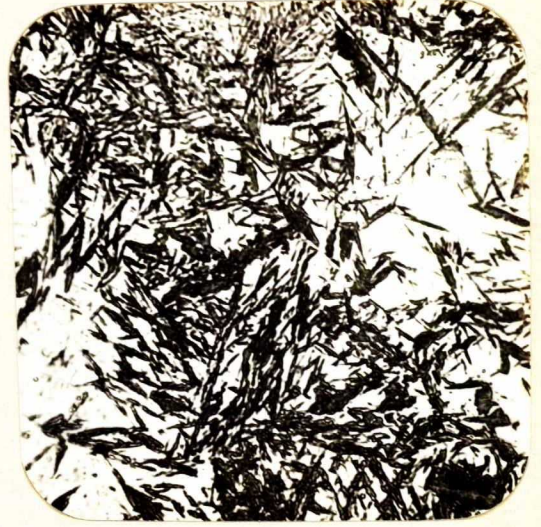
Figure 9.

To check on the effect of improper heat treatment, samples were overheated at 2200° F. and underheated at 1800° F. In the first case (Figure 9) the specimen revealed a coarse structure of retained austenite and martensite. In the second case (Figure 10), the structure was martensitic, containing free carbide.

X500, nital etch.
AFTER QUENCHING FROM 2200° F.

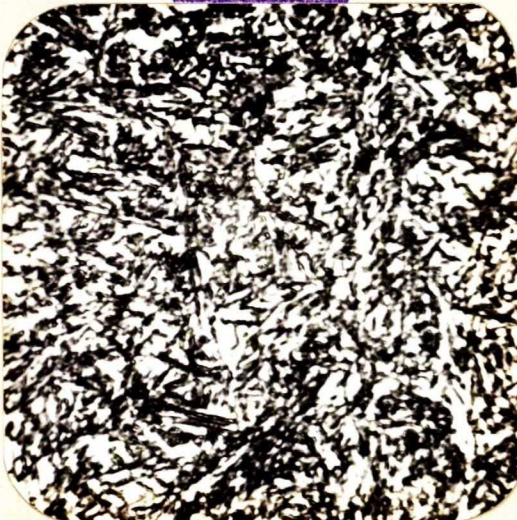
Figure 10.

X1000, nital etch.
MICROSTRUCTURE OF THE STEEL AS
QUENCHED FROM 1800° F.

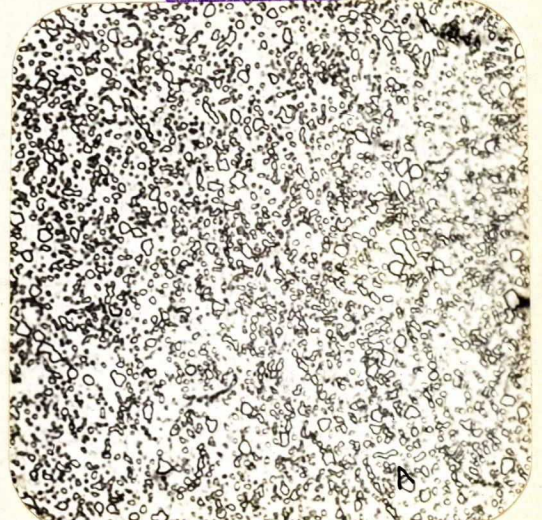
Figure 11.

Another sample was given the recommended annealing treatment. A very fine distribution of spheroidized carbides in a matrix of ferrite was found. Figure 11 shows this microstructure. Note the slight evidence of carbide envelopes at "A".

X1500, nital etch.
MICROSTRUCTURE OF THE
STEEL ANNEALED.

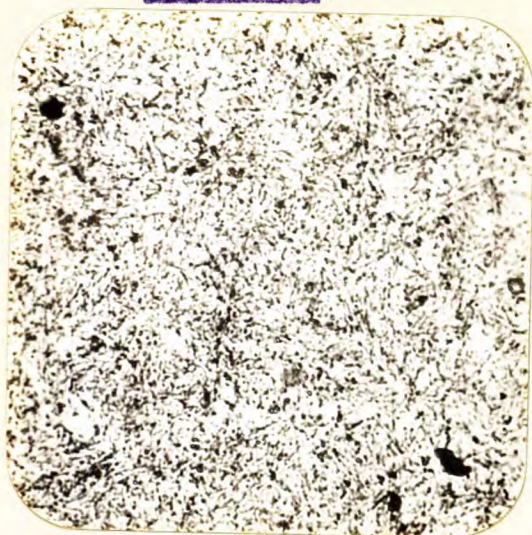
Figure 12.

One sample (Sample 1) was given a $K_3Fe(CN)_6 + KOH$ etch in the hope that the carbide distribution might be better developed. However, it is believed that the carbide pattern is shown quite as well with the nital etch (see Figure 12).

X500.
CARBIDE PATTERN IN SAMPLE 1
AFTER ETCHING IN BOILING
 $K_3Fe(CN)_6$ + KOH solution.

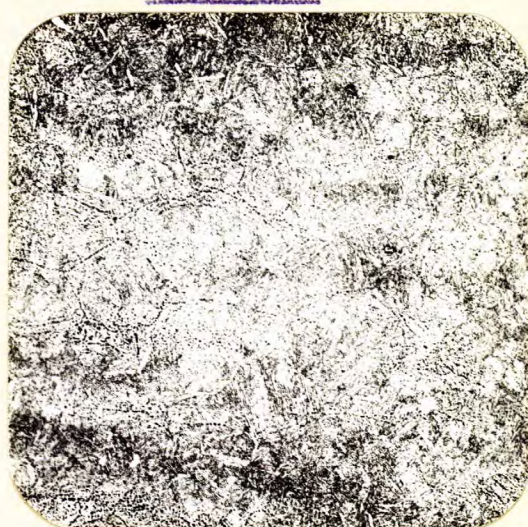
Figure 13.

In order to determine whether the carbide envelopes could be removed by the final high-temperature treatment, Sample 9 was given a new hardening treatment at the recommended temperature. It was allowed to remain in the furnace at 2000° F. for fifteen minutes. The result is shown in Figure 13, where it can be seen that carbide envelopes still

remain, although smaller in size and less continuous.

X200.
CARBIDE ENVELOPES IN SAMPLE 9
AFTER REMAINING IN FURNACE FOR
15 MINUTES AT 2000° F. AND THEN
QUENCHING.

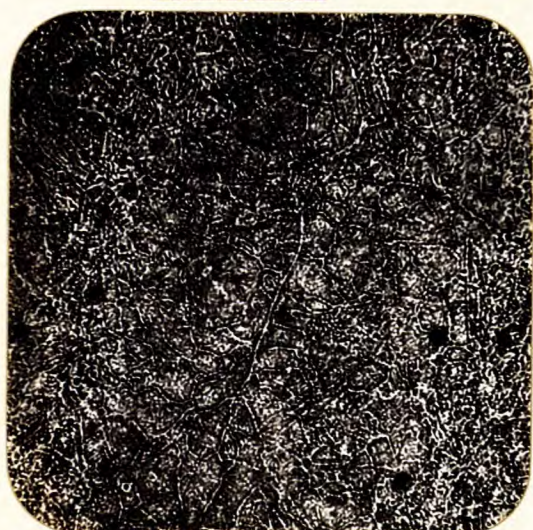
Figure 14.

Further on, a wrong annealing treatment was suspected to be a cause of the remaining of the carbide envelopes in the final product. Sample 5 "as received" (Figure 14) was annealed properly. Figure 15 shows the result of the proper anneal. Note the lack of continuity of carbide envelopes, which are now spheroidized. The final hardening treatment was given also. Note the final disappearance of carbide envelopes (Figure 16) after the full heat treatment.

X500.
SAMPLE 5, AS RECEIVED.

A comparison of Figures 14, 15, and 16 gives a very definite answer to the question of whether the carbide envelopes can be removed by proper annealing followed by hardening. The treatment responsible for the removal of carbide envelopes is really the annealing treatment which definitely spheroidizes the carbides and then takes off the continuity. This treatment is quite critical and it should be pointed out strongly that the 32-hour-cooling specification should be thoroughly observed.

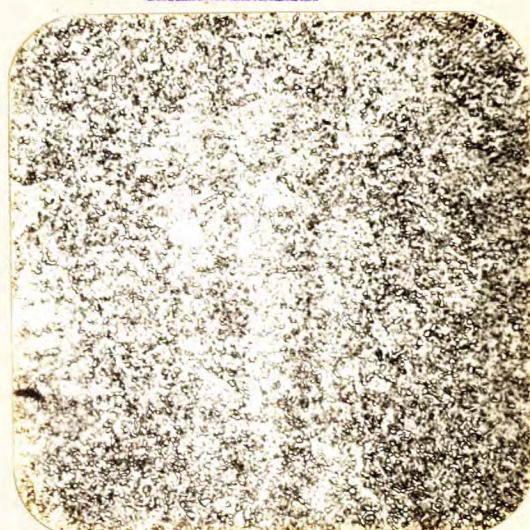
Figure 15.

X500.
SAMPLE 5, ANNEALED.
Showing discontinuity of carbide
envelopes.

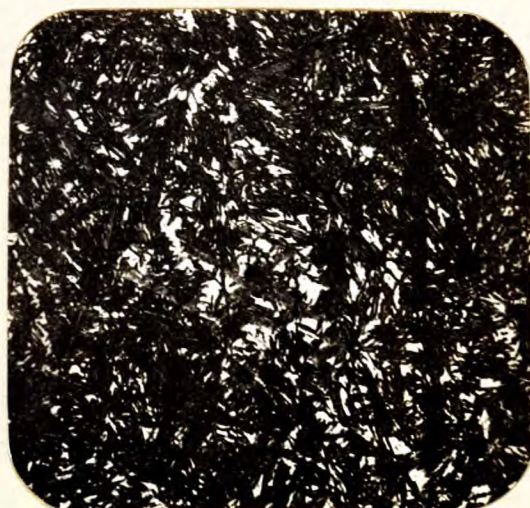
Figure 16.

X500.
SAMPLE 5, AFTER ANNEALING
AND HARDENING.
Note disappearance of carbide
envelopes.
