ORE DRESSING AND METALLURGICAL LABORATORIES.

Investigation No. 1449.

Examination of Sample of Flame-Hardened Armour Plate.

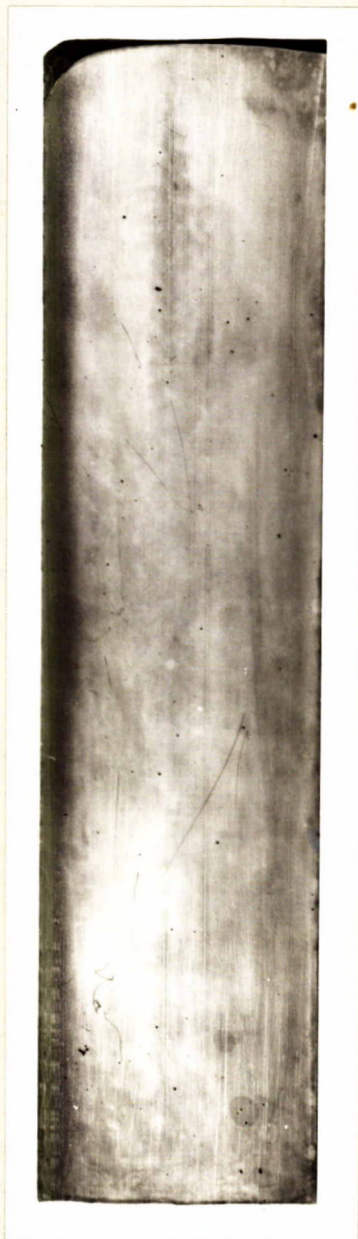
Figure 1.

Macro-etched (ammonium persulphate solution)
section of flame-hardened armour plate,
showing hardened case approximately 0.30
inch in depth and a wide transition zone.

(2) Two $\frac{3}{4}$ -in.-thick sections at right angles to one another were machined from the sample and macro-etched. Neither section showed an overlap of two passes of the flame-hardening head. Figure 1 is a macro-etched section showing the depth of the hardened zone.

An examination of Figures 1 and 2 shows a hardened zone approximately 0.50 inch in depth and a wide transition zone. A case depth of this magnitude on a plate of this thickness would require very slow hardening rates.

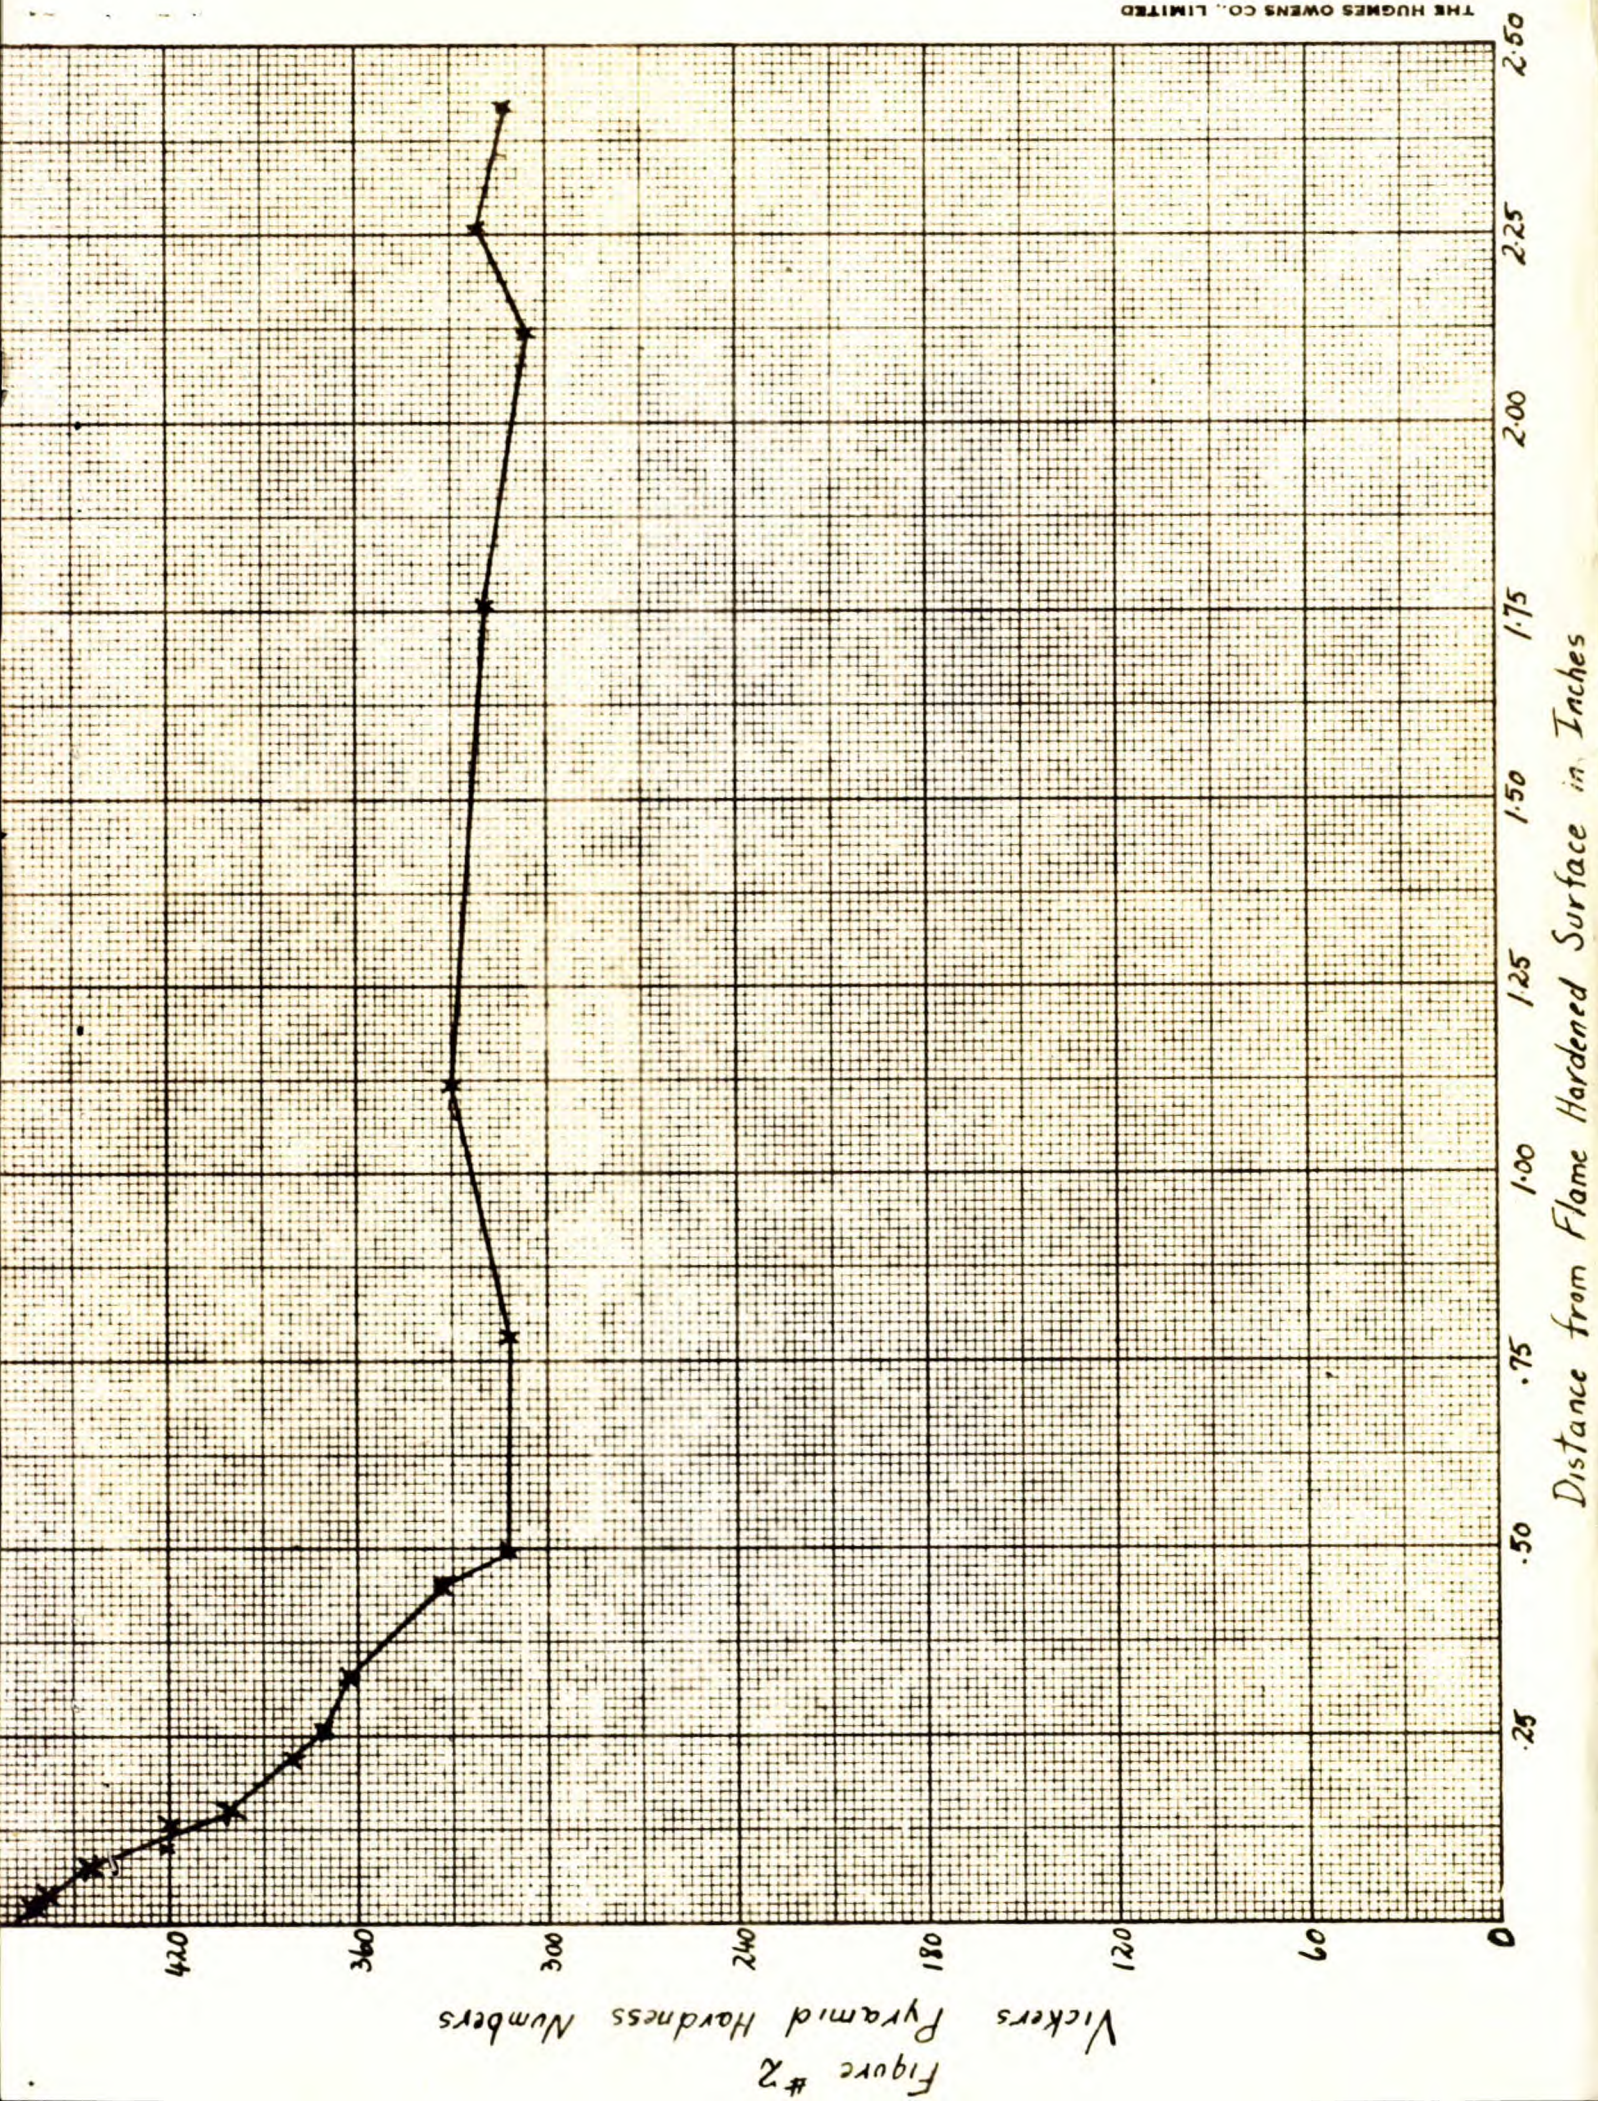
(5) Hardness readings, using a Vickers hardness tester and a 10-kg. load, were taken from surface to surface. Figure 2 shows a graph of hardness versus distance from surface.

(Figure 2, on next page, is a graph of
hardness vs. distance from surface.)

for flame hardening, in that the low carbon and manganese and high nickel and the absence of chromium and vanadium would result in a steel of low hardenability (Grossman hardenability factor, 2.4 inches), for the high percentage of nickel present does not greatly contribute to steel hardenability. The low hardenability is confirmed by the presence of precipitated ferrite in the hardened case. The low carbon content would result in a wide critical range, which would account for the wide transition zone and the gradual reduction of hardness in the hardness traverse.

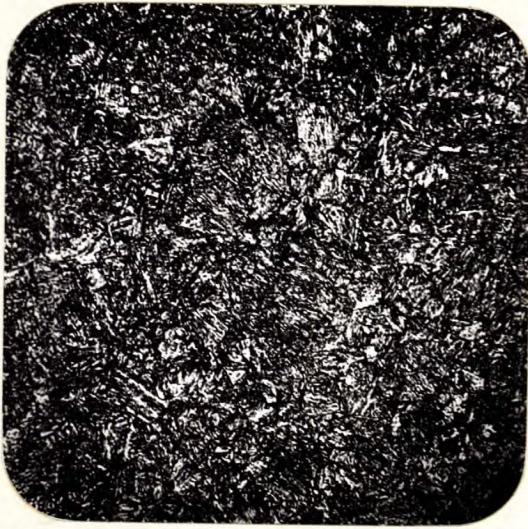
Figure 3.

X500, etched in
2 per cent nital.

MARTENSITIC STRUCTURE OF
CASE WITH SOME FERRITE
(WHITE AREAS).

(7) Sections at right angles to the flame-hardened surface were examined under the microscope. Figure 3 shows the structure of the flame-hardened zone. Figure 4 shows the structure of the transition zone. Figure 5 shows the structure of the core of the plate.

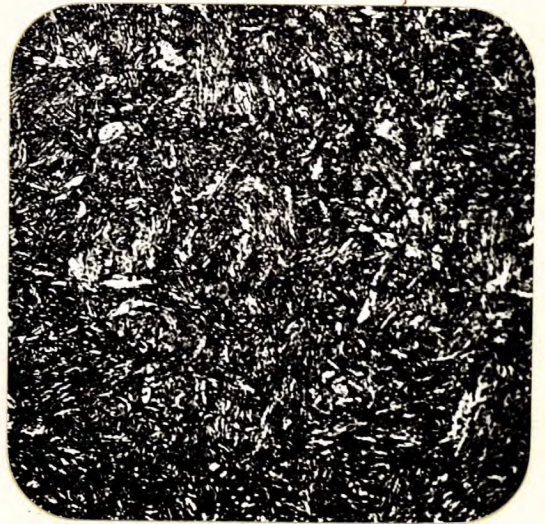
Figure 4.

X500, etched in
2 per cent nital.

TRANSITION ZONE - COARSE
MARTENSITE AND SOME FERRITE
(WHITE AREAS).

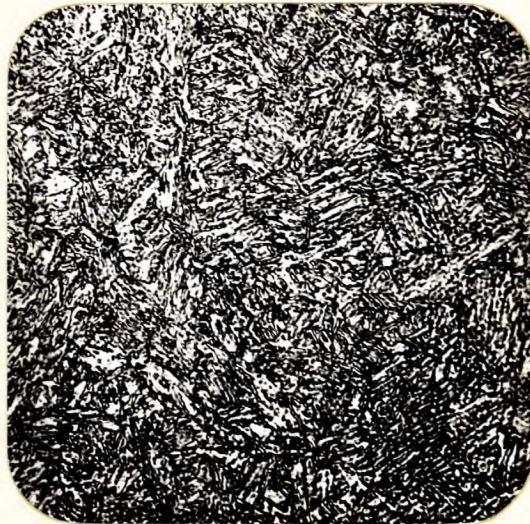
Figure 5.

X500, etched in
2 per cent nital.

CORE STRUCTURE - TEMPERED MARTENSITE.
