REPORT
of the
ORE DRESSING AND METALLURGICAL LABORATORIES.

Investigation No. 1450.

Examination of Manganese Steel from a
Crusher Cone.

DEPARTMENT
OF
MINES AND RESOURCES
Mines and Geology Branch

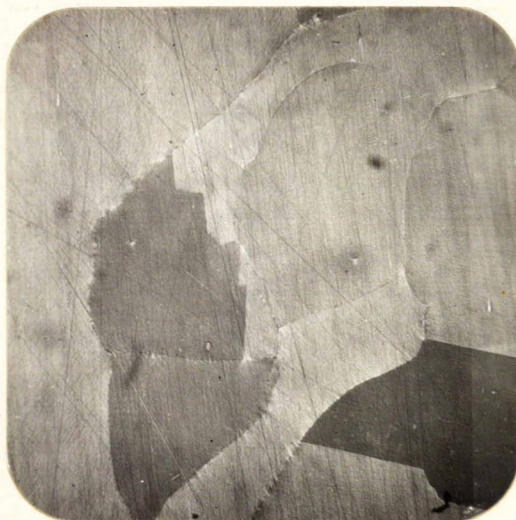
Figure 1.

No free carbides were present in the steel, though some porosity was found in the sample.

The grain size of the material is fairly large, as can be recognized in Figure 1 which is a photomicrograph of the steel "as received".

X100, picral etch.

MICROSTRUCTURE OF THE AUSTENITIC
MANGANESE STEEL.

However, the grain size of the material is definitely large. This is evidence of a high pouring temperature. It is possible to develop better properties in such a type of steel by refining the grain. This is done only by pouring the molten steel as cold as possible.
