ORE DRESSING AND METALLURGICAL LABORATORIES.

Investigation No. 1455.

Examination of Cast and Welded  
Ram Tank Return Idlers.

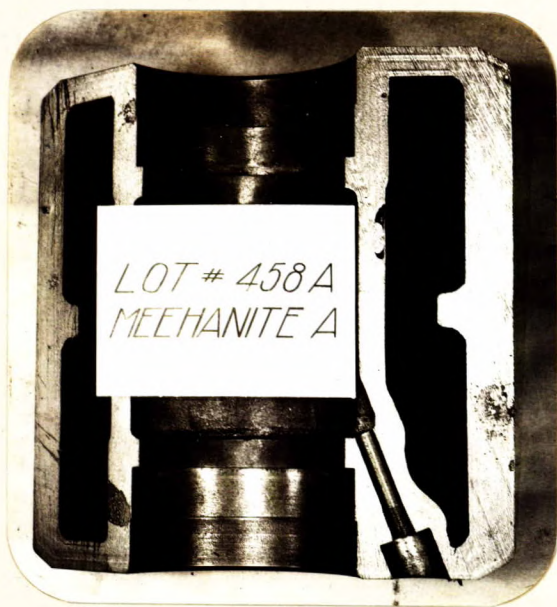
Figure 1.

All these rollers were sent to the National Research Council (Ottawa) for X-ray examination. Indications of unsoundness were observed only in Lots Nos. 458A and 452B. These areas were on the same side as the oil holes. A sectioning at these areas revealed blowholes, as shown in Figures 1 and 2. By their position with relation to the parting line on the casting it is indicated that these blowholes occurred in the cope side of the casting.

SECTIONS OF ROLLERS, SHOWING BLOWHOLES.

It is clear, from their position and type, that the defects found in these castings originate in the moulding or core-making practice. However, if the present design of casting is retained, defects of this size should have little effect on the roller performance.

1. Under present conditions of manufacture there is a doubtful difference between the Meehanite "B" and Meehanite "A" supplied.
2. Metallurgical examination indicates that some irregularities exist in the control of the manufacturing process.
3. Blowholes in the cope side of some of the castings indicate that there is room for improvement in moulding sand and core sand control.

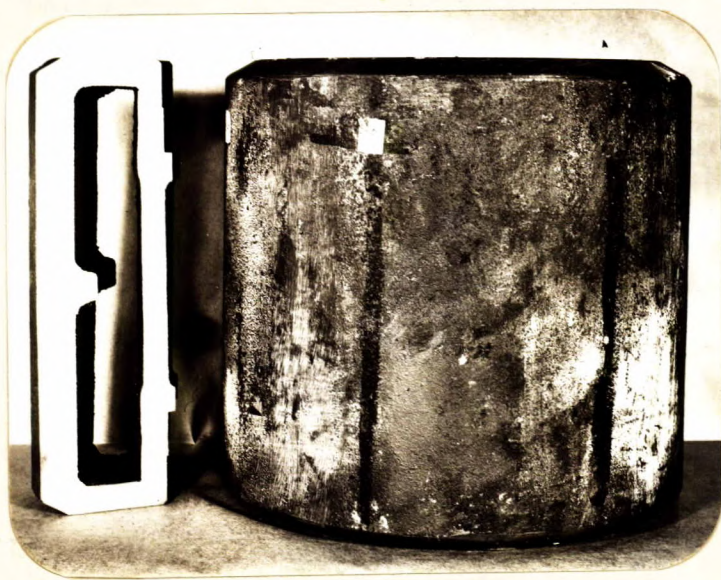
Figure 3.

The two steel rollers weighed 45 pounds each, while the weights of the machined cast rollers ranged from 68½ pounds to 72 pounds each. The "as cast" weight of these castings was about 80 pounds each. Views of the cross-section of the welded and cast rollers respectively are shown in Figures 3 and 4. The outer wall of the welded steel roller is 5/16" thick, while that of the cast iron roller is 3/4" thick with a reinforcing rib around the middle.

SECTION AND GENERAL VIEW OF A CAST ROLLER.  
(Approximately  $\frac{1}{4}$  actual size).

demonstrates its ability to consistently produce the higher process of Meehanite in castings reasonably free from blowholes, a change in design of the rollers be considered, reducing the outer wall of the roller to 1/4-inch thickness. When this is done the material specification should be advanced to at least Class No. 45. In the lighter section this should be equivalent to a Class 50 C.I.

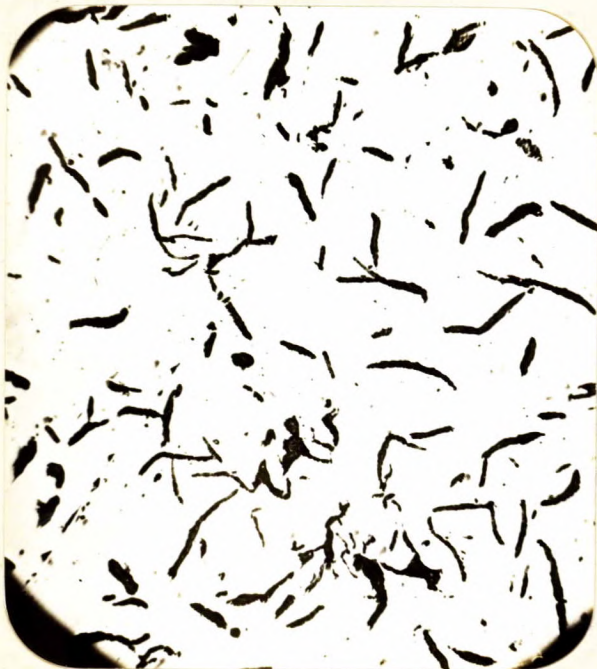
Figure 5.

Sections from the ends of the tensile bars were prepared for the microscope. Photomicrographs to show the graphite arrangement are shown in Figures 5, 6, 7, and 8. The microstructure of the graphite has been evaluated according to the tentative practice recommended by the American Society for Testing Materials, A.S.T.M. designation A-247-41T. These evaluations are given in Table III.

<u>A.E.D.B. Lot No.</u>	<u>Figure No.</u>	<u>Graphite Size</u>	<u>Graphite Type</u>
458-A	5	5	A
453-A	6	4	A
458-B	7	4	A
458-A	8	3	A

X100, unetched.  
PHOTOMICROGRAPH,  
A.E.D.B. LOT NO. 458A,  
SHOWING GRAPHITE.

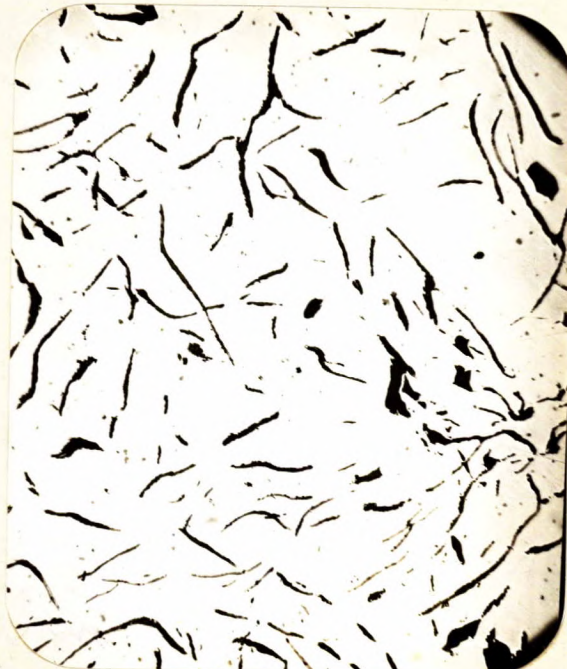
Figure 6.

X100, unetched.  
PHOTOMICROGRAPH,  
A.E.D.B. LOT NO. 453A,  
SHOWING GRAPHITE.

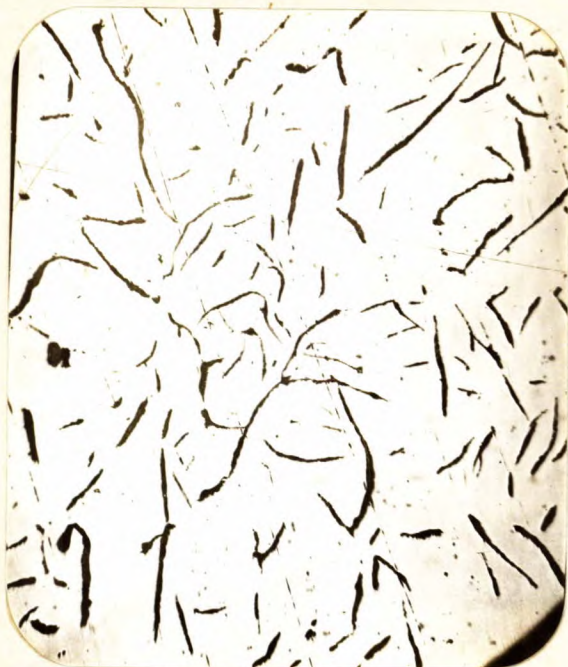
Figure 7.

X100, unetched.  
PHOTOMICROGRAPH,  
A.E.D.B. LOT NO. 452B,  
SHOWING GRAPHITE.

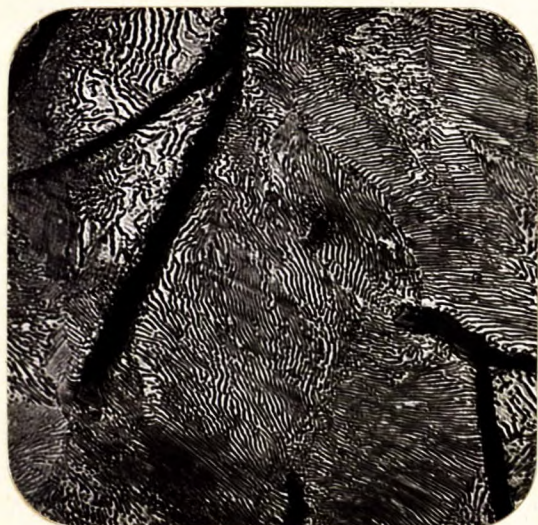
Figure 9.

The etched structure, showing the pearlite, is given in Figures 9, 10, 11, and 12. There are no massive areas of ferrite in this iron.

X500, picral etch.  
PHOTOMICROGRAPH,  
A.E.D.B. LOT NO. 458A.

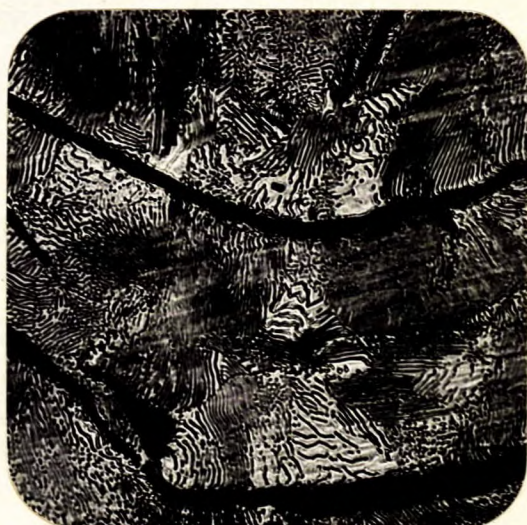
Figure 10.

X500, picral etch.  
PHOTOMICROGRAPH,  
A.E.D.B. LOT NO. 453A.

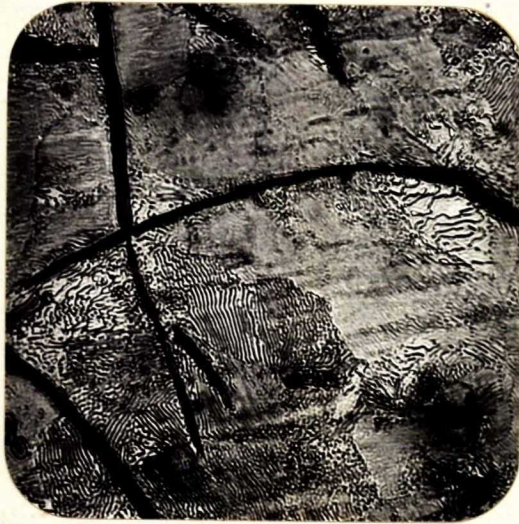
Figure 11.

X500, picral etch.  
PHOTOMICROGRAPH,  
A.E.D.B. LOT NO. 459B.
