ORE DRESSING AND METALLURGICAL LABORATORIES.

Investigation No. 1513.

Examination of Welded Splash Strips.

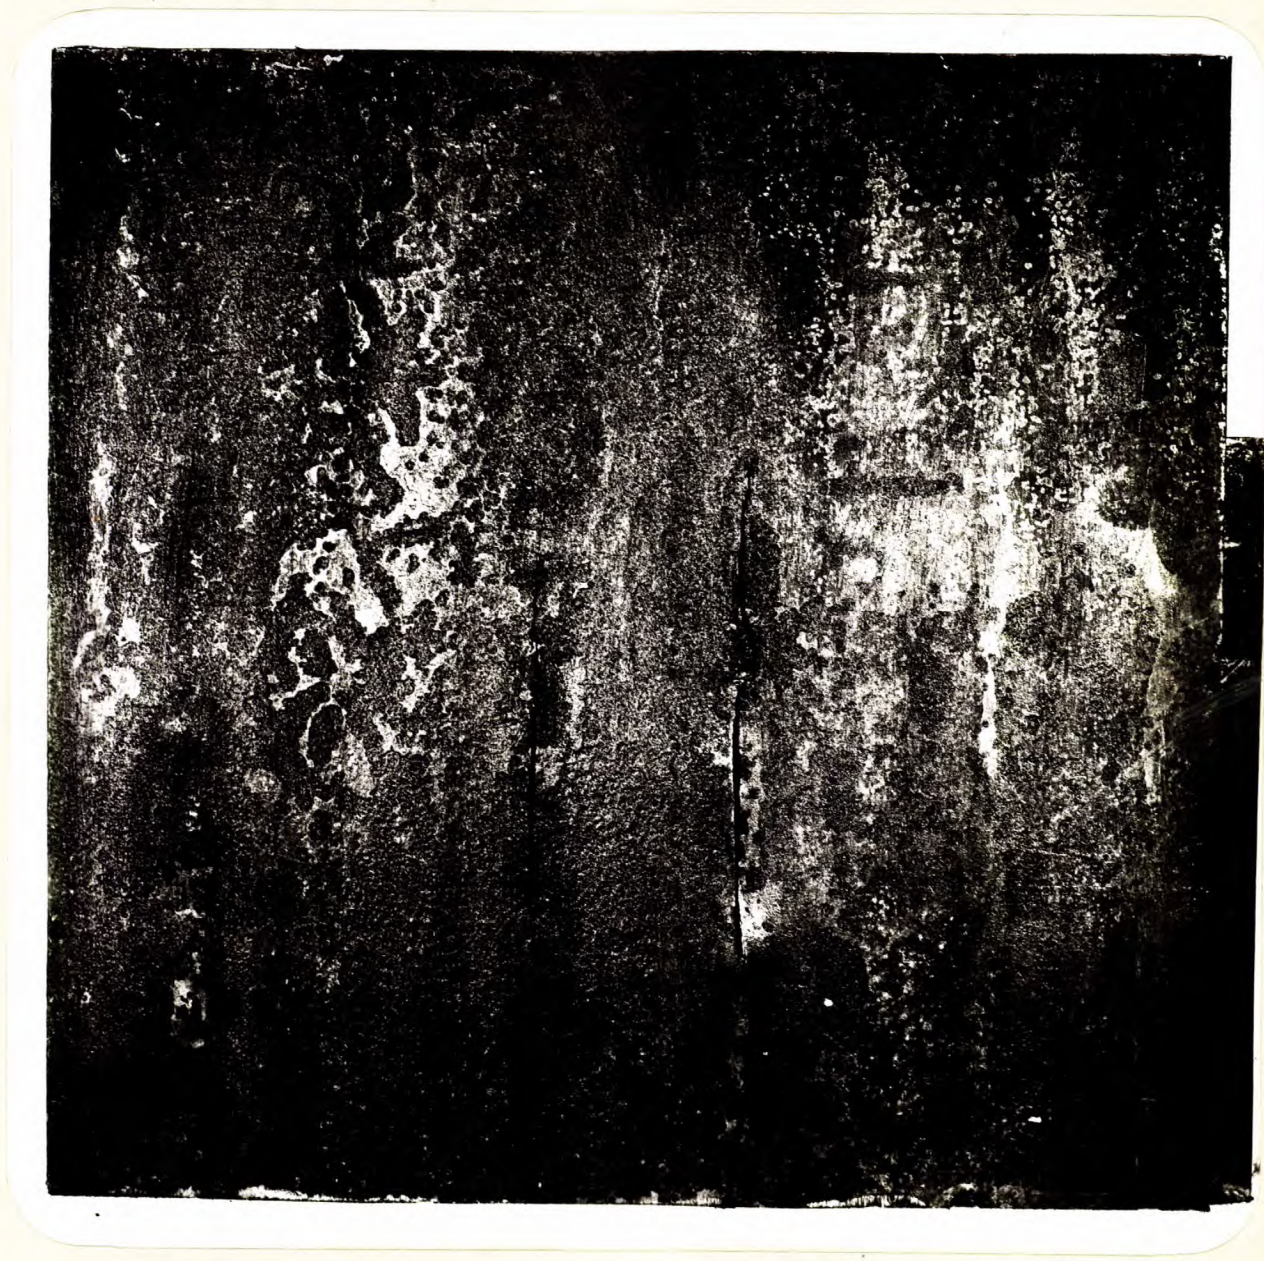
Figure 2.

PHOTOGRAPH OF BACK OF PLATE, SHOWING  
THE LOCATION AND EXTENT OF CRACKING.

1. The plate and welds were given a thorough visual examination.
2. Figure 1 is a photograph of the assembly as received, showing the location of the cracks. Figure 2 is a photograph of the back of the plate, showing the location and extent of cracking.
3. Sections of the welds were removed, polished, and etched. Figure 3 shows sections from Welds 1 and 5 (austenitic). Figure 4 shows sections of two austenitic plug welds (Welds 2 and 4). Figure 5 shows sections of Welds 2 and 3 (ferritic).
4. Samples were machined from the splash strips and the armour plate for chemical analysis. The following table

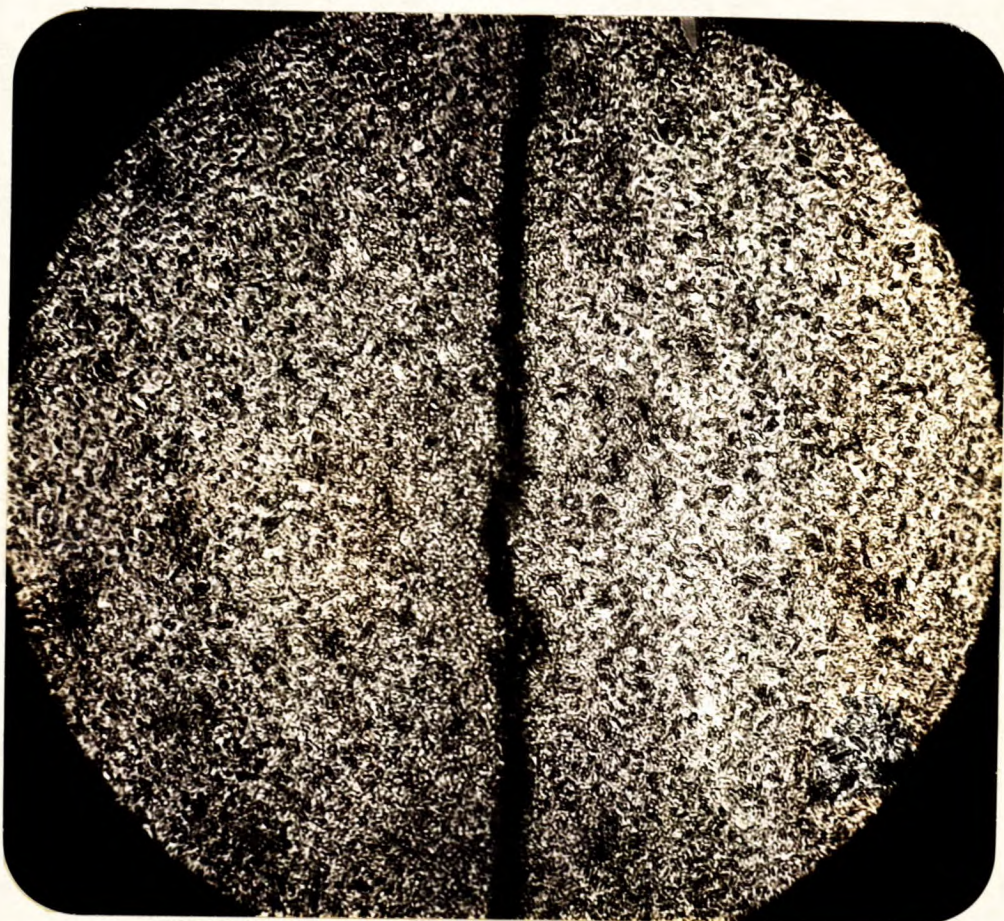
Figure 6.

5. Transverse sections of all welds were examined under the microscope. Figure 6 (obtained from Weld 2) shows the typical structure of the heat-affected zones close to the fusion line. A crack running through the heat-affected zone of Weld 2 may also be seen. Figure 7 shows the typical transformation zone structure of all welds. Figure 8 shows the normal plate structure.

X500, etched in 4 per cent picral.

TYPICAL FINE MARTENSITIC STRUCTURE  
OF ALL HEAT-AFFECTED ZONES.

Note crack.

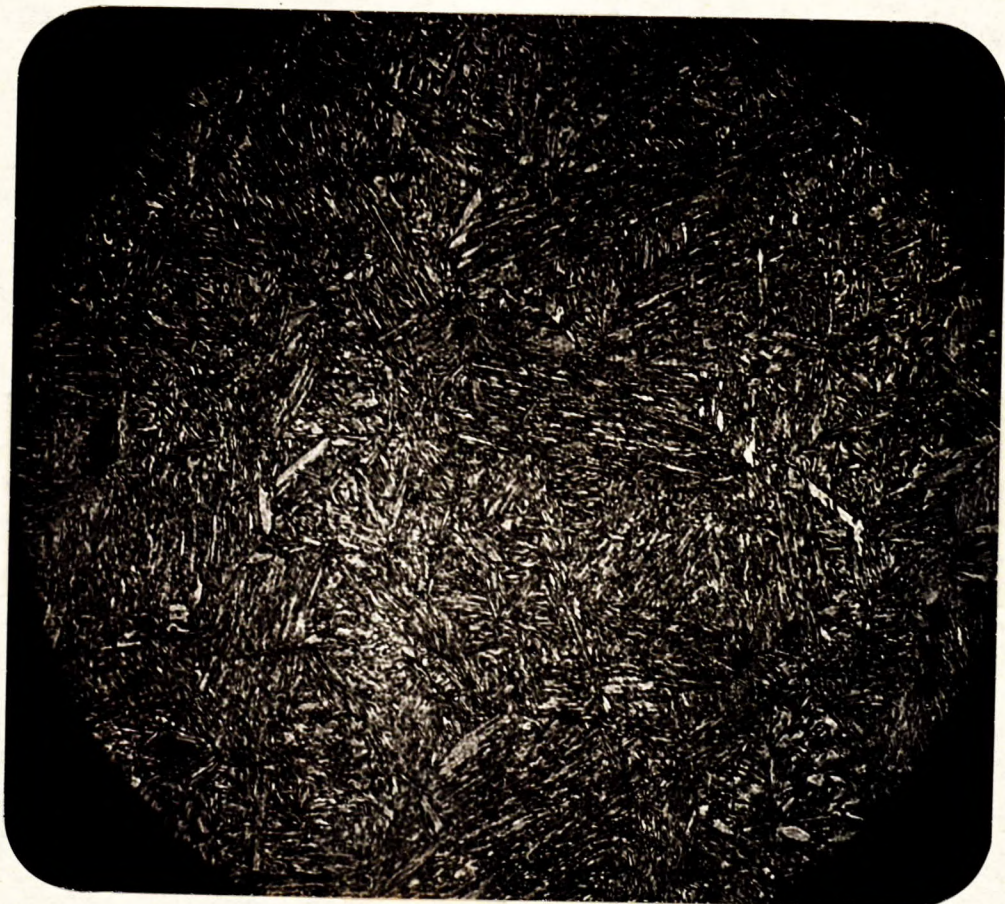
Figure 8.

X500, etched in 4 per cent picral.  
NORMAL PLATE STRUCTURE OF TEMPERED MARTENSITE.

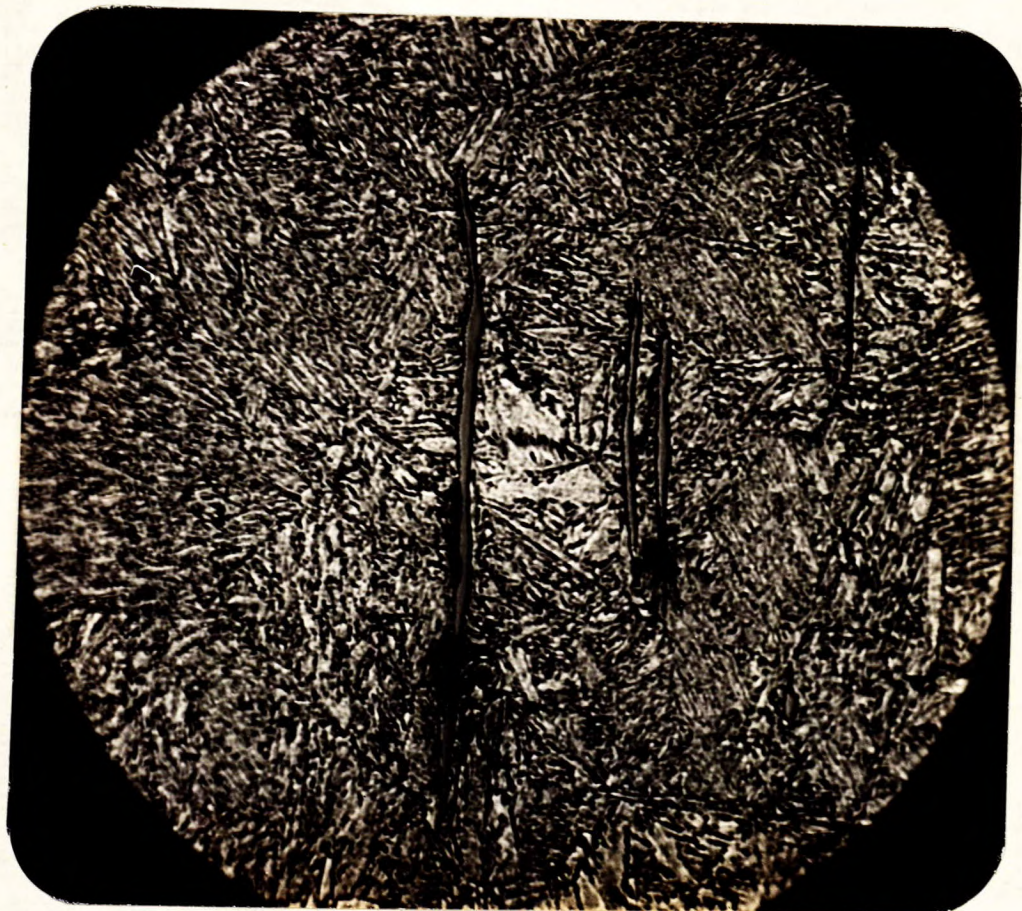
Figure 12.

6. A longitudinal section of the armour plate was examined under the microscope. Figure 11 shows a typical group of inclusions. In Figure 12, at higher magnification, it may seem that the inclusions are mainly sulphides with a few oxides.

X500, etched in 4 per cent picral.

SULPHIDE INCLUSIONS IN LONGITUDINAL  
SECTION OF ARMOUR PLATE.

The presence of heavy stringers of inclusions is definitely detrimental to the ballistic performance of the plate. In addition, the welding is parallel to the direction of rolling and therefore parallel to the direction of progression of the inclusions. In the main these inclusions are sulphides and as shown in Figure 13 they provide stress raisers, thus acting as a fertile starting point for cracks. The examination indicates that armour plate is homogeneous and shows no evidence of banding.

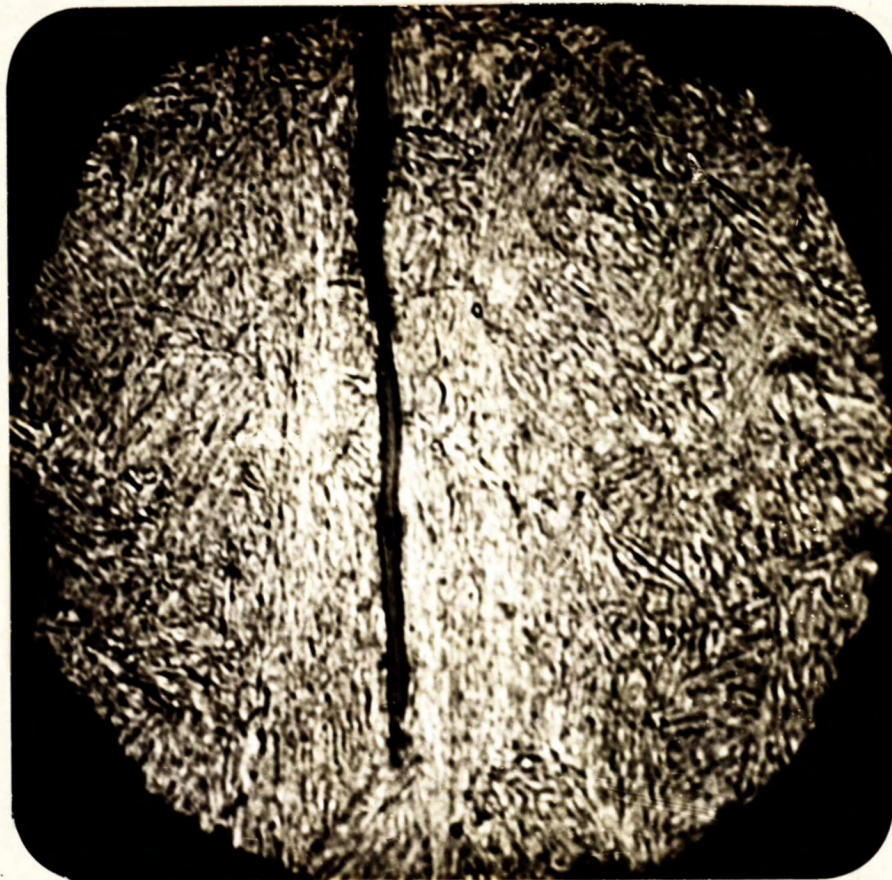
7. A longitudinal section of Weld 2 was polished and then examined under a microscope. A "hard" crack (See Figure 10) in the heat-affected zone is shown in Figure 13. Note that the crack apparently originates at a sulphide inclusion.

X1500, etched in 4 per cent picral.

SMALL "HARD" CRACK, APPARENTLY ORIGINATING  
AT A SULPHIDE INCLUSION. TAKEN IN THE  
HEAT-AFFECTED ZONE OF A LONGITUDINAL  
SECTION OF WELD 2.
