# ORE DRESSING AND METALLURGICAL LABORATORIES.

Investigation No. 1553.

Examination of Six Macro-Etched Samples of Steel Bars for 17-Pdr. A/P Shot.

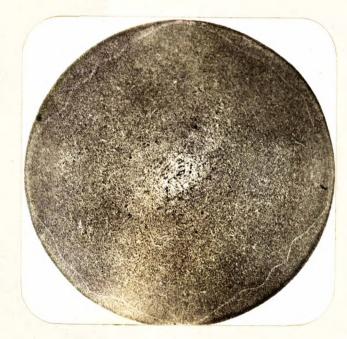
Figure 1.

The etches evidently had been made some time ago and the steel surface had rusted. Therefore, Samples 33385-AA3, 33385-XA36, and 73365-AA2 were reground and re-etched. A centre condition typical of several of the samples was noticed in 73365-AA2 (shown in Figure 1). A rather widespread rough appearance was found in 33385-XA36. This latter sample was then normalized for one hour at 1550° F. and re-etched, but no change in appearance was noticed.

SECTION FROM 73365-AA2. (Approximately to size).

The centre condition (particularly noticeable, after etching, in 33384-AA16 and 73365-AA2) was evidently caused by central segregation or inhomogeneity. This is frequently found in ingots well below the normal crop. Incidentally, ingots that showed the worst condition were from upper cuts. Also, it might be noted that Canadian steel made for the same application had fairly similar deep-etching properties. In the rolled samples examined this centre condition did not indicate overheating or porosity.

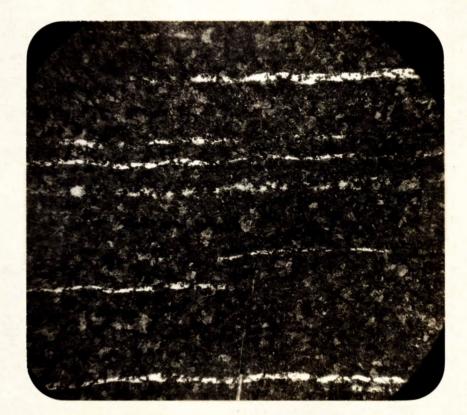
### Figure 4.

Etching the samples showed some banding to be present. This is shown, at 30 diameters, in Figure 4.

X30, nital etch. SAMPLE FROM 33384-AA16.

The bandings noticed (apparently ferrite) will undoubtedly largely disappear in the heat treatment of the shot.
