February 10th, 1944.

ORE DRESSING AND METALLURGICAL LABORATORIES.

Investigation No. 1598.

Examination of Manganese Steel from
(1) Symons Cone Crusher Liner, (2)
Dipper Tooth for a Shovel Bucket.

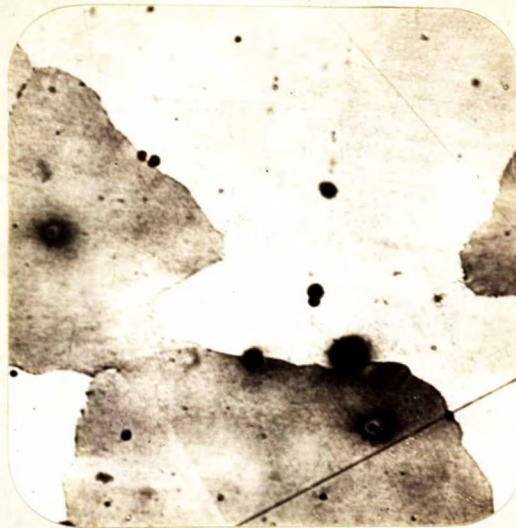
Figure 1.

The grain size of the steel is very large in both cases, as may be observed in Figures 1 and 2, which are photomicrographs, taken at a magnification of 400 diameters, of the polished sections of the crusher liner and the dipper tooth, respectively. Figure 3 is a photomicrograph, taken at a magnification of 30 diameters, of the polished section of the cone crusher liner showing how the porosity follows the grain boundaries. This was particularly prevalent in the cone crusher liner but was also noted in the examination of the polished section of the dipper tooth.

X100, nital etch.

GENERAL STRUCTURE OF CONE CRUSHER LINER,
SHOWING LARGE GRAIN SIZE.

The grain size in both polished sections was very large. It is possible to develop better properties in this type of steel by refining the grain. This is accomplished by pouring the molten steel at as low a temperature as possible.

Premature failure in both cases would appear to be due to the very large grain size, and to unsound castings due to shrinkage cavities.

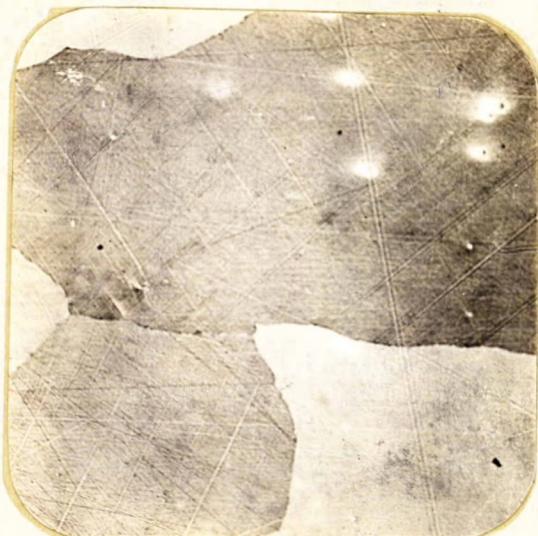
Figure 2.

X100, nital etch.

GENERAL STRUCTURE OF
DIPPER TOOTH, SHOWING
LARGE GRAIN SIZE.

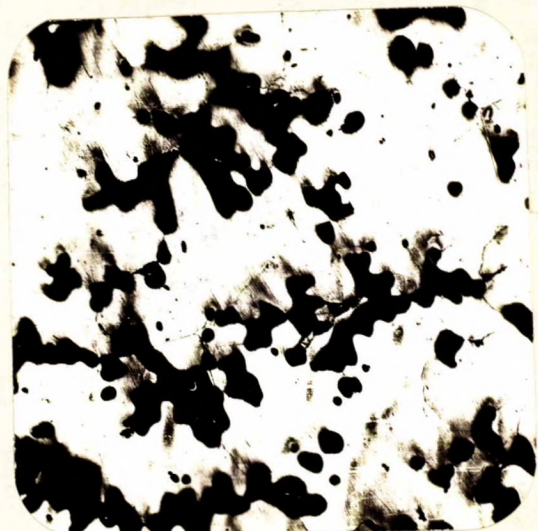
Figure 3.

porosity or shrinkage. Both of the samples examined showed considerable shrinkage, along the grain boundaries and throughout the samples generally.

X30, nital etch.

CONC CRUSHER LINER,
SHOWING POROSITY FOLLOWING
GRAIN BOUNDARIES.
