ORE DRESSING AND METALLURGICAL LABORATORIES.

Investigation No. 1608.

Examination of Three 21-Inch-Torpedo
Connecting Rods.

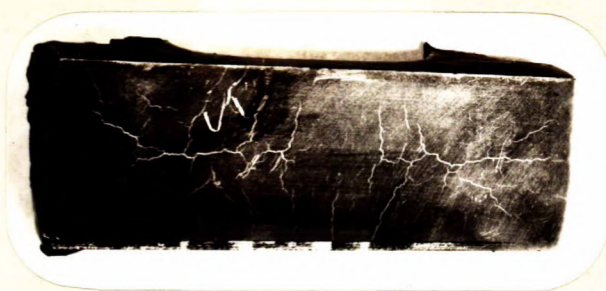
Figure 3.

PHOTOGRAPH OF SAMPLE NO. 3, SHOWING
NETWORK OF BRONZE-FILLED CRACKS AT
STEEL-BRONZE INTERFACE.

(About $\frac{3}{4}$ actual size).

while the bronze was being burnt on and were filled with bronze. An example of these cracks is shown in Figure 3 and also in Figure 4. The sample shown in Figure 3 was obtained by cutting off the bronze just down to the bronze-steel interface. This was the third sample supplied by the British Admiralty Technical Mission.

For identification purposes, the unfinished connecting rod (Figure 1) showing the cracks in the end was designated as Sample No. 1; the completed connecting rod that showed no cracks at all (Figure 2), Sample No. 2; and the section of connecting rod that was badly cracked (Figure 3), Sample No. 3. Samples Nos. 1 and 3 are considered to be characteristic of the cracked connecting rods, and Sample No. 2 characteristic of the sound ones.

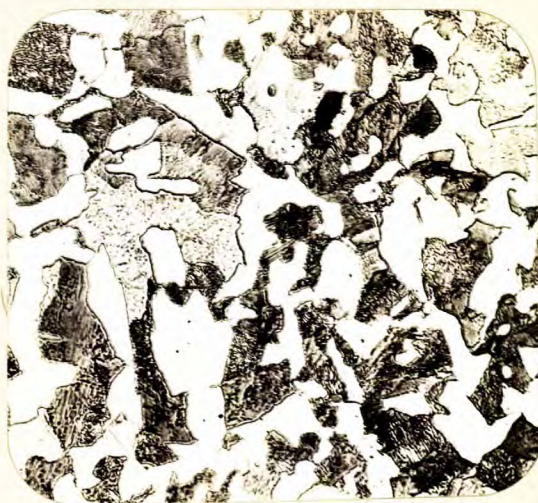
Figure 9.

X500, nital etch.
SAMPLE NO. 2,
ORIGINAL STRUCTURE.

It is interesting to note that Figures 7, 9 and 11 show approximately the same grain size as do Figures 6 and 8, while the grain size shown in Figure 10 is much finer.

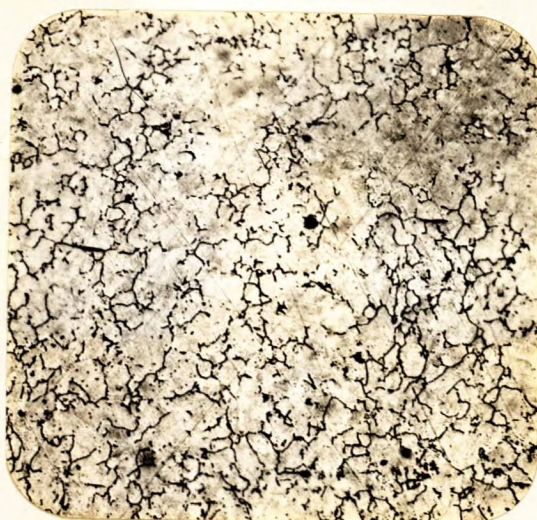
Figure 14.

X100, nital etch.

SAMPLE NO. 3,
MCQUAID-EHN GRAIN SIZE, 4-5.

The McQuaid-Ehn grain size of the steel in Samples Nos. 1, 2 and 3 was determined at 1700° F. The results of this test are shown in Figures 12 (Sample No. 1), 13 (Sample No. 2), and 14 (Sample No. 3), and are tabulated below:

<u>McQuaid-Ehn grain size at 1700° F.</u>	
Sample No. 1	-	6 to 7
" No. 2	-	4 to 5
" No. 3	-	4 to 5
