ORE DRESSING AND METALLURGICAL LABORATORIES.

Investigation No. 1627.

Examination of Section from a Stainless  
Steel, Centrifugally Cast Retort  
which Had Failed in Service.

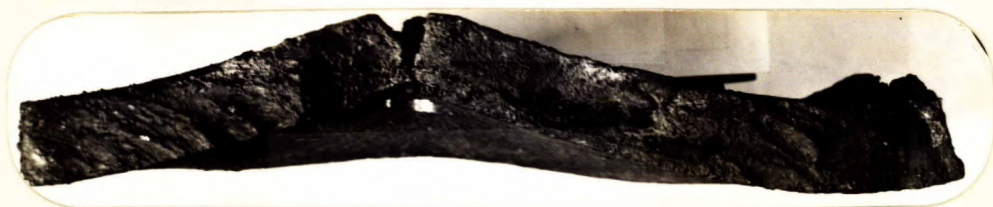
Figure 2.

SECTION OF RETORT, SHOWING FAILURE.  
"AS RECEIVED" CONDITION.  
(Approximately 1/2 size).

The section submitted measured approximately  $9\frac{1}{2} \times 7\frac{1}{2} \times 1$  inch. Figures 1 and 2 are photographs of the section in the "as received" condition. The cracking is plainly shown in these photographs. Figure 3 is a photograph of a deep-etched section (etched in 2 per cent picric, 10 per cent HCl in ethyl alcohol for  $\frac{1}{2}$  hour). Note, in this photograph, the increased grain size at the top of the section, indicating extent of decarburized zone.

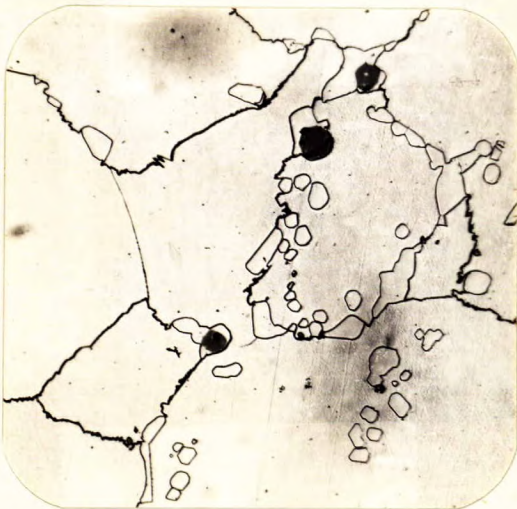
Figure 4.

X100, etched.

SAMPLE A (AS RECEIVED).

Wholly austenitic structure with some massive carbides at grain boundaries.

This sample was hand polished, etched, and examined microscopically. The structure revealed was wholly austenitic with some free massive carbides mainly on the grain boundaries. There was a tendency towards segregation of the carbides. Figure 4, at a magnification of 100 diameters, shows this section under bright field (normal) illumination. Figure 5, at a magnification of 200 diameters, is a photomicrograph taken

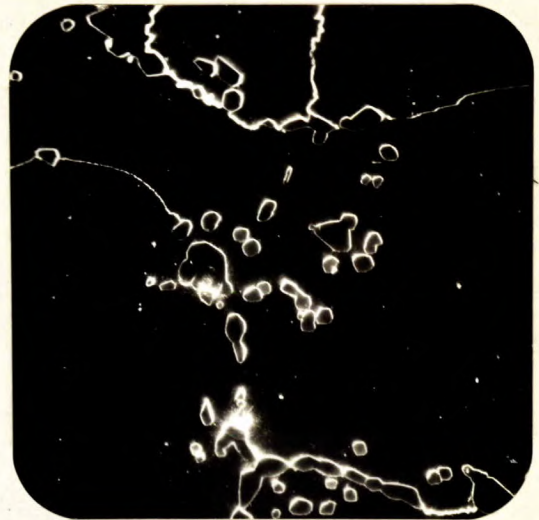
Figure 5.

X200, etched.

SAMPLE A (AS RECEIVED).

Dark field illumination. Note absence of precipitation of carbides.

on the same sample (but a different field) under dark field illumination.

A section of the retort, after heat treating as described above, was hand polished, etched, and examined microscopically. The structure revealed was wholly austenitic with free massive carbides on the grain boundaries and no precipitation of carbides within the grains. Figure 8, at a magnification of 100 diameters, shows a section of this sample under bright field illumination, while Figure 9, at a magnification of 200 diameters, shows a section of the sample under dark field illumination. The similarity of the "as received" structure with the structure after heating at 1200° C. is evident from a comparison of Figures 5 and 9.

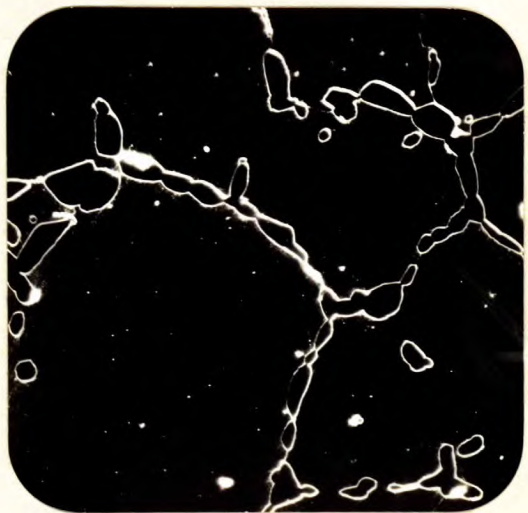
Figure 9.

X200, etched.

SAMPLE C  
(HEAT TREATED AT 1200° C.).

Dark field illumination.  
Note absence of carbide  
precipitation.

For the same reason the absence of precipitation after heating Specimen C to 1200° C. indicates that the solubility of the austenite for carbides at that temperature was high enough to retain the dissolved carbides in solution. This means that these carbides were taken into solution at some temperature between 1160° and 1200° C. Had this retort been heated to a temperature above 1200° C. in service, there would also have been a precipitation of carbides in
