ORE DRESSING AND METALLURGICAL LABORATORIES.

Investigation No. 1629.

Examination of Welded Shaft and Coupling Plate.

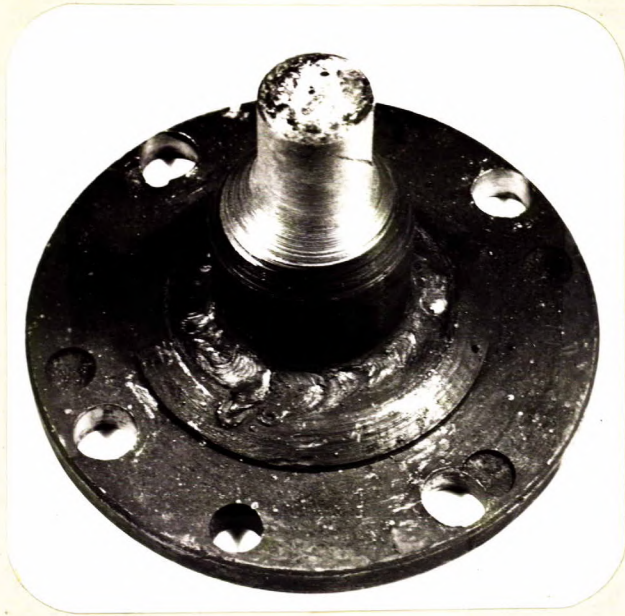
Figure 1.

WELDED SHAFT AND COUPLING PLATE  
ASSEMBLY AS RECEIVED.

1. The assembly was subjected to a careful visual examination. Figures 1 and 2 show the assembly in the "as received" condition, and the location of the welds.
2. Chemical analysis samples were machined from the shaft and coupling plates. In the following table are listed the results of these analyses together with the SAE 3140 specification, for the purpose of comparison:

A visual examination of the assembly reveals some undercutting on the shaft material and some weld metal porosity. Both of these defects are avoidable and should be eliminated.

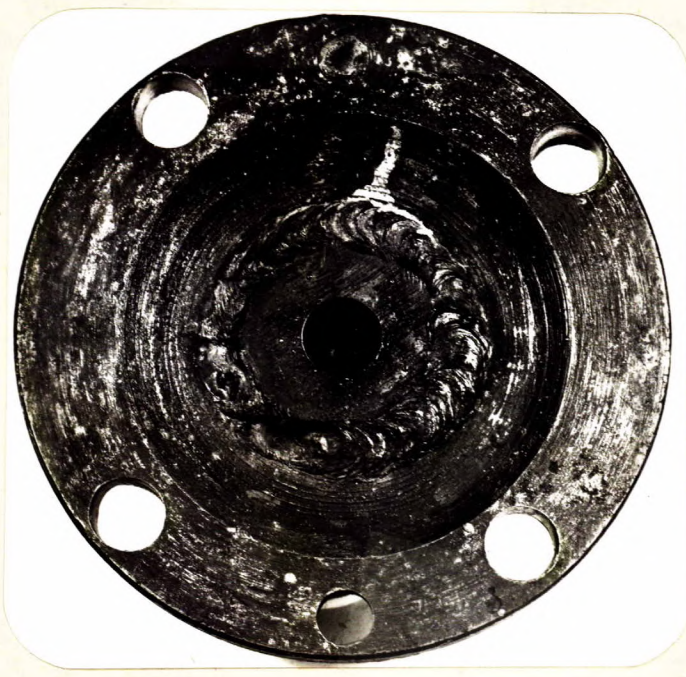
Figure 2.

Note, in Figure 2, that weld metal is irregular  
and there is a fairly large arc crater.

1. Undercutting and porosity were found in both welds. Both are avoidable and every effort should be made to eliminate them.
2. The composition of the two materials are nearly identical. They most closely approach that of SAE 5140 steel.
3. Variations in amounts of weld metal deposited

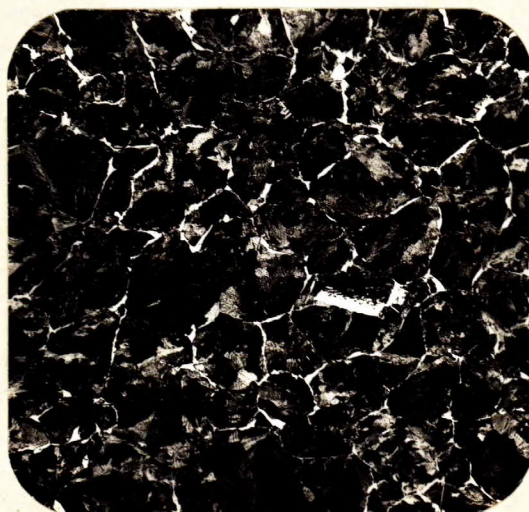
Figure 4.

X100, etched in 4 per cent picral.

NORMAL STRUCTURE OF SHAFT MATERIAL.

Coarse-grained sorbite with ferrite at  
grain boundaries. Good machinability.

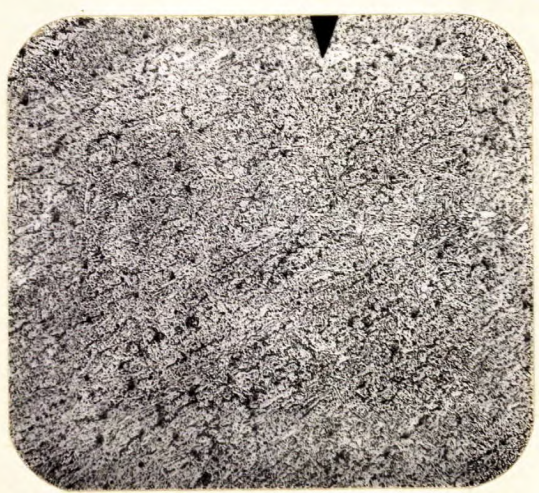
Figure 8.

X100, etched in 4 per cent picral.  
 STRUCTURE OF WELD METAL.  
 Dense, fine-grained metal.

A metallographic examination of the welds and the welding zones reveals nothing unusual. The thermal cycle of welding has, in the transition zone, produced a spheroidizing action on the pearlite areas, whereas in the heat-affected zone there has been produced a structure consisting of slight amounts of ferrite but mostly bainite and/or other higher transformation products. The normal structures of the shaft and coupling plate are considerably different. That of the coupling plate material is a normalized structure with considerable precipitated ferrite. On the other hand, the structure of the shaft material is sorbite and the grain size is comparatively coarse. Of these two structures the latter would be better from the point of view of machinability, and this may be a factor of some importance in this assembly. The weld metal structure is normal, pearlite in a matrix of ferrite.
