ORE DRESSING AND METALLURGICAL LABORATORIES.

Investigation No. 1647.

Examination of Manganese Steel from a
Symons Cone Crusher Bowl Liner.

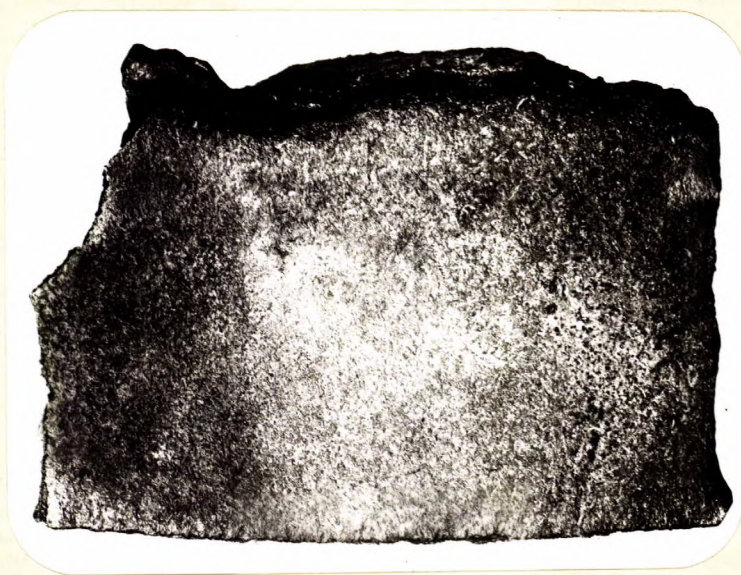
Figure 1.

The sample submitted measured approximately $5\frac{1}{2} \times 4 \times 1\frac{1}{2}$ inches. Figure 1 shows the sample in the "as received" condition.

SAMPLE "AS RECEIVED".
(Approximately 7/10 actual size).

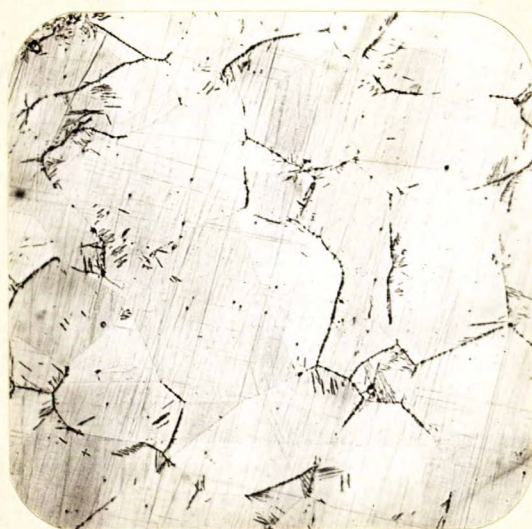
Figure 2.

One specimen was cut from the sample, hand polished, and etched for 20 seconds in 4 per cent picral. The structure revealed was austenitic, with free carbides on the grain boundaries. Needles of martensite were noted in the vicinity of the grain boundaries. Figure 3, at a magnification of 100 diameters, shows a representative field from this specimen.

X100, picral etch.
AUSTENITIC STRUCTURE WITH FREE
CARBIDES ON GRAIN BOUNDARIES
AND NEEDLES OF MARTENSITE.

structure with some needles of martensite. Steel having a carbon content of 1.16 per cent and a manganese content of 6.4 per cent should be considered a border line steel; that is, under perfect conditions of quenching the structure would be austenitic, but if the quenching were not sufficiently drastic the result would be a martensitic structure. In the section of steel under examination, the structure is mainly austenitic with some martensite. The free carbides on the grain boundaries would indicate too slow a quench, which indication is further proved by the presence of the martensite. If the quenching had been exceptionally fast, the structure would probably have been austenitic with no martensite but, because of the low manganese, there would have been a few carbides on the grain boundaries.

The premature failure of the crusher liner was due to the low manganese content of the steel, giving rise, under normal heat treating conditions, to free carbides on the grain boundaries and also some martensite, rather than to a completely austenitic steel.
