R E P O R T  
of the  
ORE DRESSING AND METALLURGICAL LABORATORIES.

Investigation No. 1652.

Metallurgical Examination of Bottom  
Bearing Pieces for A.R.K. Gyros.

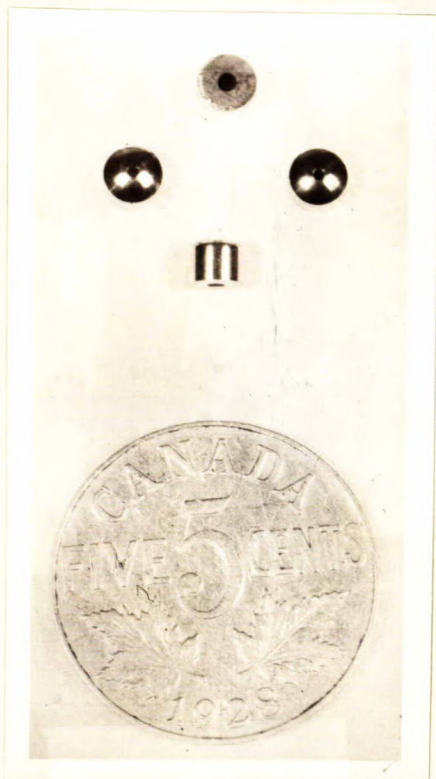
Figure 1.

Figure 1 shows several of the bearing pieces in the "as received" condition. Figures 2 and 3, at X30 magnification, show respectively a bearing surface of one of the parts and a cross-section of the bearing surface. There was no evidence of wear on any of the surfaces examined but there were signs of scoring, as shown in Figure 2.

BEARING PIECES,  
"AS RECEIVED".  
(Approximately twice  
actual size).

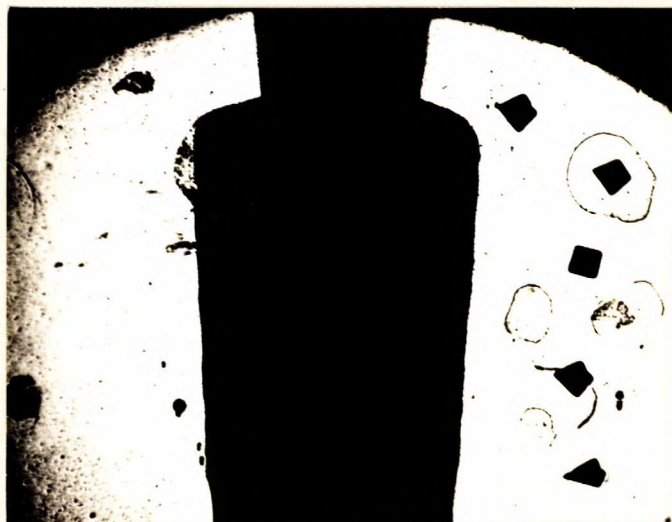
Figure 3.

X30.  
CROSS-SECTION OF BEARING PIECE.  
Note absence of any evidence of wear.

The macroscopic examination showed no wear taking place on the bearing surfaces of the pieces, although there was evidence of scoring.
