R E P O R T
of the
ORE DRESSING AND METALLURGICAL LABORATORIES.

Investigation No. 1661.

Investigation of German Half-Track
Troop Carrier Track Pin.

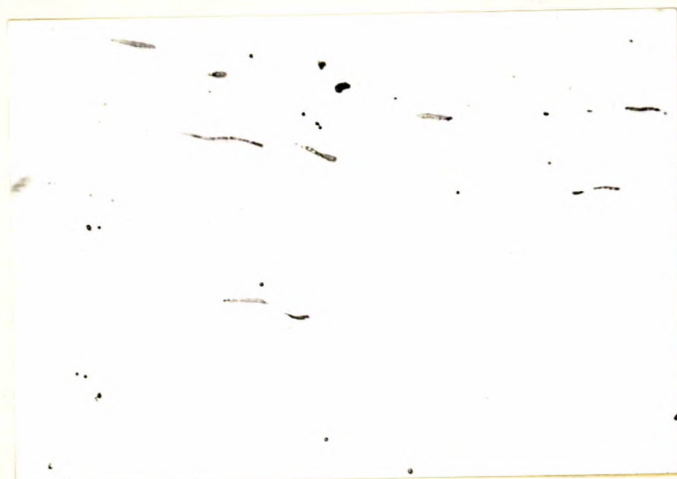
Figure 2.

Transverse and longitudinal specimens were cut from the pin. These were polished and then examined under the microscope. Figure 2 (X500) illustrates the distribution of inclusions in a longitudinal specimen. These inclusions were identified as FeMnS (elongated in the direction of rolling), sometimes duplexed with FeMnO. Other inclusions were of the alumina FeO Al₂O₃ variety. The specimens were etched in 2 per cent nital. Figure 3 (X250) shows the structure at the surface of the pin. Figure 4 (X1000) illustrates the tempered martensite structure of the core of the pin.

X500, unetched.
DISTRIBUTION OF INCLUSIONS.

The steel used for fabrication of the pin examined was in a rather dirty condition, sulphides, FeMnO , $\text{FeO Al}_2\text{O}_3$ and alumina inclusions being evident throughout. In addition to the alumina inclusions, the fine austenitic grain size shows that the steel was aluminium-killed. The tempered martensite pin structure indicates that the pin has received the conventional quench-and-draw heat treatment. No decarburization was seen on any part of the pin. If the original pin had been decarburized this could not have been detected, however, as it would have worn away in service. The slightly increased surface hardness obtained with the Vickers machine is probably due to a work-hardening effect.

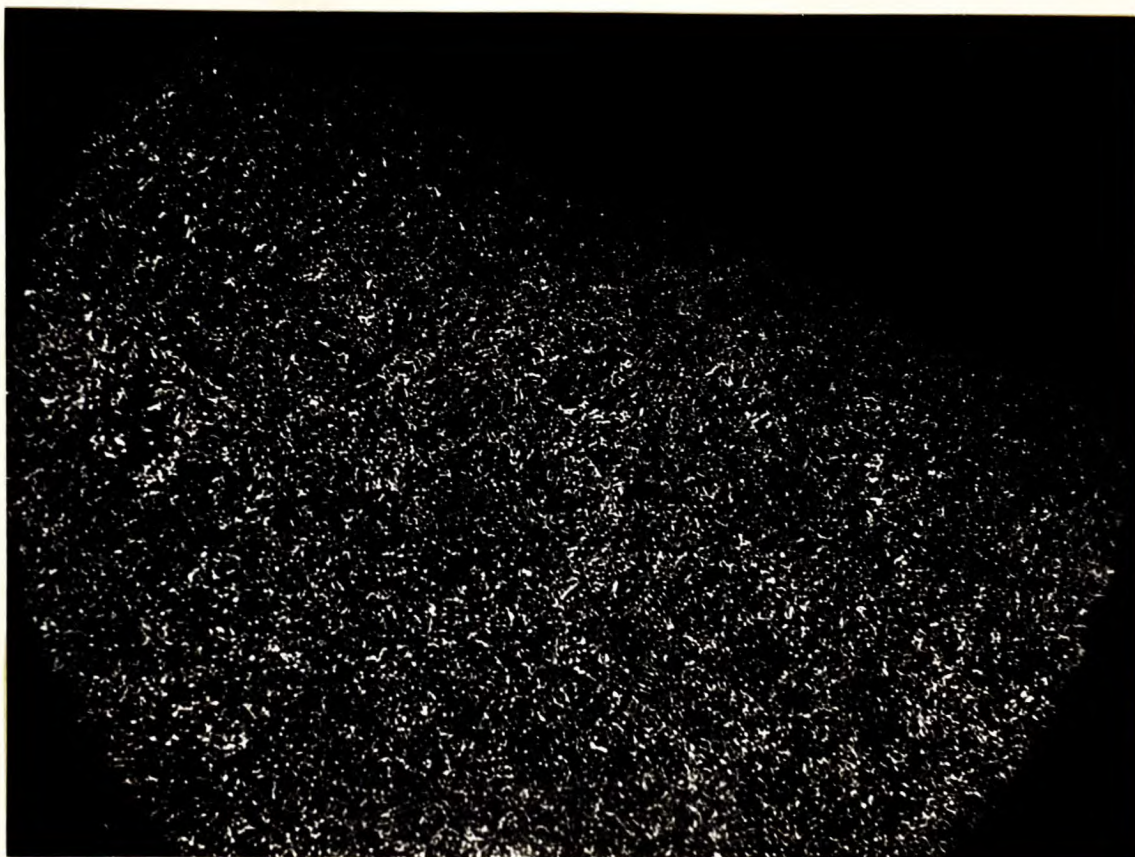
Figure 3.

X250, nital etch.

STRUCTURE AT THE SURFACE OF THE PIN.
