ORE DRESSING AND METALLURGICAL LABORATORIES.

Investigation No. 1667.

Metallurgical Examination of Broken
Main Leaves of Springs.

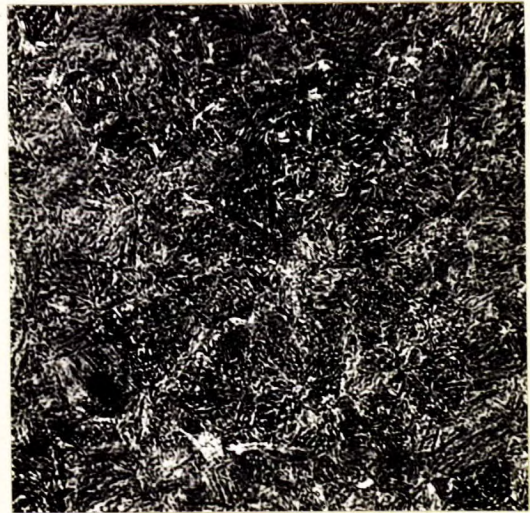
Figure 4.

Figures 3, 4 and 5 are the normal microstructure obtained when this steel is treated according to the specifications, viz.,

X250, nital etch.

MICROSTRUCTURE OF LARGE SPRING
IN "AS RECEIVED" CONDITION.

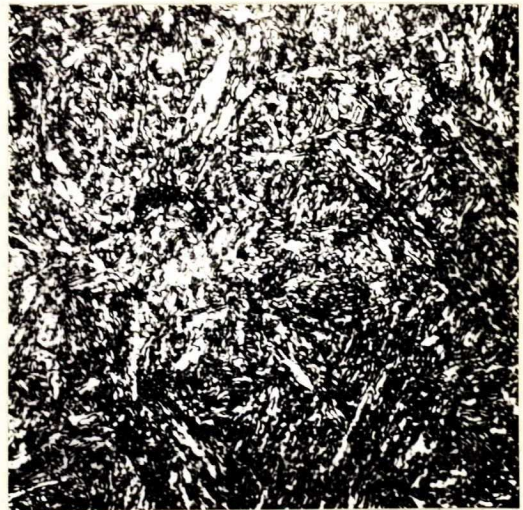
Figure 8.

X1000, nital etch.

MICROSTRUCTURE OF SMALL
SPRING, AFTER QUENCHING IN
OIL FROM 1525° F.
AND DRAWING AT 1000° F.

Heat to 1525° F. for quenching;
quench in oil.
Draw at 1000° F.

This heat treatment should result in a hardness of approximately 40 Rockwell 'C' (375 Brinell).
