June 26th, 1944.

ORE DRESSING AND METALLURGICAL LABORATORIES.

Investigation No. 1670.

Examination of an Italian Track Link Assembly.

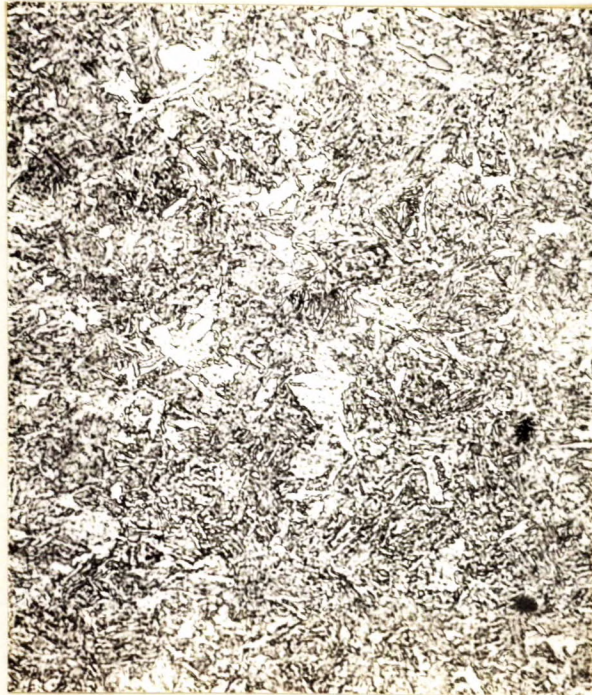
Figure 3.

X500, nital etch.
STRUCTURE OF LINK.

A microspecimen was cut from the link. It was polished and then examined under the microscope. In the unetched condition the steel was fairly clean. The specimen was etched in 2 per cent nital and re-examined. Figure 3 (X500) illustrates the sorbitic structure obtained.

The link was fabricated by forging a relatively clean metal. The chemical analysis corresponds to SAE 5140. On this continent, this type of steel is very often used for gears. The conventional heat treatment after forging is to oil-quench from 1500 to 1600° F., then draw to the required hardness. Since the link is 285 Brinell and the microstructure is sorbitic it can be assumed that the link was oil-quenched and then drawn at approximately 1150 to 1200° F.

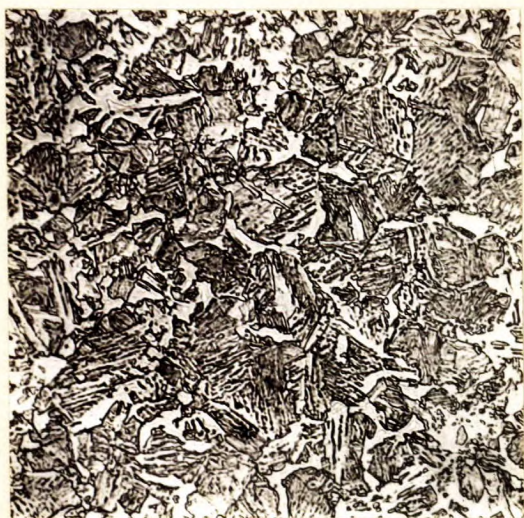
Figure 5.

X500, nital etch.
STRUCTURE OF PIN CORE.
Low-carbon martensite
and ferrite.

A transverse specimen was cut from the pin, polished, and examined under the microscope. In the unetched condition the steel was clean. It was then etched in 2 per cent nital and re-examined. Figure 5 (X500) illustrates the core structure, which consists of low-carbon martensite and ferrite. Figure 6 (X1000) is a photomicrograph taken of the case, close to the surface of the pin. Cementite envelopes (white constituent) are clearly visible, outlining the austenitic grain boundaries. The structure of the case is mainly fine nodular martensite.

The ferrite in the core may be due to a quench from below the critical point of the core and/or a slow quench. The former results in patches of ferrite, whereas the latter usually produces ferrite around the grain boundaries. The pins were probably pack-carburized at 1650 to 1700° F., held in the box to about 1375 to 1400° F. (a point below the AR_3), and finally oil-quenched.
