ORE DRESSING AND METALLURGICAL LABORATORIES.

Investigation No. 1673.

Testing of Magnesium Alloy Trench Mortar Base  
and Steel Trench Mortar Barrel with Brittle  
Lacquer Coatings.

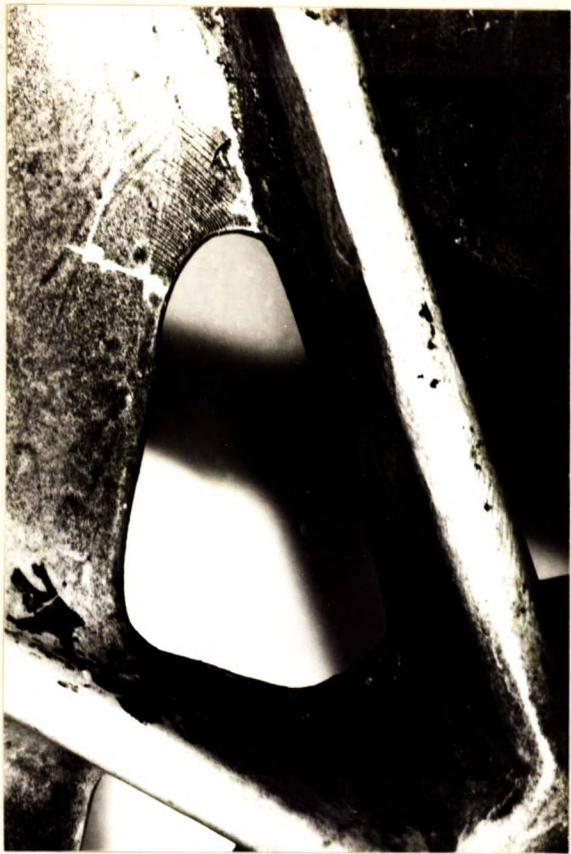
Figure 7.

CLOSEUP AT POSITION "A" ON TOP OF MORTAR BASE.

As mentioned previously, it was not possible to ascertain the direction and amount of the compressive stresses set up in the mortar base. These, however, may be found by developing a method for statically loading the base. However, the direction of the tensional stresses was easily found and may be seen by referring to Figures 4, 5, 7 and 8. The direction of the principal tensile stresses is at right angles to the cracks. No definite statement can be made as to the actual stress created in firing the charge. It can be said, however, that wherever cracked patterns have appeared in the 1201 lacquer, the tensile stress is over  $0.001 \times 7,000,000$ , or 7,000 pounds per square inch (7,000,000 being the modulus of elasticity of magnesium). It may be observed, from Figure 4, that tensile stresses at points C and D were caused by the members E and F loading this beam. A suggested design of this casting would be to eliminate members E, F, G and H, and to shorten members I and J so that they project radially from the centre portion. As a result of this, it would probably be possible to lighten the sections C and D since no stress will be placed upon that portion, the stress being taken up by the corners and the members K, I, L and J, as shown in Figure 9.

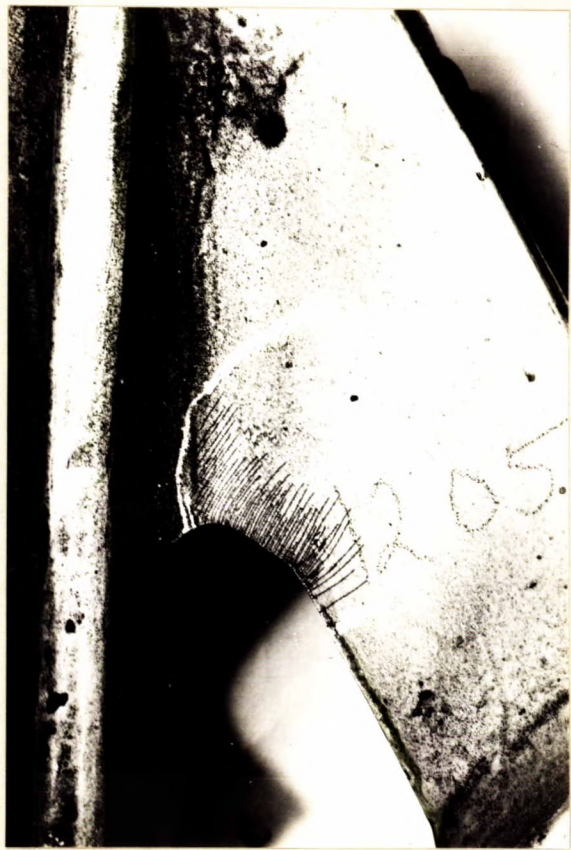
Figure 8.

CLOSEUP AT POSITION "B" ON TOP OF MORTAR BASE.
