ORE DRESSING AND METALLURGICAL LABORATORIES.

Investigation No. 1685.

Investigation of Silver Brazing Process.

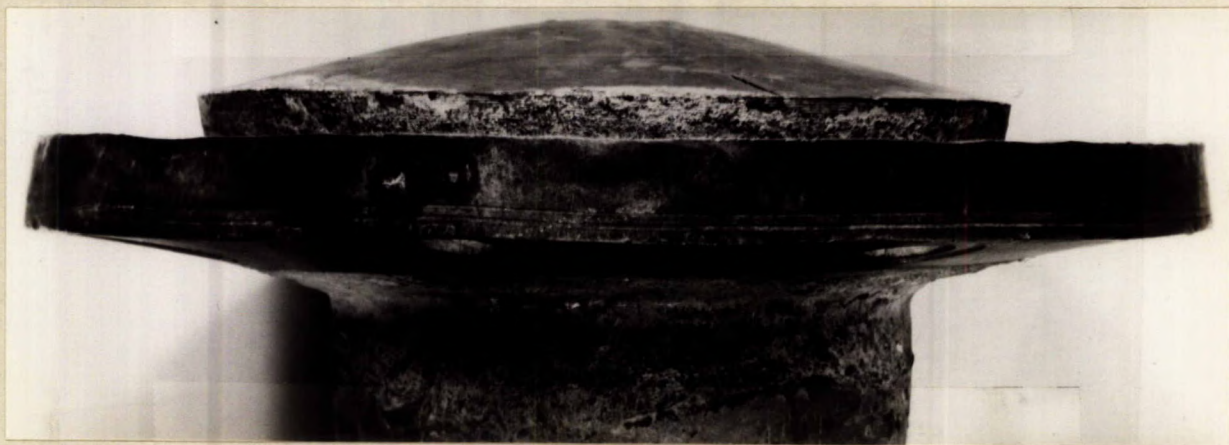
Figure 2.

PIPE PRESSURE TEST ASSEMBLY AFTER TESTING.
Note pronounced outward expansion of end cover plate.

2. The assembly was subjected to a 1000-pound internal hydrostatic pressure test and the assembly hammered while under pressure, in an attempt to start leakage. No such leakage was observed. The pressure caused one cover plate to bulge and both ends of the copper tube to expand considerably. Figure 2 shows the bulged cover plate.

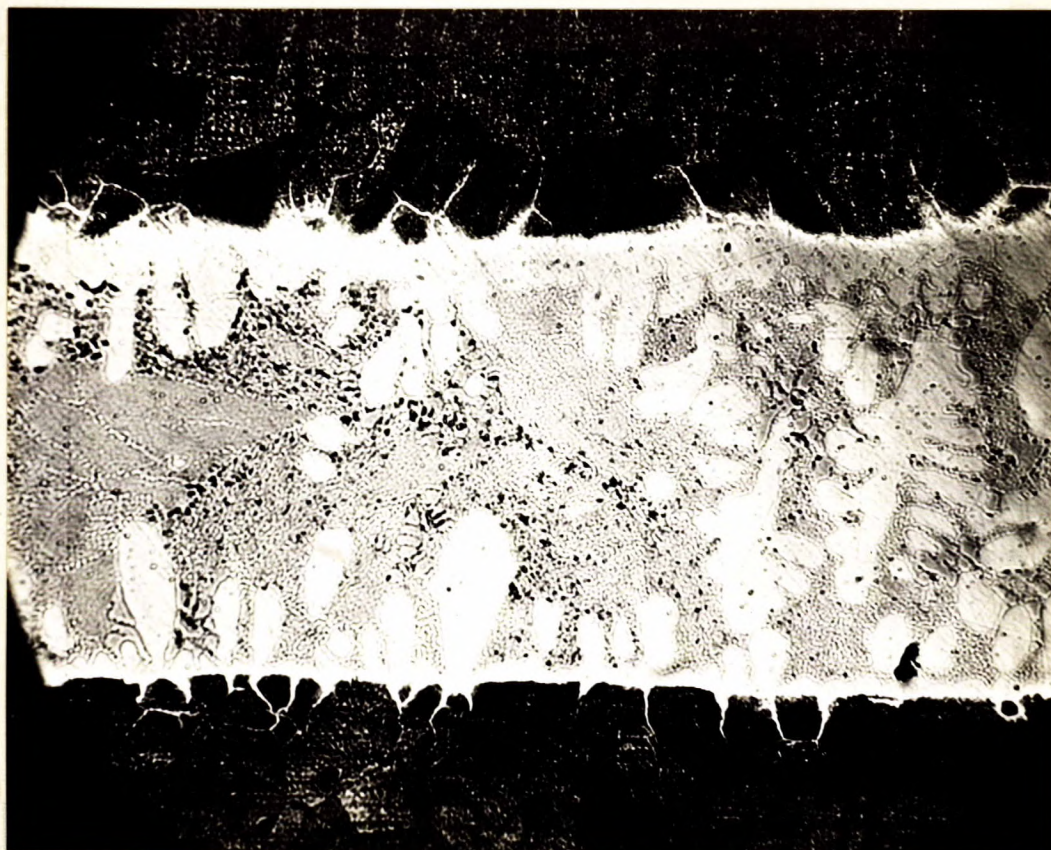
Figure 4.

X250, etched in ferric chloride
and hydrochloric acid in water.

EASY-FLO JOINT BETWEEN BRASS FLANGE
AND BRASS COVER PLATE.

Note penetration of brazing alloy
into both members.

4. A microscopic examination revealed that a good bond had been secured between the two brass components and also between the copper pipe and brass flange. Figures 3 and 4, respectively, show these two joints.

The microscopic examination shows that the silver alloy has bonded well with both brass and copper components to give a strong joint.
