ORE DRESSING AND METALLURGICAL LABORATORIES.

Investigation No. 1688.

Examination of Six Universal Carrier Cased  
Pins Which Failed Impact Test.

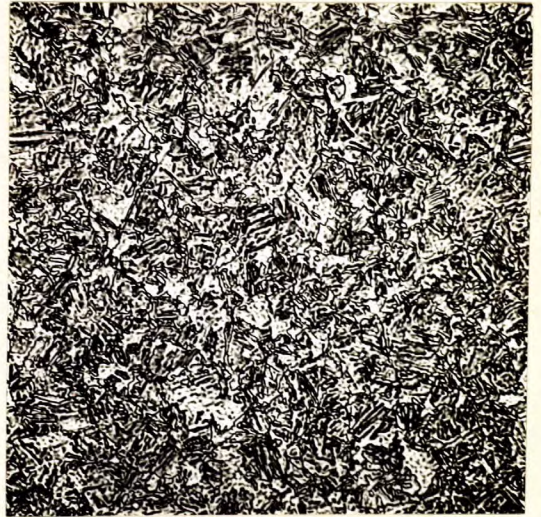
Figure 2.

X500, etched in  
2 per cent nital.

CORE STRUCTURE, PIN NO. 1100.

Pins Nos. 1100 and 1105 had homogeneous martensitic core and case microstructures which are typical for suitably heat-treated SAE 3115 pins (see Figures 2 and 3, photomicrographs at 500 and 200 diameters respectively).

7. Pins Nos. 1103 and 1104 have an unusually coarse martensite core structure. This suggests that the pins were quenched from a high temperature.
8. Pins Nos. 1100 and 1105 have been properly heat treated.

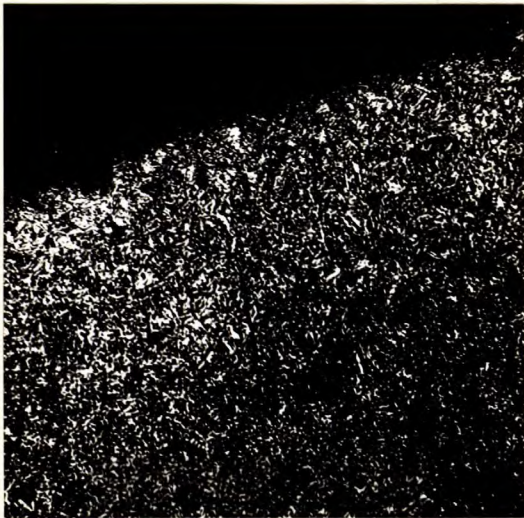
X250, etched in  
2 per cent nital.

CASE STRUCTURE, PIN NO. 1100.

Pins Nos. 1103 and 1104 had a normal case microstructure, typical of that shown in Figure 3. The core microstructure was uniformly martensitic but of unusual coarseness (see Figure 7, a photomicrograph at X500).

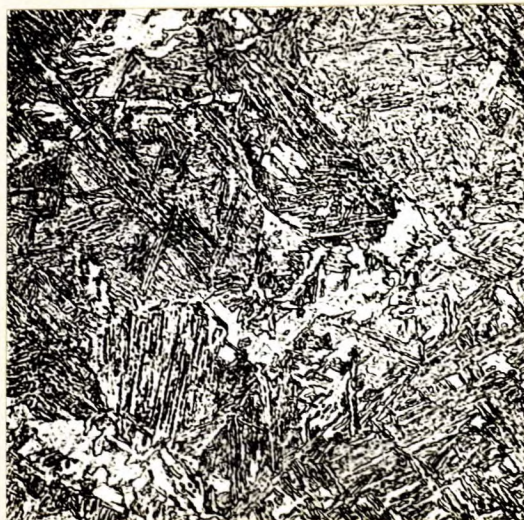
Figure 7.

X500, etched in  
2 per cent nital.

CORE STRUCTURE OF PIN NO. 1103.

1104 indicate that the quenching temperature was high.
