Investigation No. 1720.

Metallurgical Examination of CTL 875 Coupling.

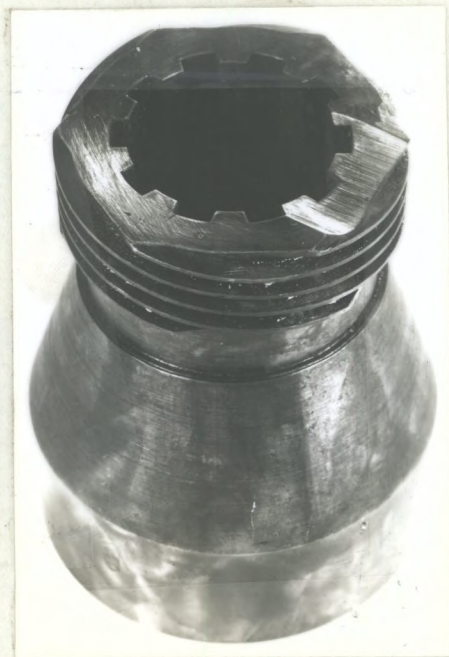
The coupling is shown in Figure 1.

CTL 875 COUPLING.

(Approximately 2/3 full size).

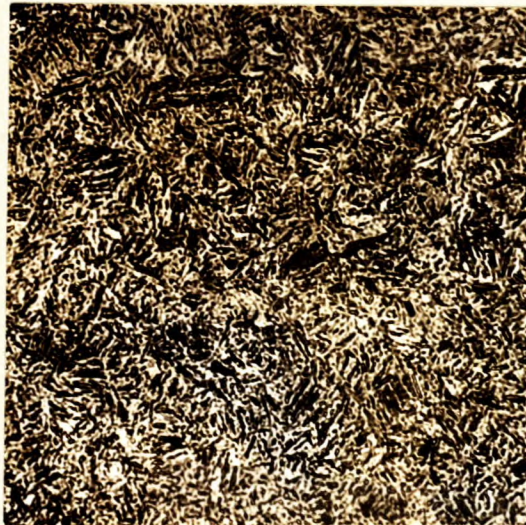
Figure 2.

The structure was tempered martensite (see Figure 2).

X250, nital etch.

Small particles of what was apparently spheroidized cementite were observed throughout the structure.

The uneven hardness of the sample was thought to be due possibly to the fact that the part, which had probably been spheroidized before final heat treating, had not been given a sufficiently long soak at the austenitizing temperature. As a result, a percentage of the carbides did not go into solution, with a consequent loss in hardenability. The presence of carbides in the martensite background would support this view. There was no decarburization.
