ORE DRESSING AND METALLURGICAL LABORATORIES.

Investigation No. 1749.

Metallurgical Examination of Two Steel Pots  
Used for Melting Magnesium.

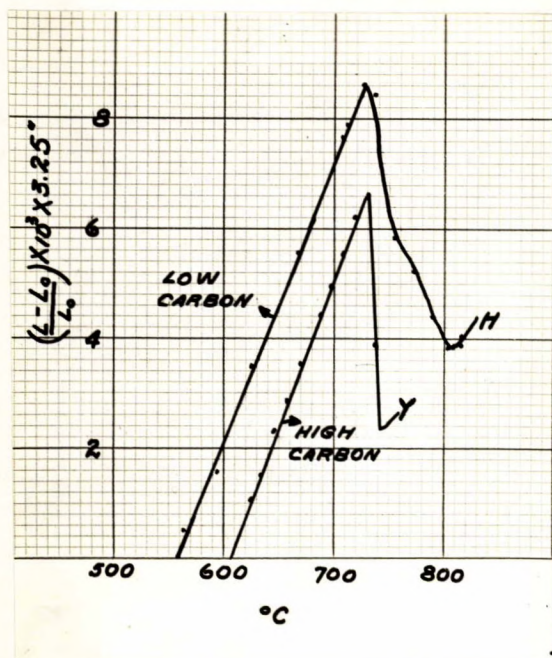
Specimens,  $3\frac{1}{4}$  in. x  $\frac{1}{2}$  in. diameter, were cut from both sections and heated up to obtain the comparative expansion and contraction of the high carbon and low carbon steels.

Figure 2 illustrates the curves obtained.

L = Final length.  
L<sub>0</sub> = Original length, 3.25 inches.

Note: Divide the vertical ordinates by 3.25 to get to unit expansion in mils per inch.

One factor which may account for the difference in the length of life of the Hull as compared with the Allegheny pot is shown by the chemical analysis. The latter has been poured from a high carbon (0.69%) steel whereas the former corresponds to the 0.25-0.35 carbon required by the blueprint. The dilatometer curves show the relative expansion and contraction of the two steels at different temperatures. It is interesting to note that if the pots are kept for any length of time in service at temperatures between 1373° - 1472° F. (745° - 800° C.) the low-carbon steel would be subjected to greater internal change. The volumetric change for the high-carbon steel would be merely due to thermal change whereas for the low-carbon pot it would be the sum total of thermal change plus change induced from being within the critical range 1341°-- 1472° F. (727° - 800° C.)<sup>⊙</sup>. If this hypothesis is correct the high-carbon steel should be superior.

<sup>⊙</sup> See Figure 2.

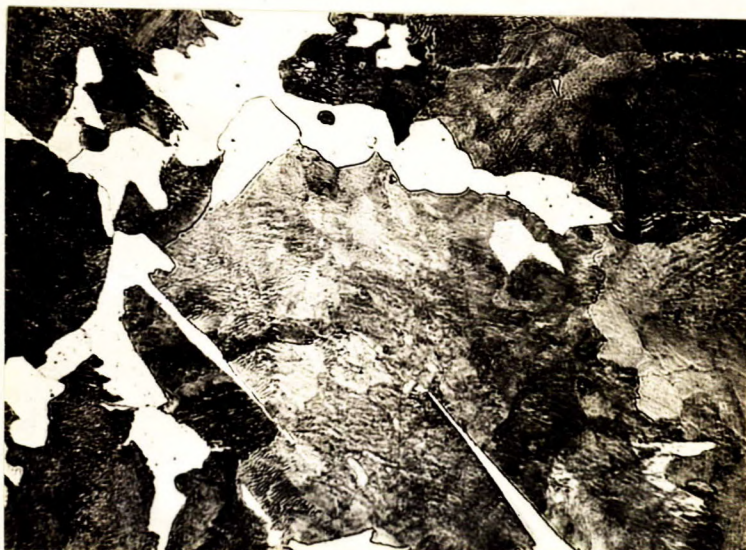
Figure 3.

Specimens were cut from each section for microscopic examination. In the unetched condition the samples were fairly clean. Some sulphide and oxide inclusions were observed but these were well dispersed. The latter type were much more evident in the Hull specimen, where they were duplexed with the sulphides. The samples were etched in 2 per cent nital. Figure 3 (X250) shows the structure of the Hull section and Figure 4 (X250) that of the Allegheny pot. The Hull structure contains, as would be expected from the analysis, more ferrite. The pearlite is also somewhat coarser.

X250, nital etch.

HULL POT.

Note ferrite (white constituent) and pearlite.

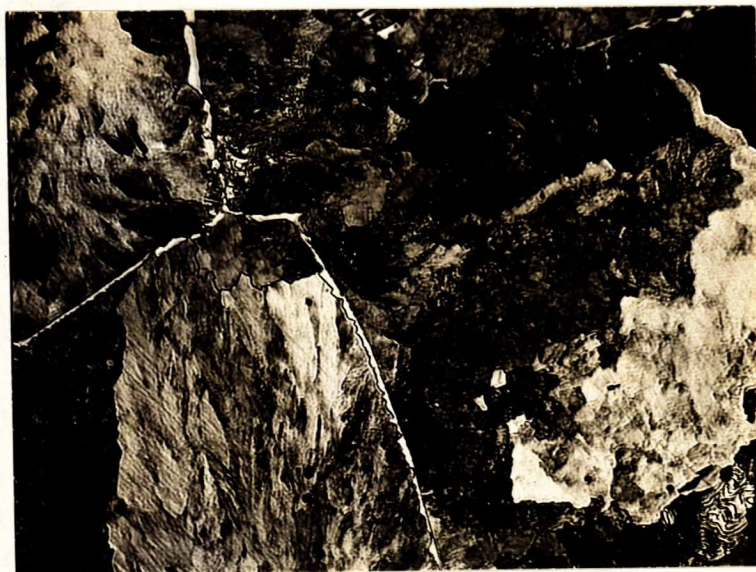
Figure 4.

X250, nital etch.

ALLEGHENY-LUDLUM POT.

Note smaller amount of ferrite (white constituent) and finer pearlite.
