Investigation No. 1768.

Metallurgical Examination of Defective
4.5-Inch Shell Forgings.

Description of Material and Object of Investigation:

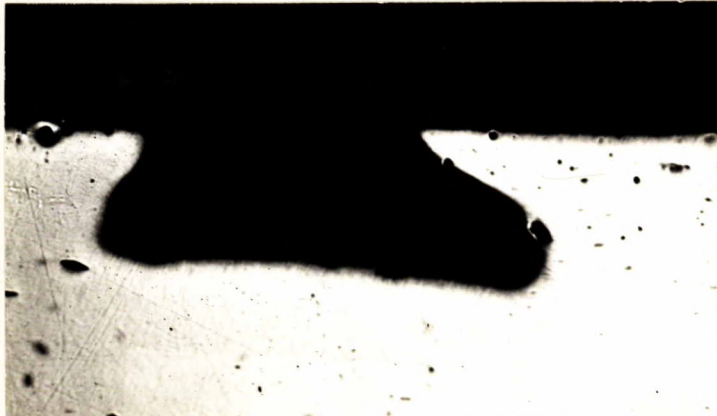
Figure 3.

Figure 3, taken at X100 magnification, shows another of the "cracks" at the cavity surface. This is also taken along the cross-section.

X100, unetched.

CROSS-SECTION SHOWING DEPTH AND CHARACTER
OF "CRACK" AT THE SURFACE OF CAVITY.

Microscopic examination of specimens in the unetched condition very clearly showed that the defects or "cracks" were quite shallow, as shown in Figures 2 and 3. Holes quite round in shape were also evident along the edge of the cavity (see Figure 2). These holes were found to be round both in the cross-section and in the longitudinal section, thus proving that they were formed after the forging operation.

1. It is recommended that any shell showing these defects be discarded, because their presence indicates that excessive temperatures have been reached.
2. Forging temperatures should be carefully controlled

in order to avoid the possibility of heating beyond the maximum of 2300° F.

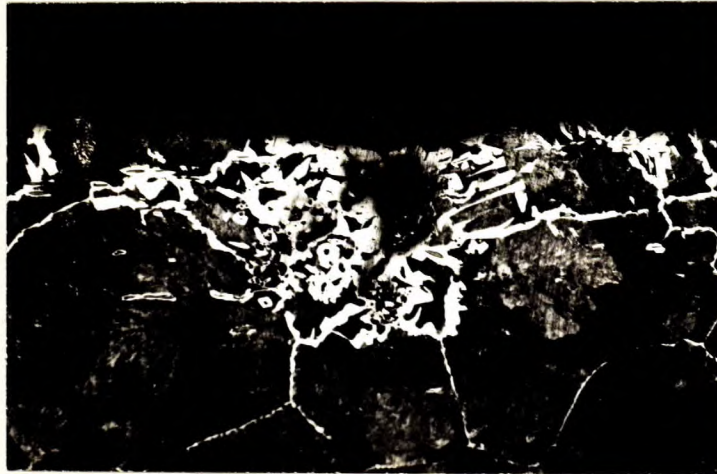
Figure 4.

Figure 4 is a photomicrograph, at X100 magnification, also along the cross-section, etched in nital, showing the concentration of ferrite around the hole at the surface of the cavity.

X100, nital etch.

CROSS-SECTION SHOWING HOLE
AT SURFACE OF CAVITY.

Note concentration of ferrite,
suggestive of melting.

The opinion that burning had occurred at the surface of the cavity is further supported by the microstructure shown in Figure 4, which discloses a hole surrounded by ferrite, an indication of free oxygen in the furnace atmosphere, a condition which would promote burning when the forging temperature is high.

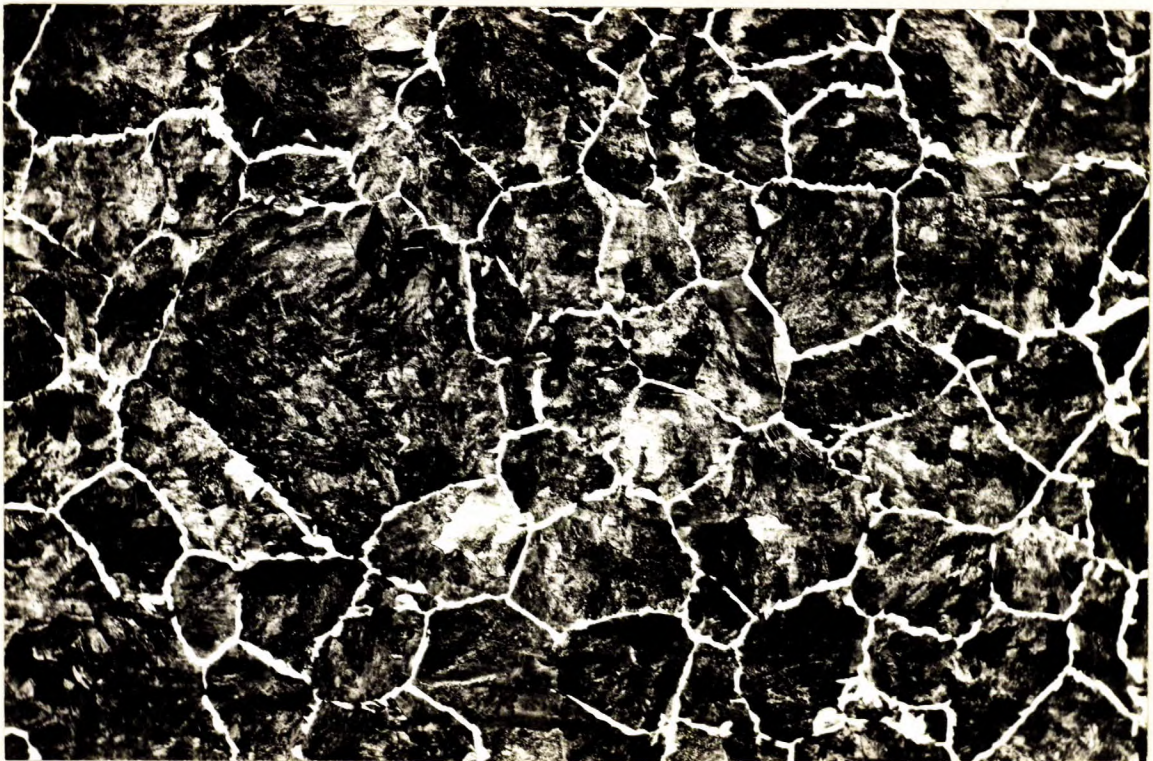
Figure 5.

Figure 5, taken at X100 magnification, shows the microstructure and grain size of the steel at the centre of one of the sections.

X100, nital etch.

MICROSTRUCTURE AND GRAIN SIZE AT
CENTRE OF ONE OF THE SECTIONS.

Examination of the steel in the etched condition revealed grains of such magnitude (see Figures 5 and 6) that overheating or burning was immediately suspected. Consequently, a sample was heated at 2460° F., approximately 90° F. below the melting point for this steel. The resulting grain size, shown in Figure 7, is actually smaller than that of Figure 6, thus
