ORE DRESSING AND METALLURGICAL LABORATORIES.

Investigation No. 1770.

Evaluation of Corrosion Resistance of  
Selenium-Coated Steel Strip.

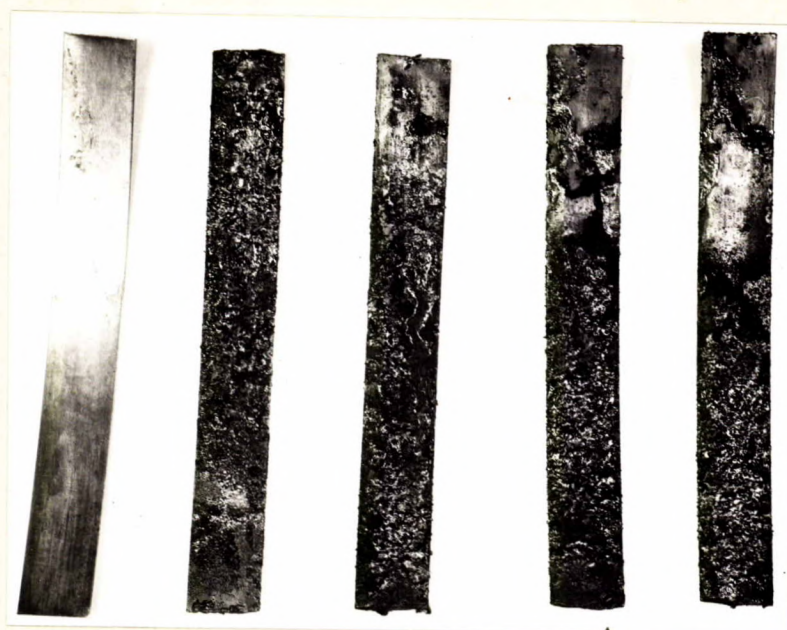
Figure 1.

Concave side.

SELENIUM-COATED STEEL STRAPPING AFTER  
57 HOURS IN THE SALT SPRAY TEST.

5% sodium chloride was used as the corroding liquid,  
at a temperature of 95° F. (35° C.).

First rust was observed after 5 hours. At the end of the 57 hours the samples were badly rusted. They were removed from the test, dried, and both sides photographed (see Figures 1 and 2). In each photograph an uncorroded sample is included for comparison.

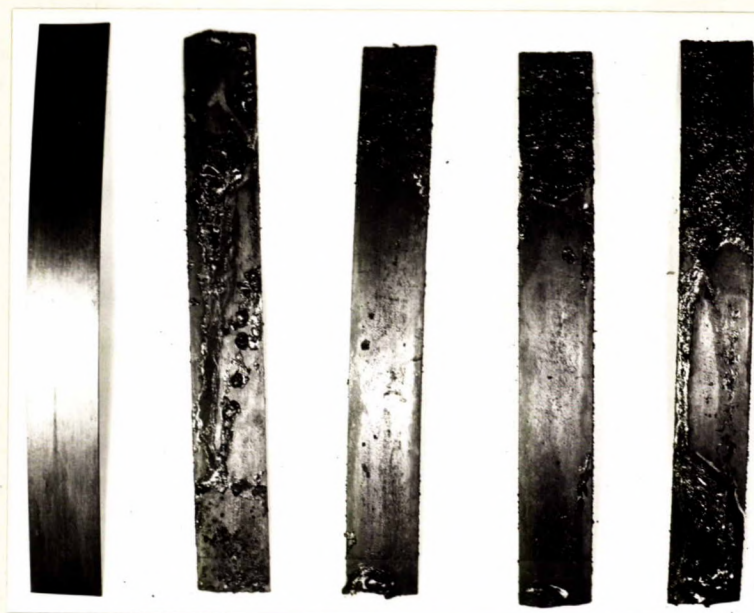
Figure 2.

Convex side.

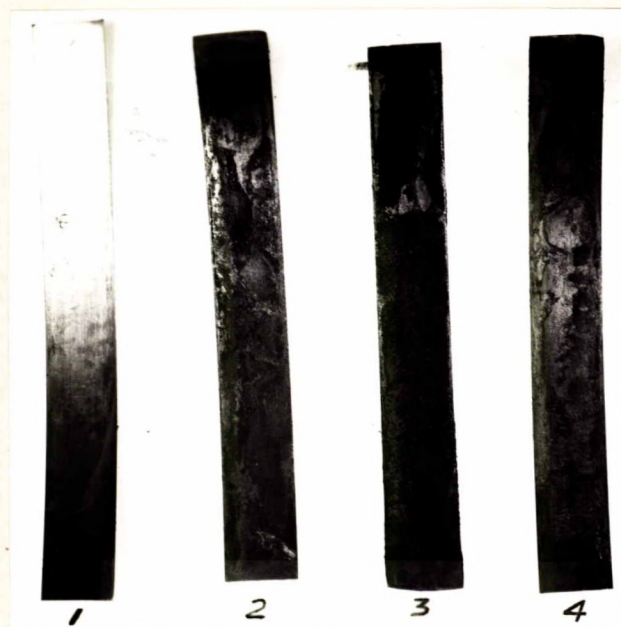
Figure 3.

Concave side.

SELENIUM-COATED STEEL STRAPPING AFTER  
89 HOURS IN THE TOTAL IMMERSION TEST.

5% sodium chloride was used as the corroding liquid,  
at a temperature of 93° F. (34° C.).

At the end of the 89 hours the samples were removed from the test, dried, and both sides photographed (Figures 3 and 4). In each photograph an uncorroded sample is included for comparison. It should be added that when Samples No. 2 and 3 were removed from their jars a considerable amount of rust dropped off from the concave side. Actually, Samples No. 2 and 3 were corroded to about the same extent as Sample No. 4.

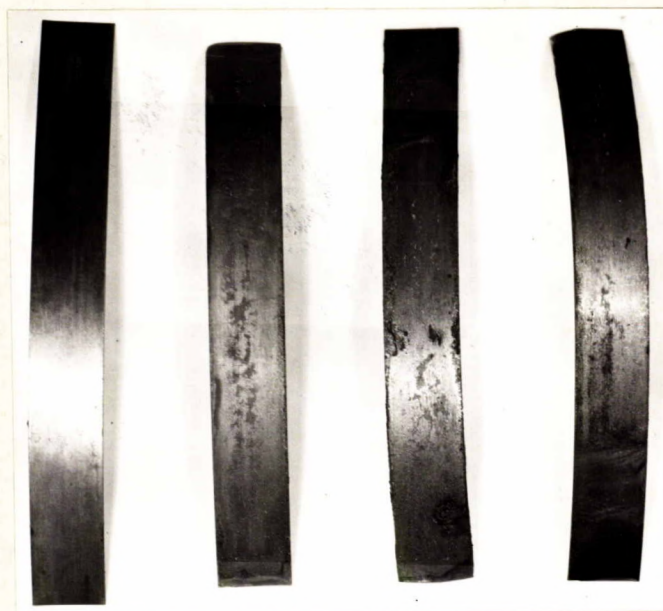
Figure 4.

Convex side.

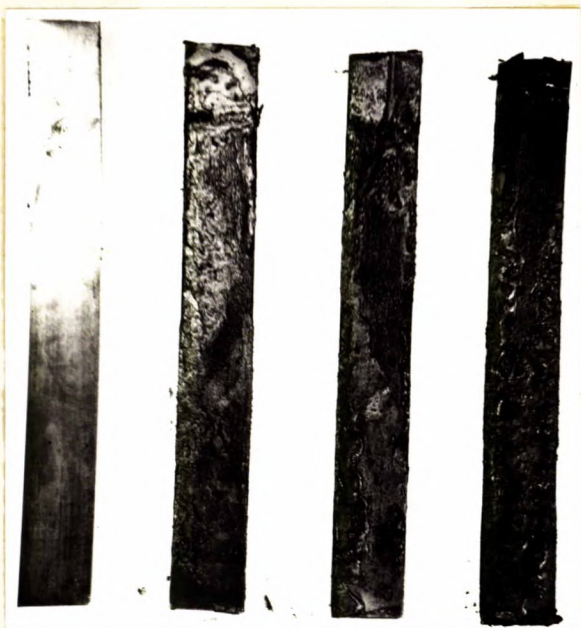
Figure 5.

Concave side.

SELENIUM-COATED STEEL STRAPPING AFTER 89 HOURS  
IN THE INTERMITTENT CORROSION TEST.

5% sodium chloride was used as the corroding liquid  
at a temperature of 93° F. (34° C.).

At the end of the 89 hours the samples were removed from the test, dried, and both sides photographed (Figures 5 and 6). In each photograph an uncorroded sample was included for comparison.

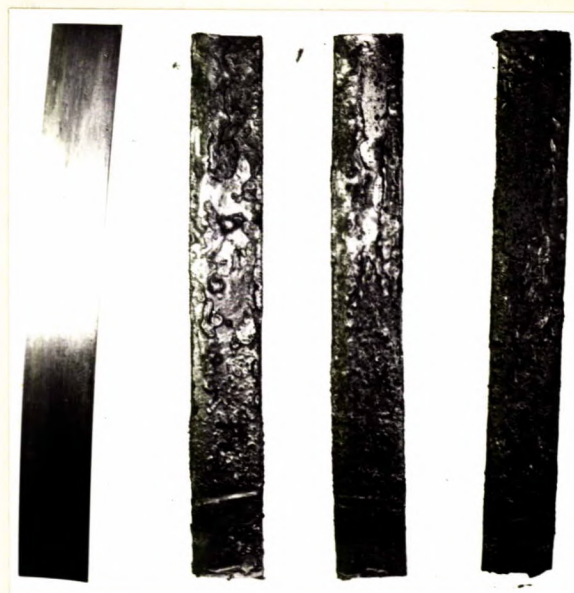
Figure 6.

Convex side.

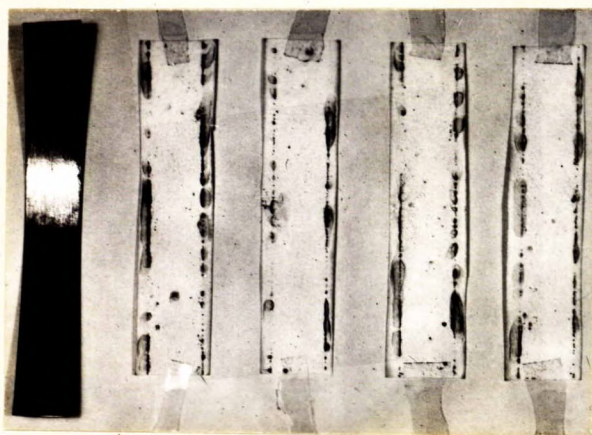
Figure 7.

Concave side of samples.

PAPERS SHOWING THE NATURE AND LOCATION OF PORES  
IN THE SELENIUM-COATED STEEL STRAPPING.

steel, moistened with distilled water, and then allowed to dry. A blue spot appeared on the paper wherever a pore existed in the selenium coating. Four of these samples were tested on the concave side and four on the convex side. The papers were photographed (Figures 7 and 8). The results would indicate that considerable porosity existed in the selenium coating, particularly along the edges of the samples. The convex side appeared to be somewhat superior to the concave side.

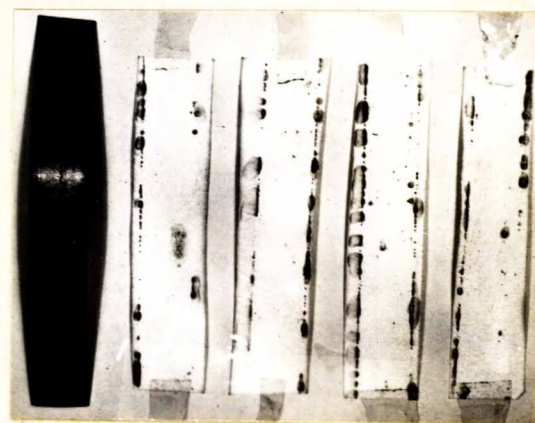
Figure 8.

Convex side of samples.
