Investigation No. 1773.

Metallurgical Examination of Armour Welds of a Sexton
25-Pdr. Self-Propelled Gun Mount.

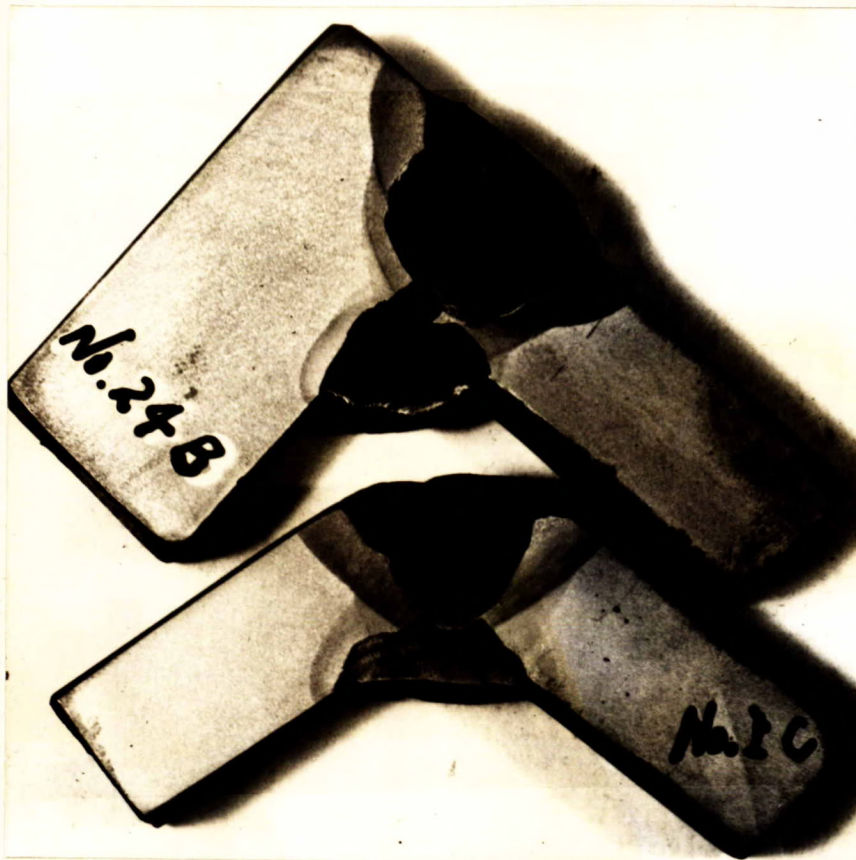
Figure 1.

1.25 X.

MACRO SECTIONS OF WELDS 24 AND 1,
REPRESENTATIVE OF NORMAL ROOT BEAD PREPARATION.

Note widths of root bead and heat-affected zones.

(3) Macro sections were machined from each sample, polished, etched, and photographed. Figures 1 and 2 show the samples after these operations.

Examinations by various means fail to reveal any evidence of cracking in any of the samples. The macro-examination of sections of the welds reveal no appreciable differences in the widths of the heat-affected zones of the two root bead preparations. There is a slightly greater width of weld metal in the roots of the welds prepared by arc gouging, indicating a more thorough cleaning-out of this area before welding proceeded.

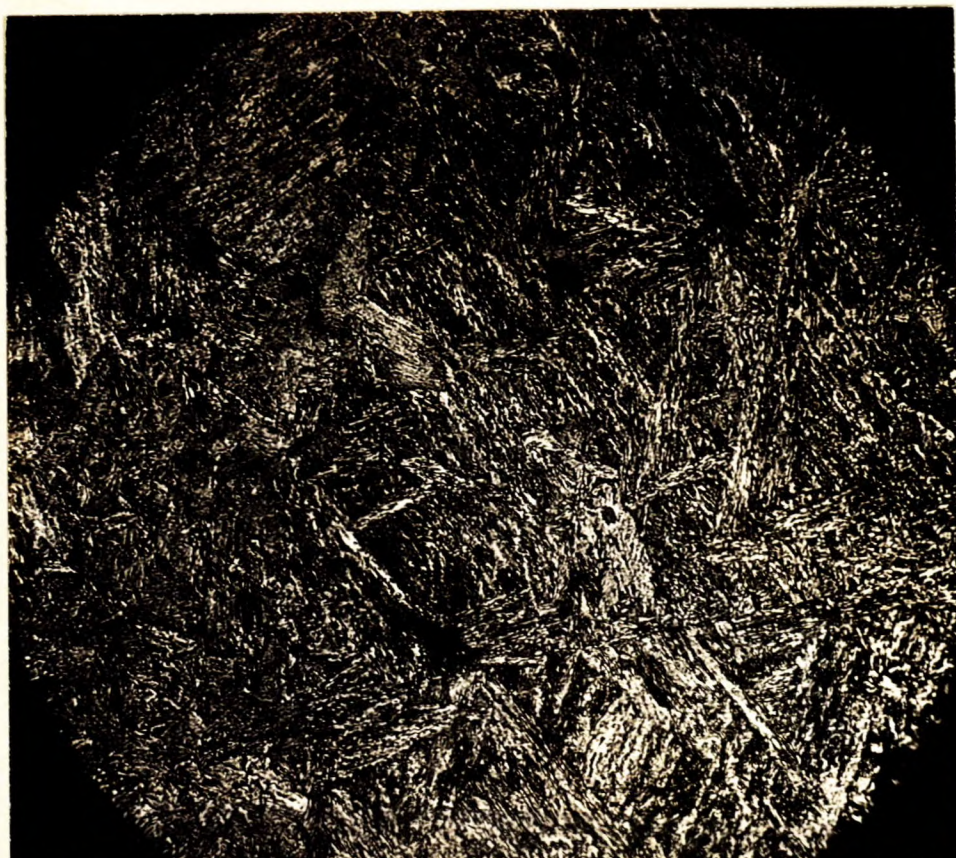
Figure 3.

X500, etched in 1 per cent HCl and 4 per cent picric acid in alcohol.

STRUCTURE OF HEAT-AFFECTED ZONE ADJACENT
TO ROOT BEAD OF WELD 1.

Coarse tempered martensite.

(4) Macro sections were repolished and etched and subjected to examination under a microscope. Figures 3 to 6 show the structures at the roots of Welds 1, 15, 19 and 24 respectively. No evidence of cracking was found in the samples.

Normal root preparation has resulted in tempered martensitic structures in the root areas whereas arc gouging has resulted in either fine pearlite (Sample No. 19) or a mixture of fine pearlite and tempered martensite. This

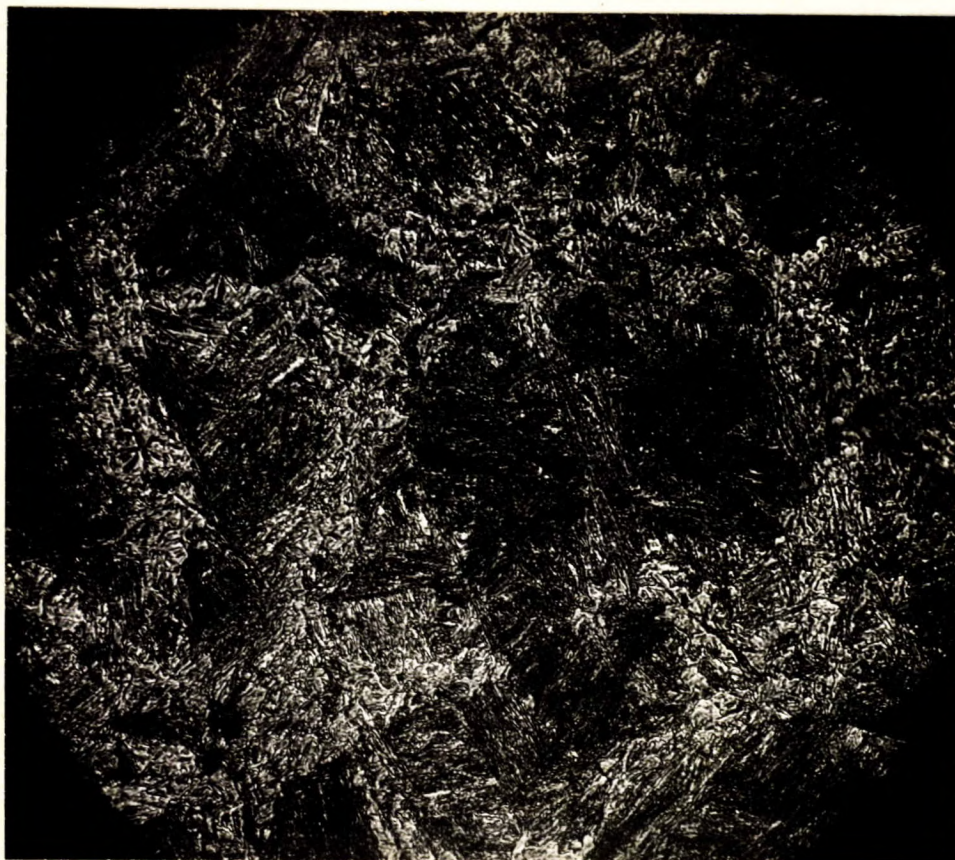
Figure 4.

X500, etched in 1 per cent HCl and 4 per cent picric acid in alcohol.

STRUCTURE OF HEAT-AFFECTED ZONE ADJACENT TO THE ROOT BEAD OF WELD 15.

Structure is a composite of tempered martensite and fine pearlite.
