ORE DRESSING AND METALLURGICAL LABORATORIES.

Investigation No. 1784.

Microscopic Examination of Twenty-Two Samples of  
Austenitic Manganese Steel.

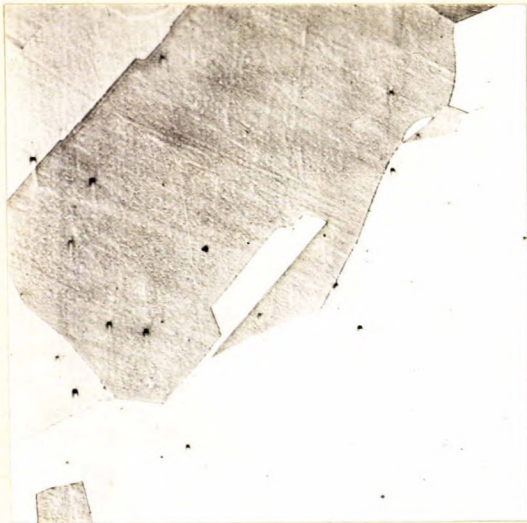
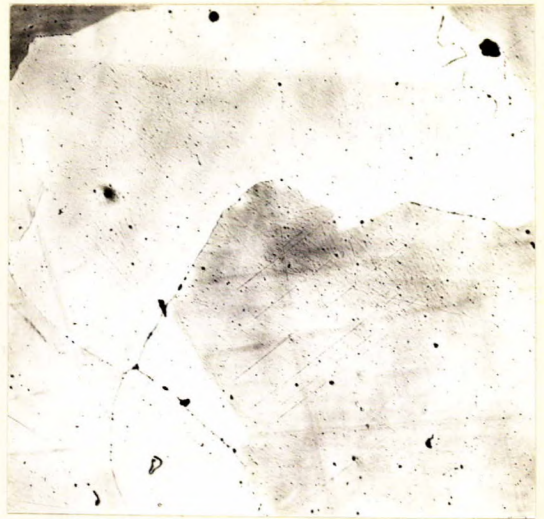
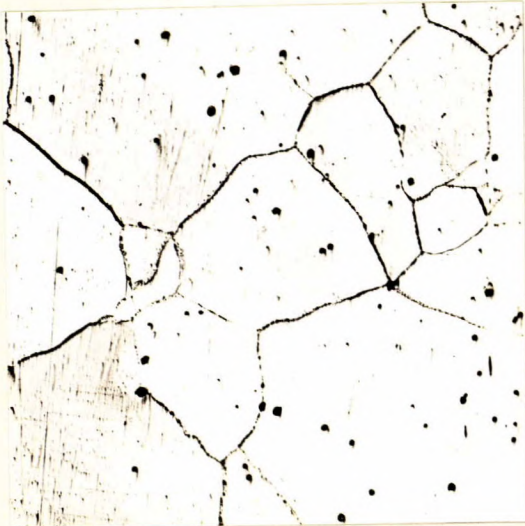
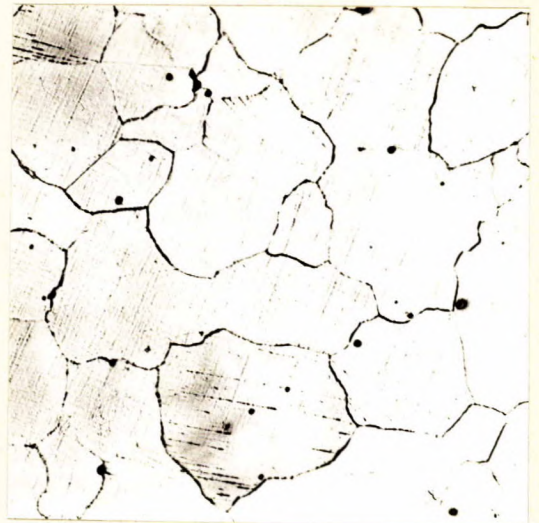
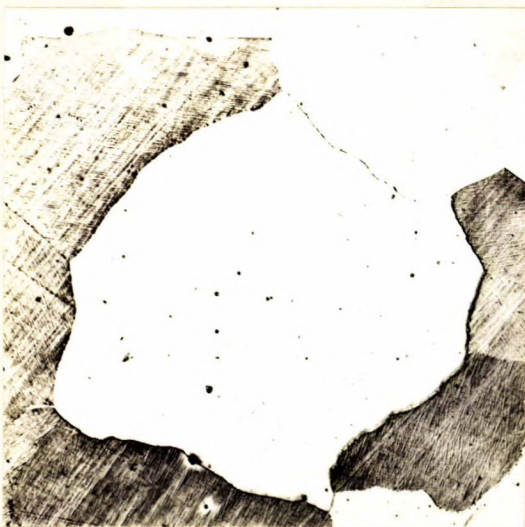
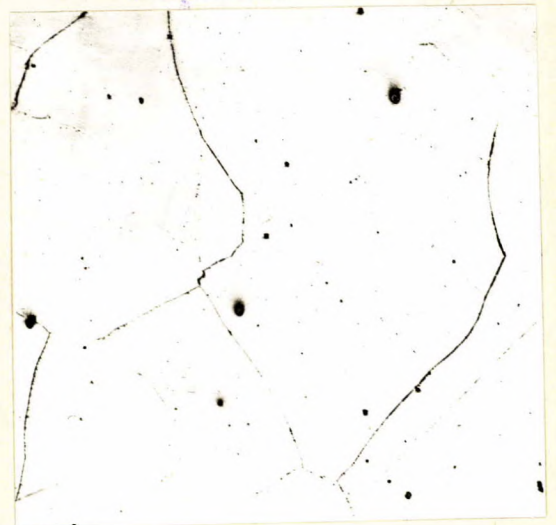
- A. Samples numbered 52, 53, 54, 55, 56, 57, 59, 60, 62, 64, 65, 67 and 68, which had a normal austenitic microstructure with no evidence of free carbides.

Photomicrographs of these microstructures, at X100 magnification, are shown in Figures 1 to 13, inclusive.

All of above photomicrographs at X100,  
etched in 2 per cent nital.

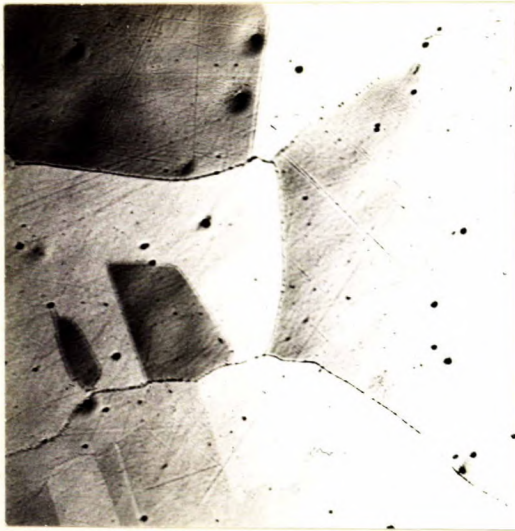
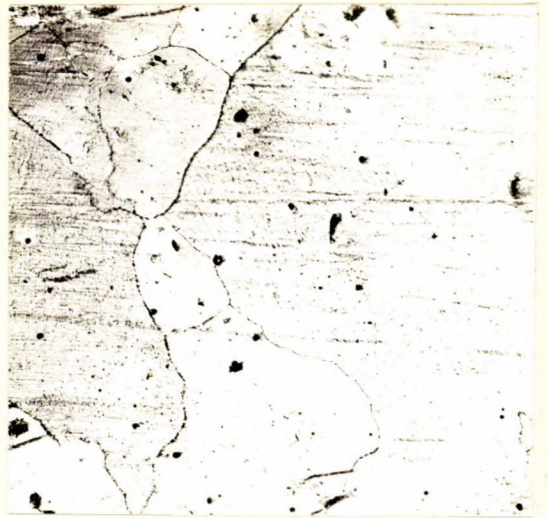
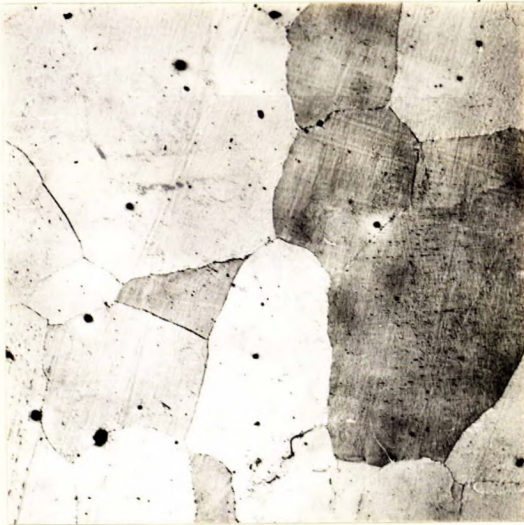
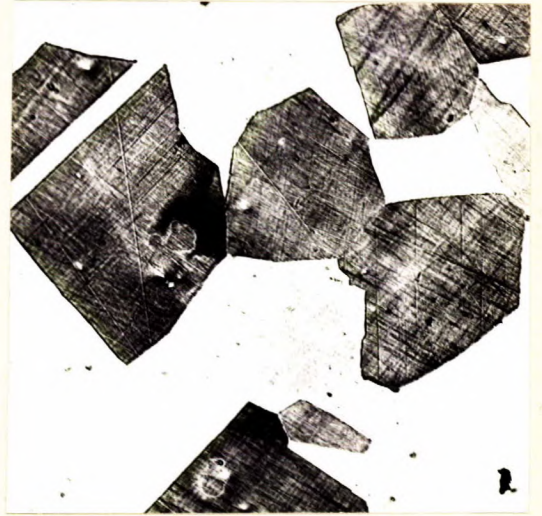
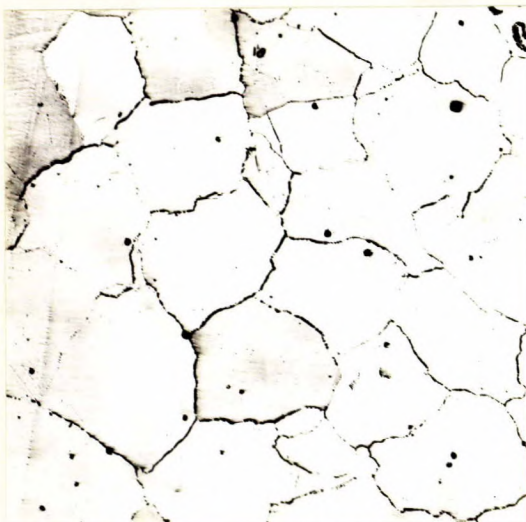
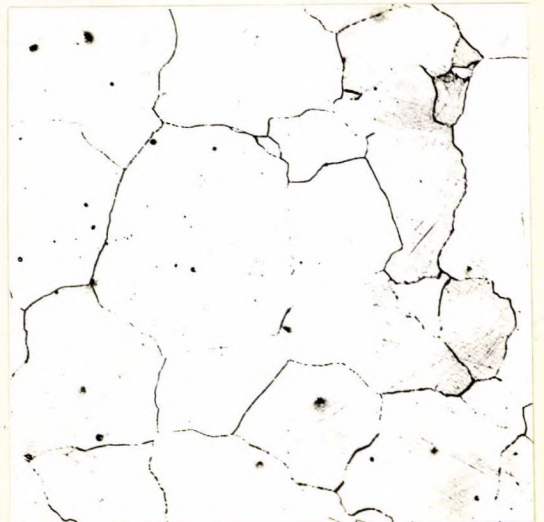
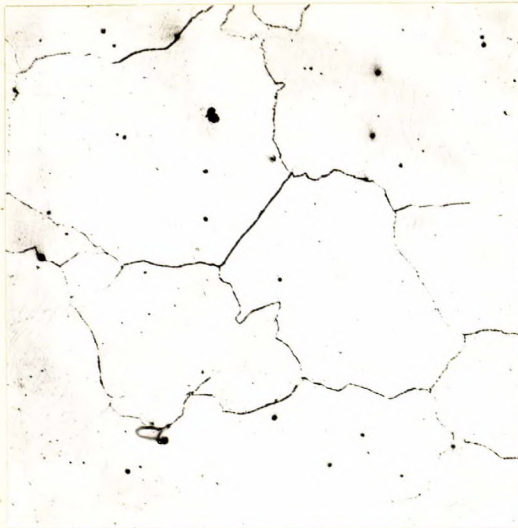
All of above photomicrographs at X100,  
etched in 2 per cent nital.

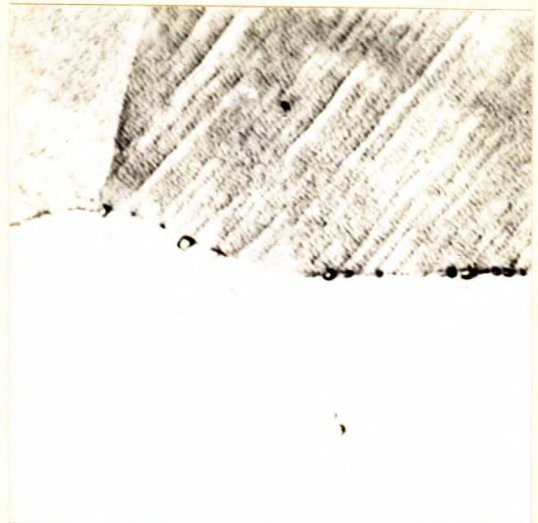
Figure 14.

- B. Samples numbered 51, 63, 70 and 73, in which microstructures occasional small particles of free carbide are present at the austenitic grain boundaries (see Figure 14).

When these specimens are examined at lower magnification, such as 100 diameters, the structure appears to be normally austenitic. Particles of free carbide are only observed at magnifications of 1000 or higher. Since the particles are very small and do not form a continuous film about the grain boundaries, the microstructure may be considered satisfactory but is indicative of marginal heat treatment.

X1000, etched in 2  
per cent nital.

SAMPLE NO. 51.

Small globular carbides at  
austenitic grain boundaries.

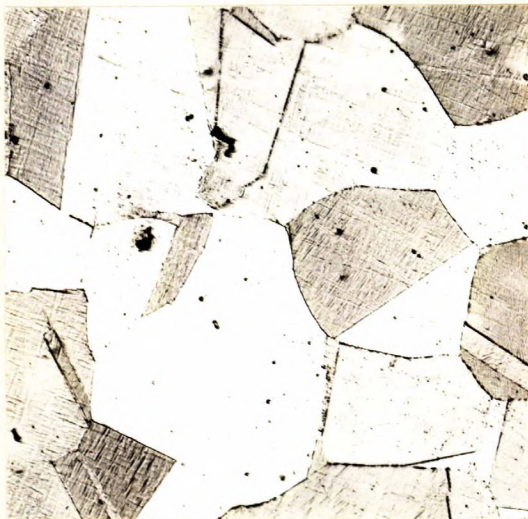
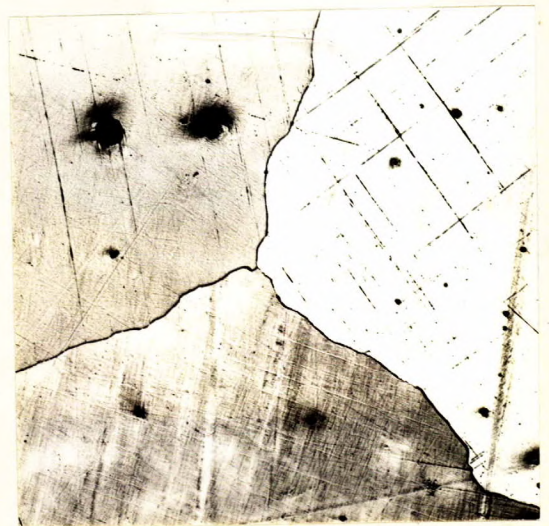
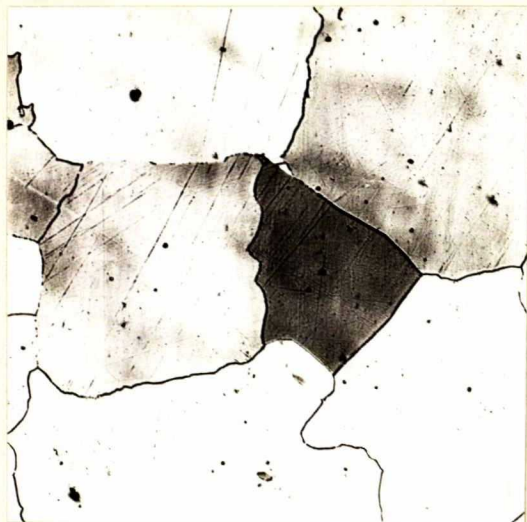
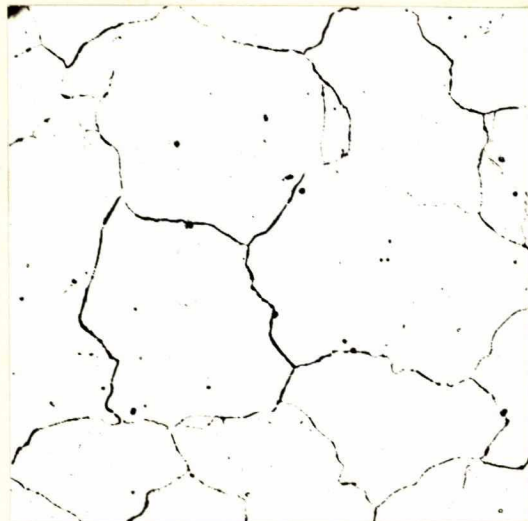
Photomicrographs of these microstructures, at X100 magnification, are shown in Figures 15 to 18.

2. Specimens Nos. 51, 63, 70 and 73 have an austenitic microstructure which may be considered satisfactory, but occasional particles of free carbide at the grain boundaries indicate marginal heat-treating practice.

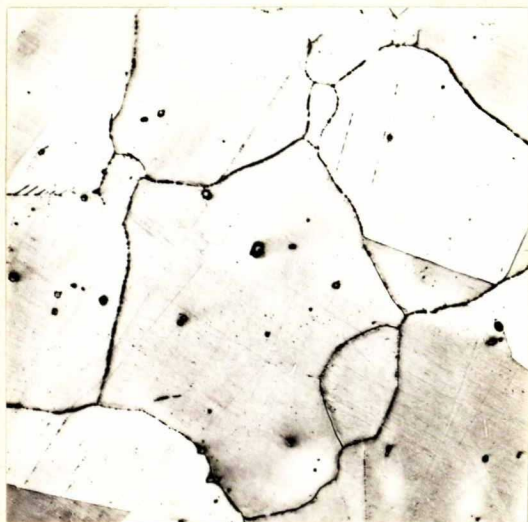
Figure 19.

- C. Samples numbered 58, 61, 66, 69 and 72, in which microstructures relatively large particles of free carbide were present, both in and at the boundaries of the austenite grains (see Figures 19 and 20).

The samples in this group have not a normal austenitic microstructure, because of either improper heat treatment or improper chemical composition.

X100, etched in 2 per cent nital.

SAMPLE NO. 66.

Note relatively large globular carbides in austenite grains.

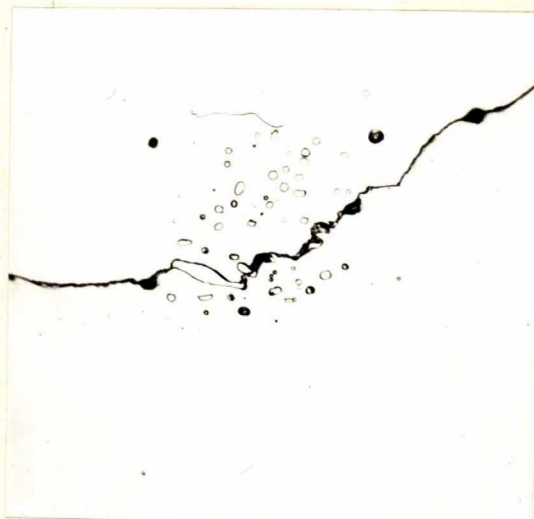
Figure 20.

X500, etched in 2 per cent nital.

SAMPLE NO. 72.

Typical arrangement of carbides found at all grain boundaries.
