ORE DRESSING AND METALLURGICAL LABORATORIES.

Investigation No. 1800.

Metallurgical Examination of Steel Base  
Plate Blanks for 5.5-inch Shells.

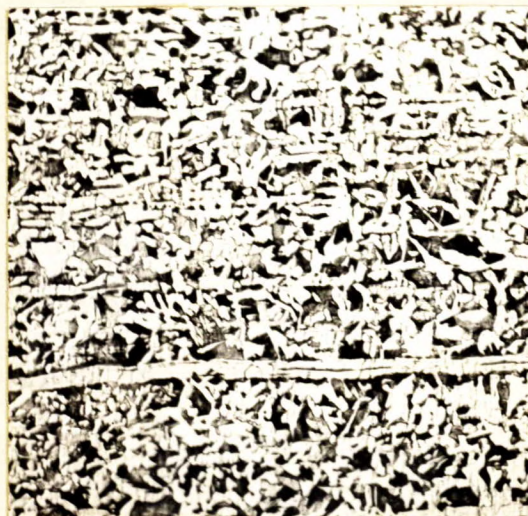
The nital-etched structure of the steel is shown in Figure 3. The structure consists of pearlite, the iron-iron carbide constituent, the dark etching material, and ferrite, the iron constituent, the light etching material. The steel has a slightly banded structure. Elongated sulphide inclusions can be seen in the ferrite bands.

X100, etched in 2 per cent nital.

The steel was found to have a chemical composition similar to that of an SAE 1025 steel except for the sulphur content which was above the upper limit. The surface markings observed in the steel are associated with banding, banding being caused by the precipitation of ferrite around inclusions. The ferrite of these bands will have a distinctly higher phosphorus content than that of the steel as a whole. This local concentration of phosphorus is one of the reasons for the transverse weakening produced by the banded structure. Charpy impact tests carried out on a transverse specimen cut from one of the plates in the "as received" condition showed that its impact strength was fairly low. A quench from 1600° F. and a 1200° F. draw heat treatment carried out in these Laboratories on a sample of this steel did not remove the banded structure, but the impact and yield strength were improved considerably without any appreciable sacrifice of ductility.
