March 22, 1945.

ORE DRESSING AND METALLURGICAL LABORATORIES.

Investigation No. 1818.

Metallurgical Examination of Bulletproof
Plate for Carrier Floor.

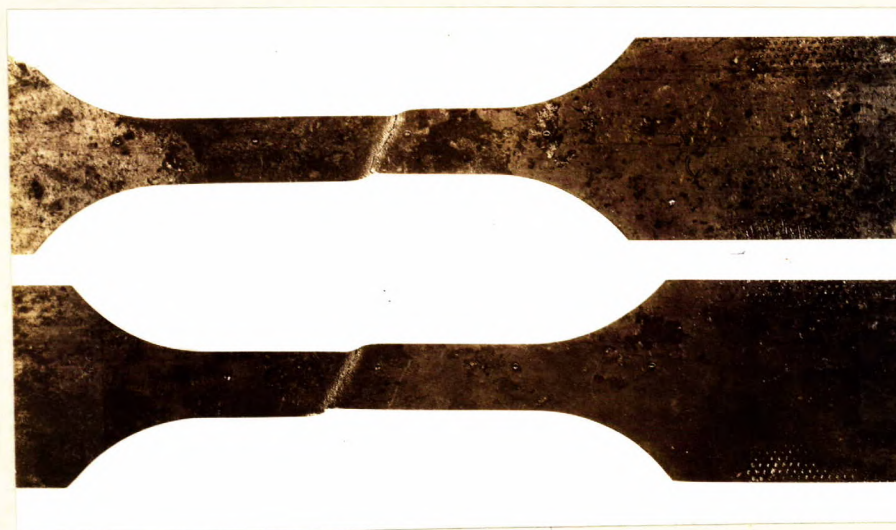
Figure 1.

FRACTURES IN 1/8-INCH BULLETPROOF
PLATE TEST SPECIMENS.

(Approximately $\frac{3}{4}$ full size).

The measurement of reduction of area on the 1/8-inch

bulletproof plate was difficult, due to the type of fracture exhibited by this plate (see Figure 1). Four specimens were pulled in Templin grips and a fifth was pulled using self-aligning grips. One specimen was macro-etched to determine the cause of this peculiar fracture but nothing of significance was observed. Reduction of area was measured on each side of the fracture and the average taken. The results, in all probability, are low.

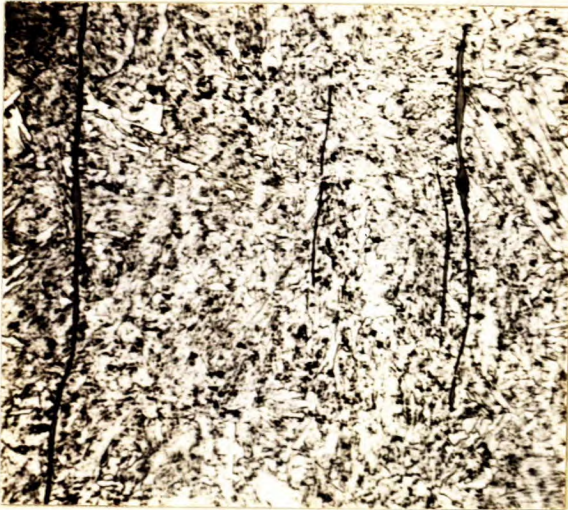
Figure 2.

X500, nital etch.

STRUCTURE OF 7-mm. PLATE.

A metallographic examination revealed the presence of duplexed sulphide-silicate inclusions in both plates, although to a slightly greater extent in the 7-mm. plate (see Figures 2 and 3). Fragmented oxide inclusions were also observed in both samples.

The structure of the 1/8-inch bulletproof plate consisted of a tempered martensite (Figure 4). The structure of the 7-mm. plate was also martensitic but the drawing temperature was evidently quite high, a fact which is borne out by the hardness values. It should be noted that Figure 3 represents the decarburized zone of the 1/8-inch plate while Figure 4 shows the core.

While neither plate could be classified as "dirty"
the inclusions were very long.

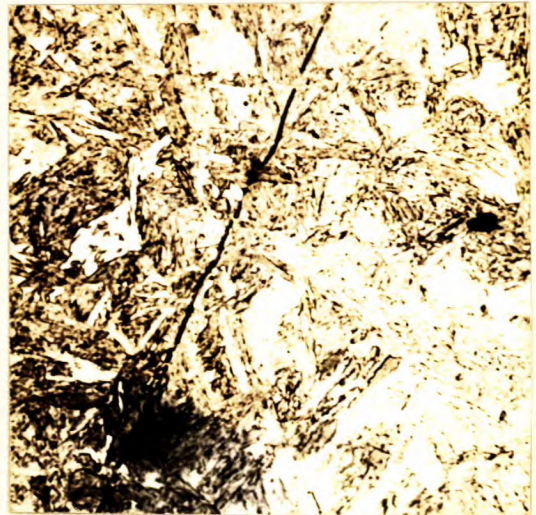
Figure 3.

X500, nital etch.

INCLUSIONS IN DECARBURIZED
ZONE OF 1/8-INCH PLATE.

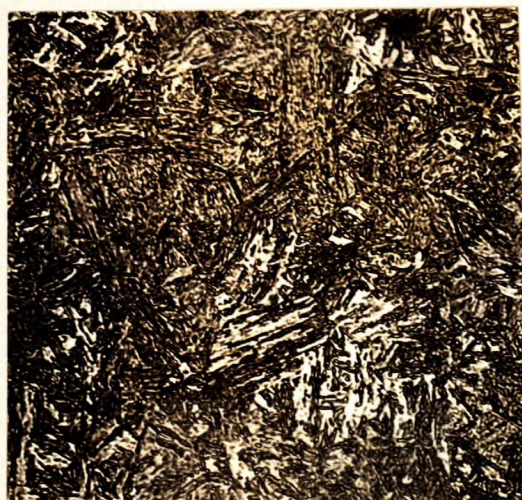
Figure 4.

X500, nital etch.

STRUCTURE OF CORE OF 1/8-INCH
BULLETPROOF PLATE.
