R E P O R T  
of the  
ORE DRESSING AND METALLURGICAL LABORATORIES.

Investigation No. 1864.

Corrosion Resistance of Galv-Weld Alloy  
Coating Applied to Steel Pipe.

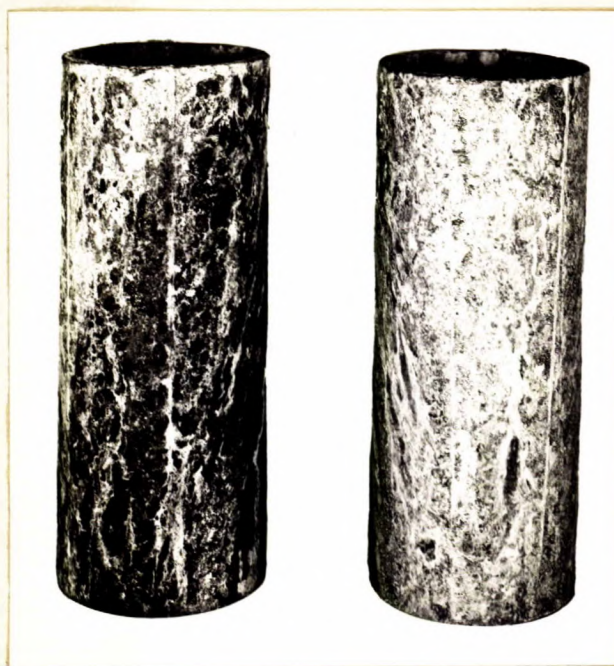
STEEL PIPES COATED WITH (a) GALV-WELD ALLOY, (b) ZINC,  
AFTER 96 HOURS IN THE SALT SPRAY CORROSION TEST.

Most of the dark material on sample (a) is iron rust. The light material on sample (b) is zinc corrosion product.

Magnification: X 0.5.

After 48 hours: Rust spots appeared on the pipe coated with Galv-Weld alloy.

After 72 hours: General breakdown occurred on that part of the Galv-Weld alloy surface which was directly exposed to the spray. One small rust spot visible on the galvanized pipe.

After 96 hours: Several other small rust spots visible on the galvanized pipe. Test discontinued.

The condition of the two pipes at the end of the test is shown in Figure 1.

In the Salt Spray Corrosion Test, the galvanized coating offers much better protection to steel than the Galv-Weld coating.
