ORE DRESSING AND METALLURGICAL LABORATORIES.

Investigation No. 1877.

Corrosion Resistance of Copper Sleeves
for Bilge Pumps for Phoenix Steel
Nesting Barges S/4.

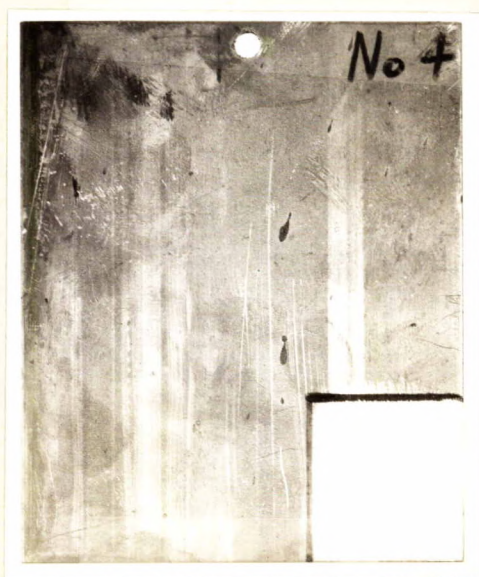
Figure 1.

SAMPLE OF COPPER AFTER 6 DAYS IN
THE HUMIDITY CABINET.

Tarnish was removed with emery cloth
at the lower right-hand corner.

One sample of copper was placed in the Humidity Cabinet for 6 days at 120° F. and 95 to 100 per cent relative humidity with air passing through.

The sample changed very little during this test. Figure 1 shows the somewhat tarnished appearance of the sample both before and after the test. At the lower right-hand corner the surface was rubbed with emery cloth to

expose the fresh copper underneath the tarnish.

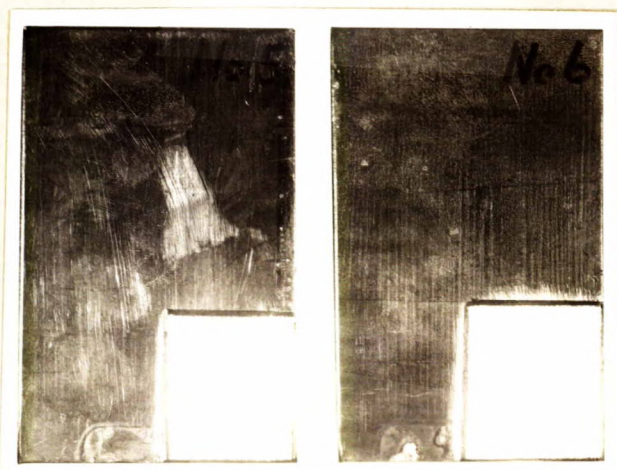
Figure 2.

SAMPLES OF COPPER AFTER 7½ DAYS IN
THE WEATHER-OMETER.

Tarnish was removed with emery cloth at
the lower right-hand corner of each sample.

One sample of copper was cut into two halves. These were placed in the Weather-Ometer for $7\frac{1}{2}$ days at 130° F. They were exposed continuously to light, resembling sunlight, produced by an electric arc, and for three minutes out of every twenty they were sprayed with ordinary tap water.

The tarnish became somewhat darker. Otherwise there was no evidence of corrosion. Figure 2 shows the appearance of the surfaces at the end of the test. Here again, the surface was rubbed with emery cloth at the lower right-hand corner to expose the fresh copper underneath the tarnish.

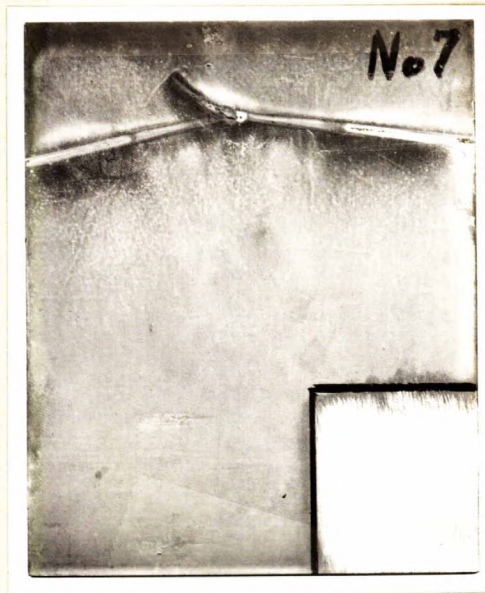
Figure 3.

SAMPLE OF COPPER AFTER 7 DAYS IN THE
INTERMITTENT IMMERSION CORROSION TEST
USING 20 PER CENT SALT SOLUTION.

Tarnish was removed with emery cloth
at the lower right-hand corner.

One sample of copper was given the Intermittent Immersion Corrosion Test, using 20 per cent salt (sodium chloride) solution at a temperature of about 95° F. The test lasted 7 days.

The sample was corroded considerably and the surface became covered with a green corrosion product (see Figure 3). The corrosion product was removed from one corner as before.

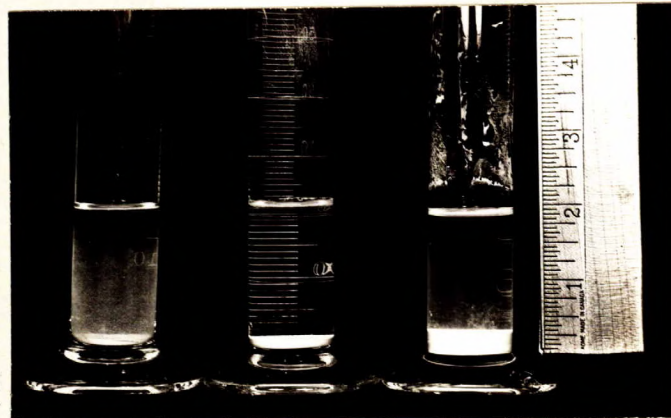
Figure 4.

(a) (b) (c)

PHOTOGRAPH SHOWING THE AMOUNT OF
CORROSION PRODUCT PRODUCED IN

- (a) THE TOTAL IMMERSION TEST (3 per cent
Salt Solution).
- (b) THE INTERMITTENT TEST (3 per cent
Salt Solution).
- (c) THE INTERMITTENT TEST (20 per cent
Salt Solution).

Figure 4(c) shows the amount of corrosion product that collected at the bottom of the container during the test.

to the bottom of the container is shown in Figure 4(b). It is apparent that the rate of corrosion was less than when 20 per cent salt solution was used.

There was a certain amount of corrosion as shown in Figure 6. The amount of corrosion product which settled to the bottom of the container is shown in Figure 4(a). The rate of corrosion in this test was somewhat less than that in the Intermittent Corrosion Test in which 3 per cent salt solution was used.

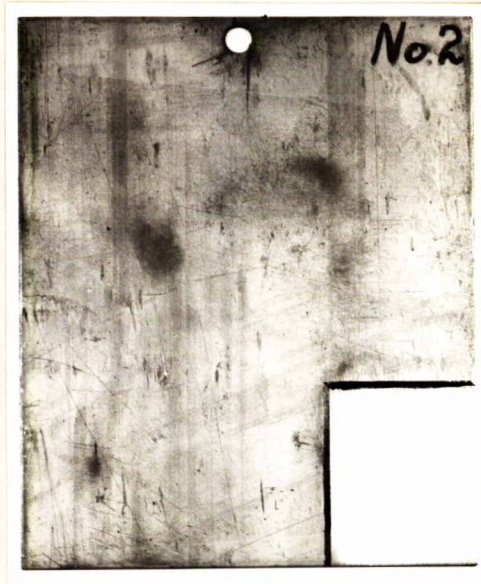
SAMPLE OF COPPER AFTER 10 DAYS IN THE
INTERMITTENT IMMERSION CORROSION TEST
USING 3 PER CENT SALT SOLUTION.

Tarnish was removed with emery cloth
at the lower right-hand corner.

One sample of copper was given the Intermittent Immersion Test, using 3 per cent salt (sodium chloride) solution at about 95° F. This test lasted 10 days.

There was a certain amount of corrosion, as shown in Figure 5. The amount of corrosion product which settled

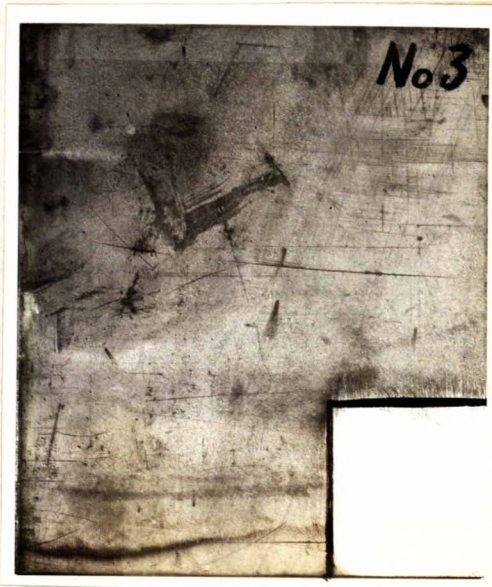
Figure 6.

SAMPLE OF COPPER AFTER 10 DAYS IN THE
TOTAL IMMERSION CORROSION TEST USING
3 PER CENT SALT SOLUTION.

Tarnish was removed with emery cloth
at the lower right-hand corner.

One sample of copper was given the Total Immersion Test in 3 per cent salt (sodium chloride) solution at about 95° F. This test lasted 10 days.

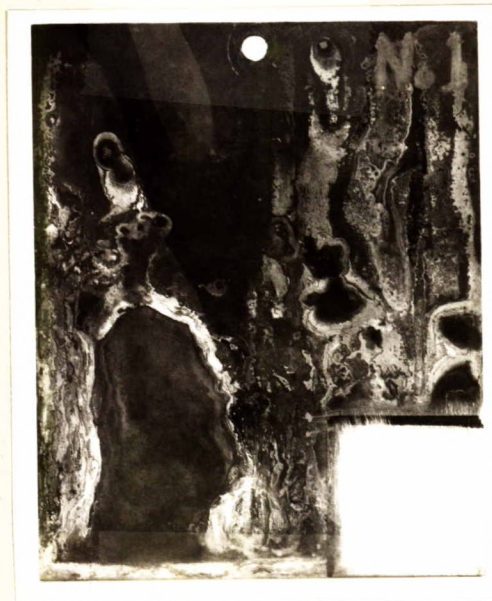
SAMPLE OF COPPER AFTER 10 DAYS IN THE
SALT SPRAY CORROSION TEST, USING 20
PER CENT SALT SOLUTION.

Tarnish was removed with emery cloth
at the lower right-hand corner.

One sample of copper was placed in the Salt Spray Test for 10 days. In this test it was exposed to the spray from a 20 per cent salt (sodium chloride) solution at 95° F.

There was considerable corrosion under these conditions, as shown in Figure 7.
