ORE DRESSING AND METALLURGICAL LABORATORIES.

Investigation No. 1909.

Effect of Salt Spray and Ordinary Atmospheric
Corrosion on Coated Steel Strapping.

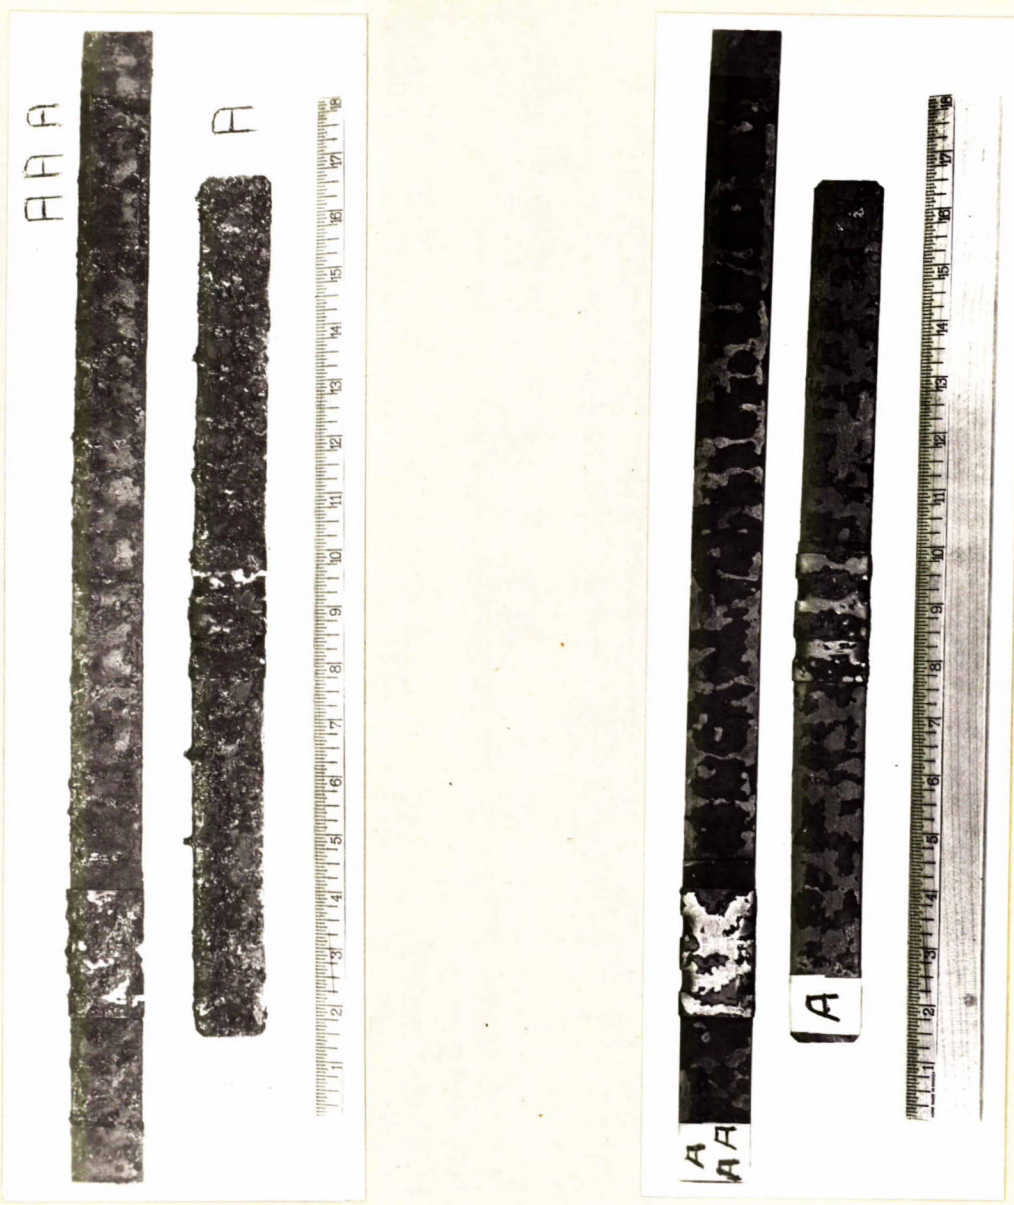
Figure 1.

ACME $1\frac{1}{4}$ " X 0.035" PAINTED STRAPS WITH SEALED JOINTS,
AFTER 21 DAYS IN THE SALT SPRAY CABINET.

- (a) Before removal of corrosion product.
- (b) After removal of corrosion product.

All A, B, D and F samples were badly corroded on the surface of straps and sealed joints.

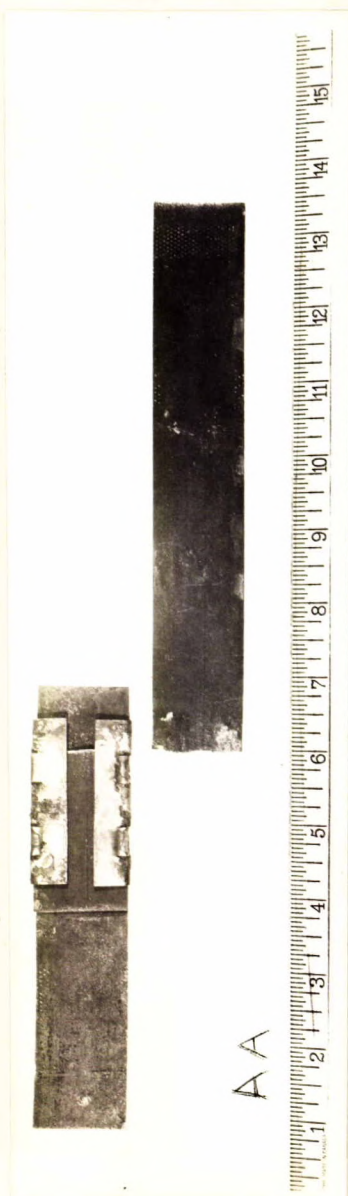
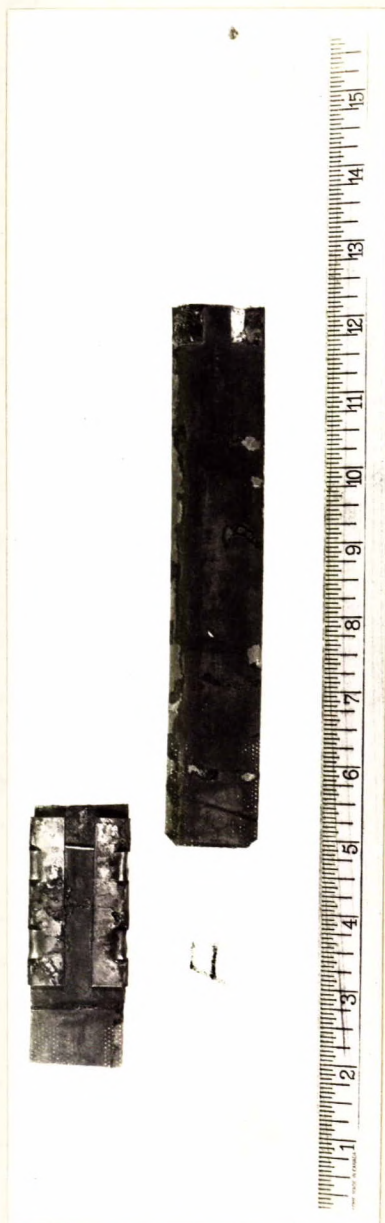
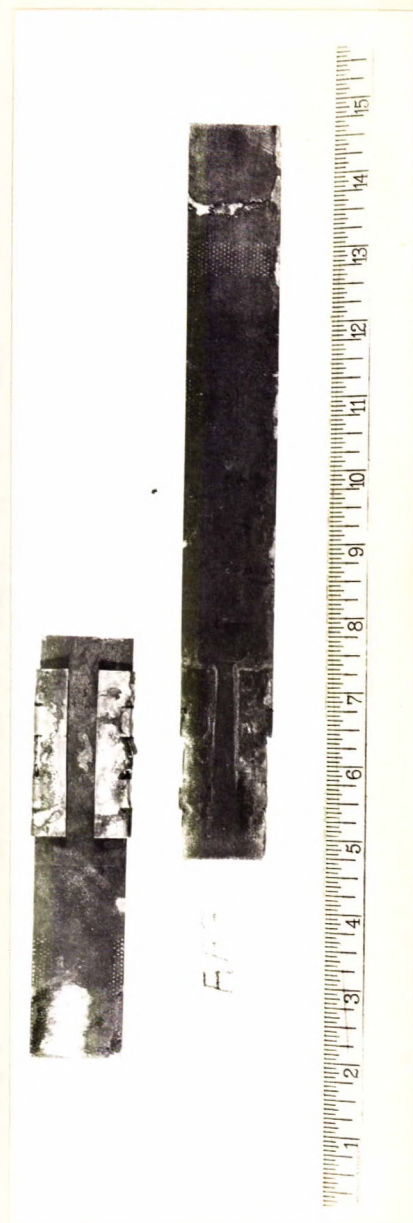
Figure 1 (cont'd)

SEALED JOINTS ON ACME $1\frac{1}{4}$ " X 0.035" PAINTED STRAPS
AFTER REMOVAL FROM THE SALT SPRAY CABINET AND UNDER-
GOING BREAKING LOAD TEST.

- (c) Strap AA after 19 days in the cabinet.
- (d) Strap A) after 21 days in the cabinet.
- (e) Strap AAA)

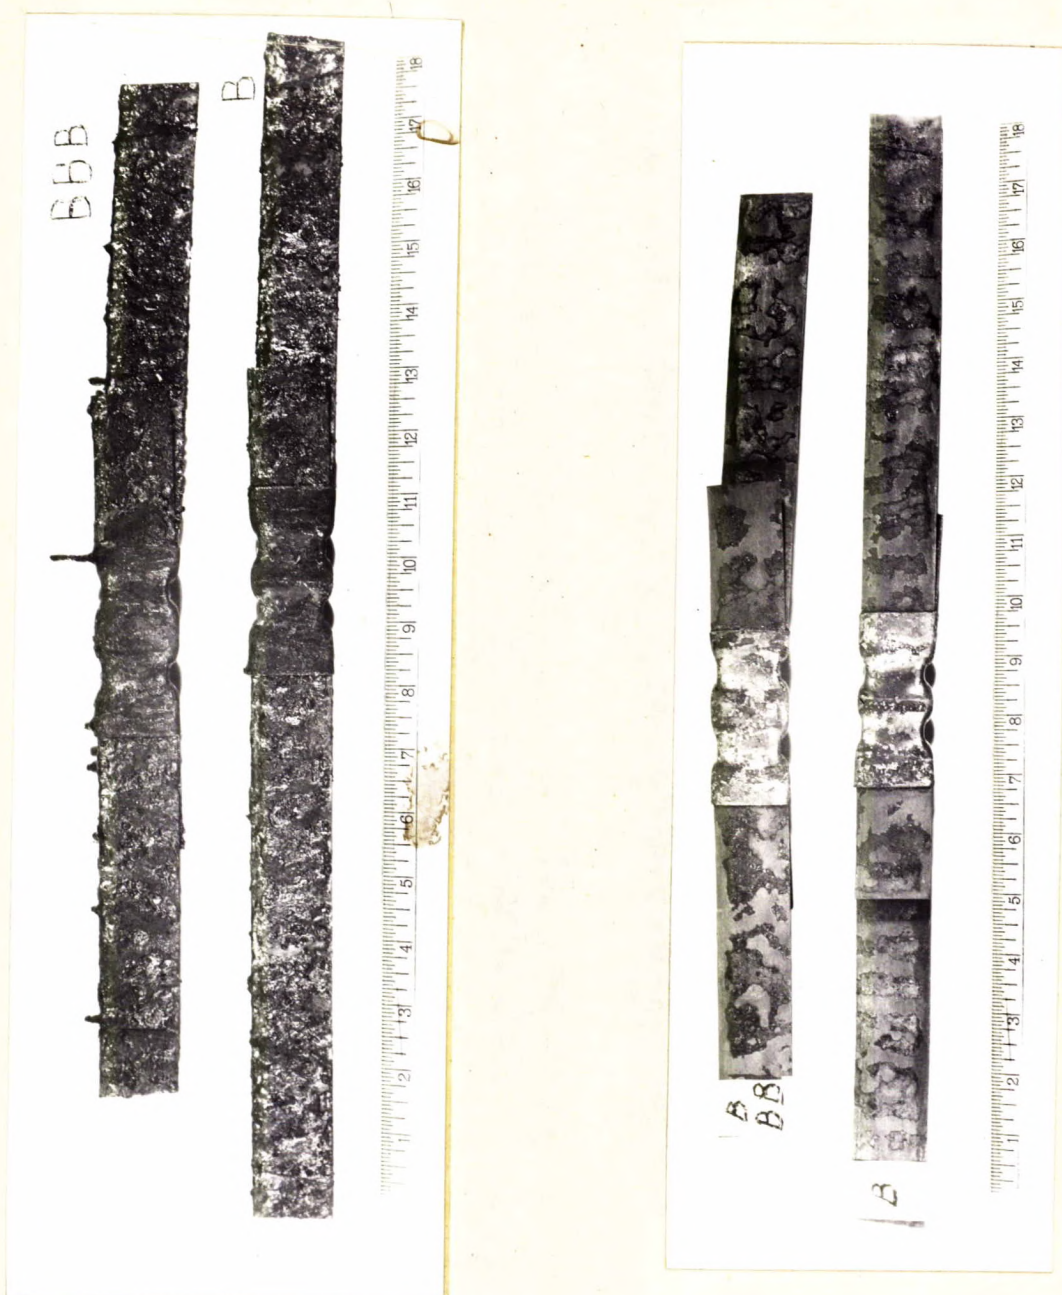
Figure 2.

SIGNODE $1\frac{1}{4}$ " X 0.035" UNPAINTED STRAPS WITH SEALED JOINTS, AFTER 21 DAYS IN THE SALT SPRAY CABINET.

- (a) Before removal of corrosion product.
- (b) After removal of corrosion product.

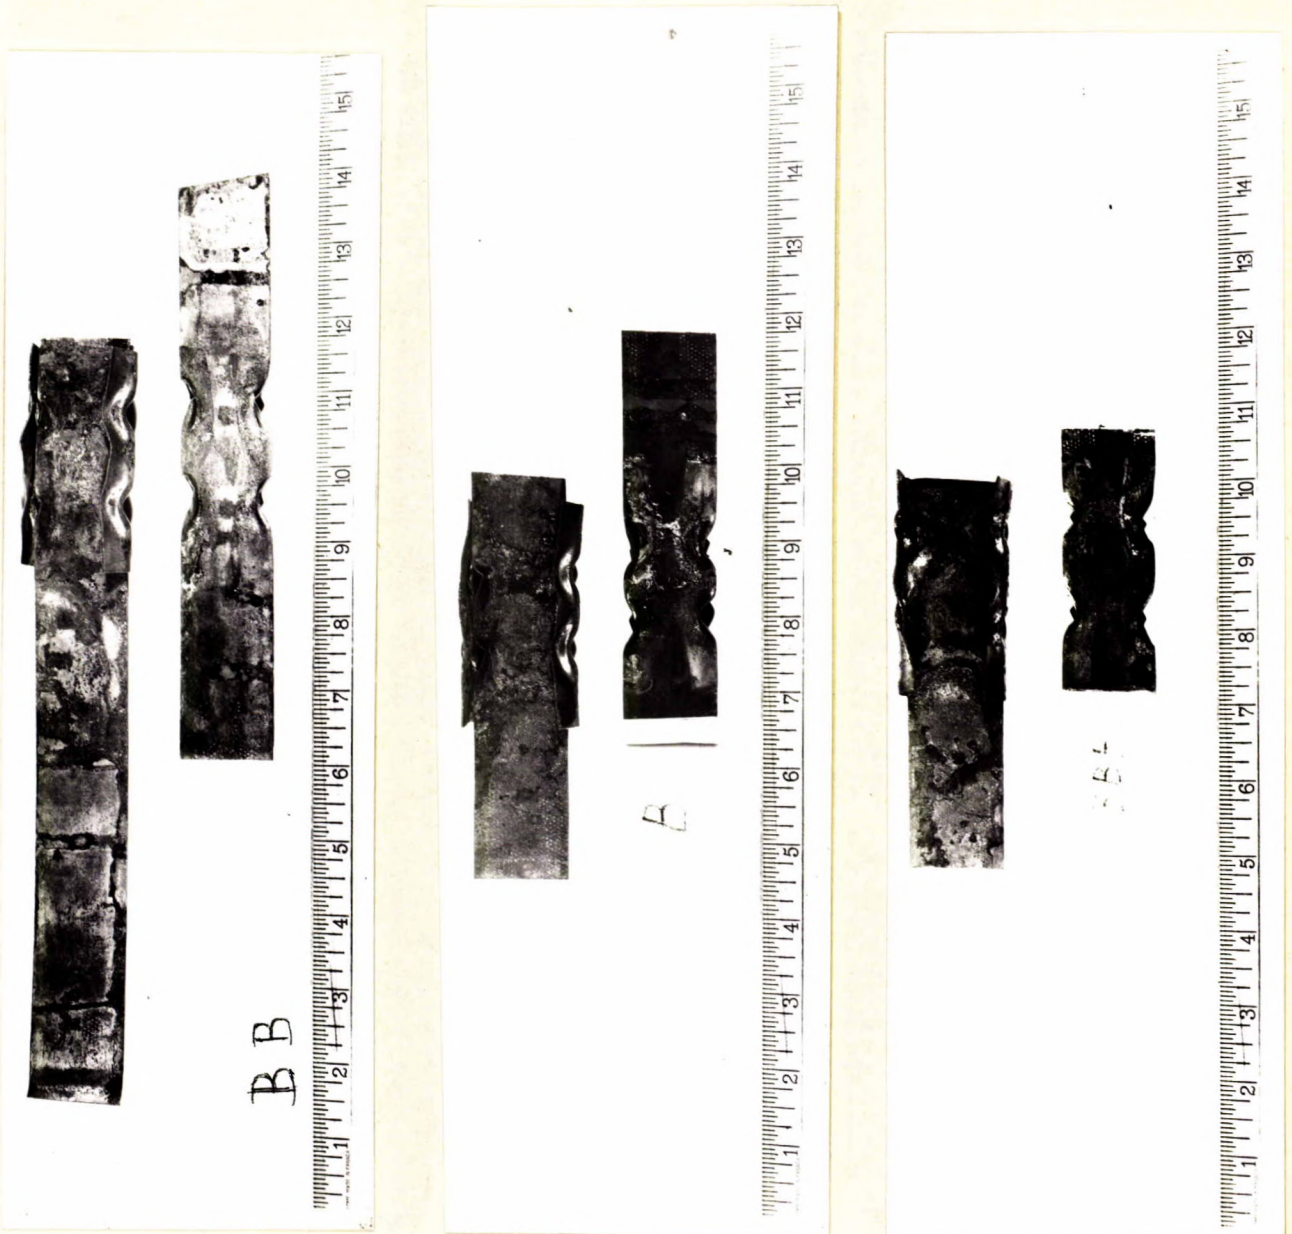
Figure 2 (cont'd)

SEALED JOINTS ON SIGNODE $1\frac{1}{4}$ " X 0.035" UNPAINTED STRAPS
AFTER REMOVAL FROM THE SALT SPRAY CABINET AND UNDERGO-
ING BREAKING LOAD TEST.

- (c) Strap BB after 19 days in the cabinet.
- (d) Strap B)
- (e) Strap BBB) after 21 days in the cabinet.

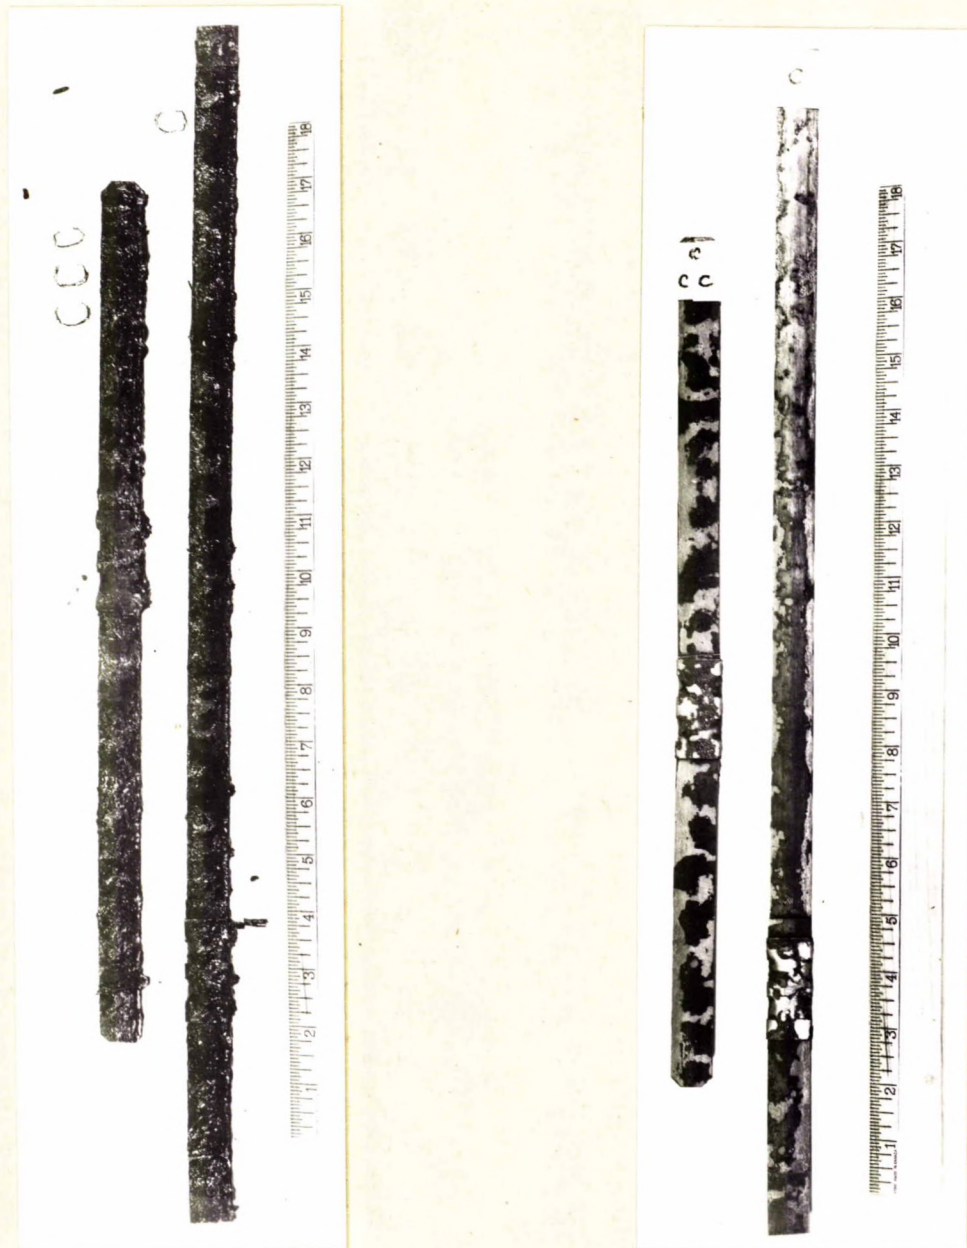
Figure 3.

ACME $3/4$ " x 0.035" PAINTED STRAPS WITH SEALED JOINTS,
AFTER 21 DAYS IN THE SALT SPRAY CABINET.

- (a) Before removal of corrosion product.
- (b) After removal of corrosion product.

All C and E samples were not quite so badly corroded on straps and sealed joints.

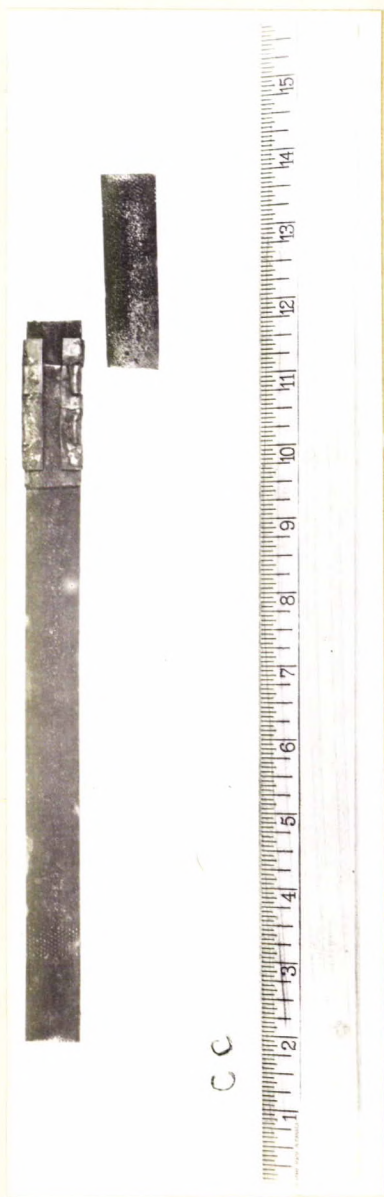
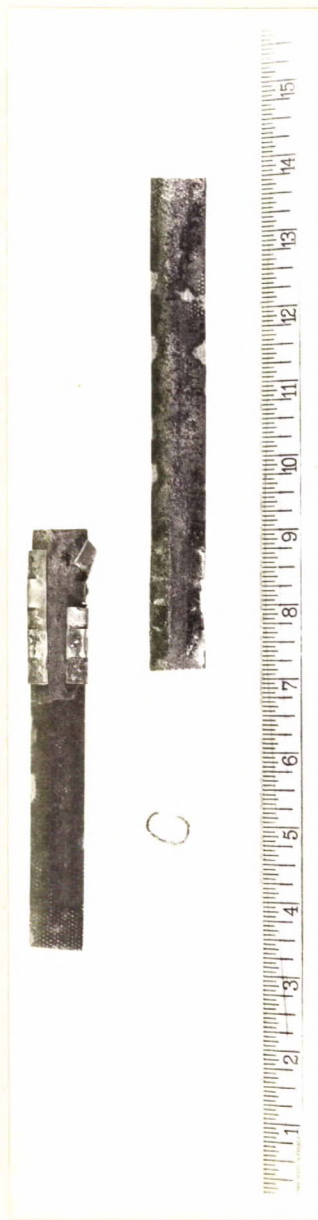
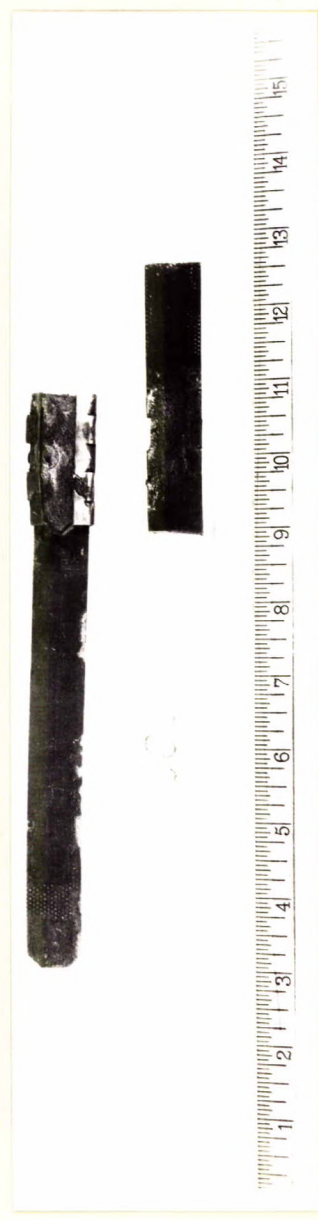
Figure 3 (cont'd)

SEALED JOINTS ON ACME 3/4" X 0.035" PAINTED STRAPS AFTER REMOVAL FROM THE SALT SPRAY CABINET AND UNDERGOING BREAKING LOAD TEST.

- (c) Strap CC after 19 days in the cabinet.
- (d) Strap C)
- (e) Strap CCC) after 21 days in the cabinet.

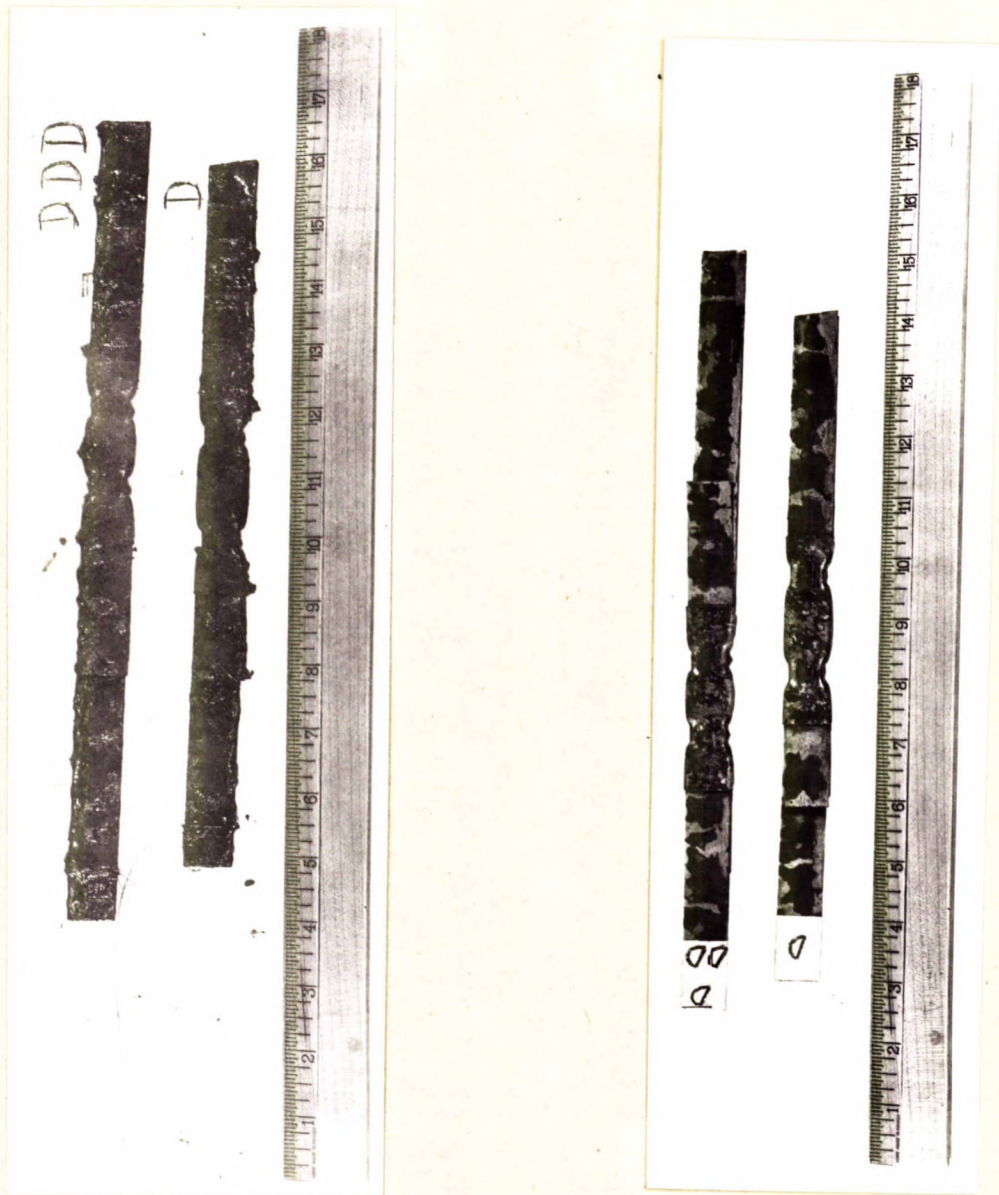
Figure 4.

SIGNODE $3/4''$ x $0.035''$ PAINTED STRAPS WITH SEALED JOINTS, AFTER 21 DAYS IN THE SALT SPRAY CABINET.

- (a) Before removal of corrosion product.
(b) After removal of corrosion product.

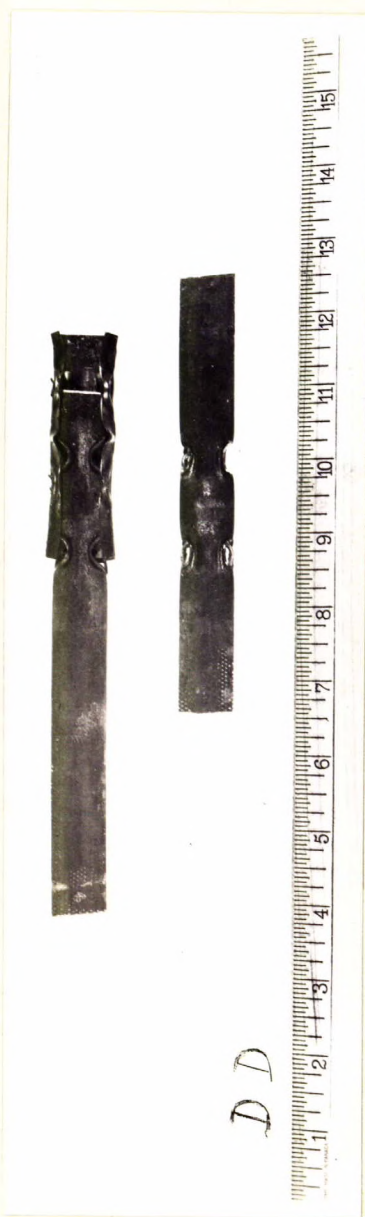
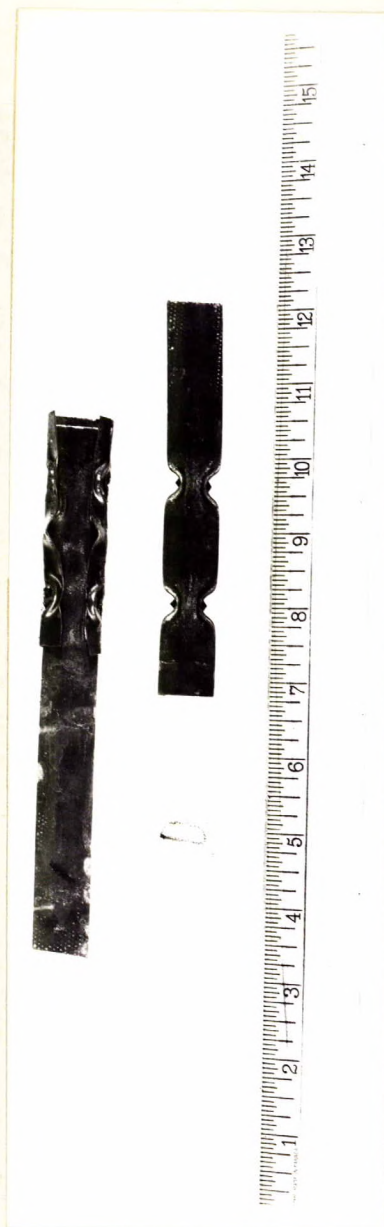
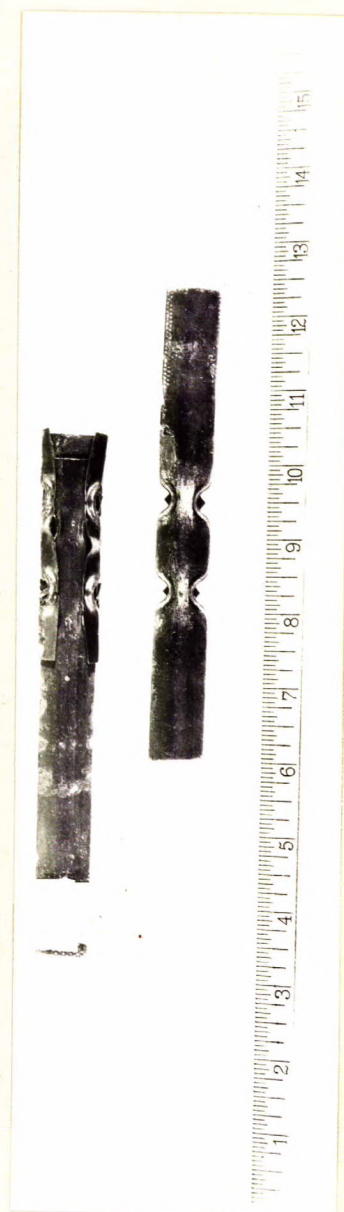
Figure 4 (cont'd)

SEALED JOINTS ON SIGNODE 3/4" X 0.035" PAINTED STRAPS AFTER
 REMOVAL FROM THE SALT SPRAY CABINET AND UNDERGOING BREAKING
 LOAD TEST.

- (c) Strap DD after 19 days in the cabinet.
- (d) Strap D)
- (e) Strap DDD) after 21 days in the cabinet.

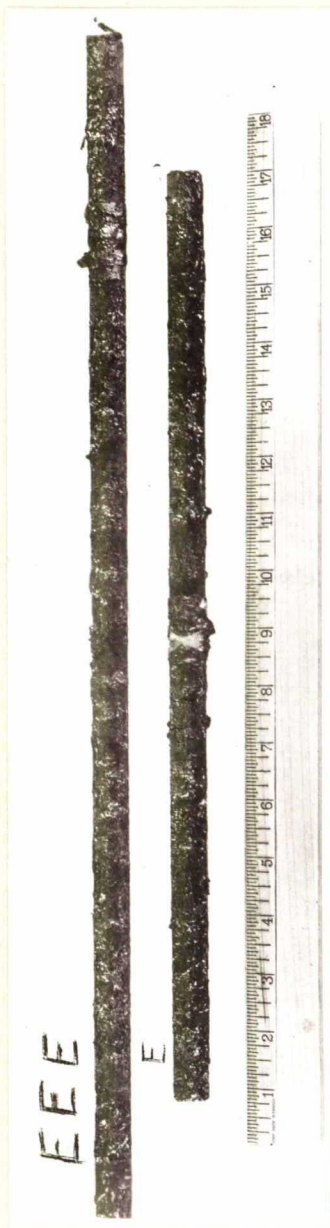
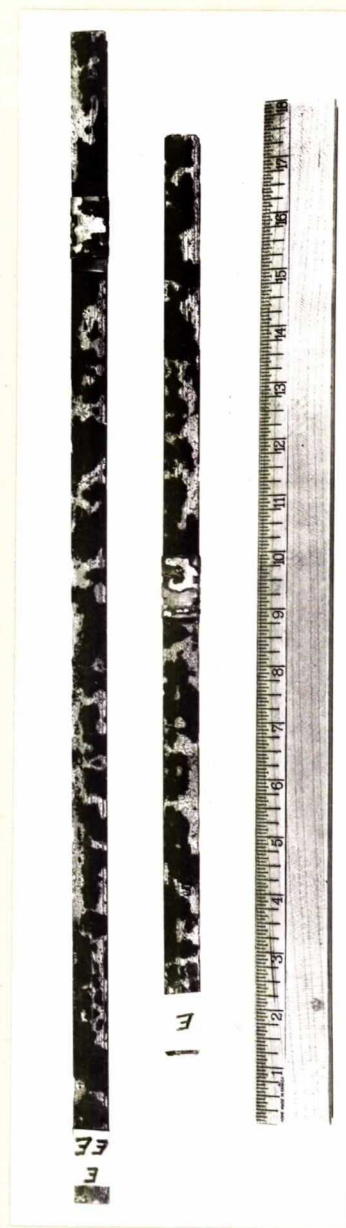
Figure 5.

ACME 5/8" X 0.020" PAINTED STRAPS WITH SEALED JOINTS, AFTER 21 DAYS IN THE SALT SPRAY CABINET.

- (a) Before removal of corrosion product.
- (b) After removal of corrosion product.

Note: In the case of Samples E, EE and EEE, the straps broke before the sealed joints in the breaking load test.

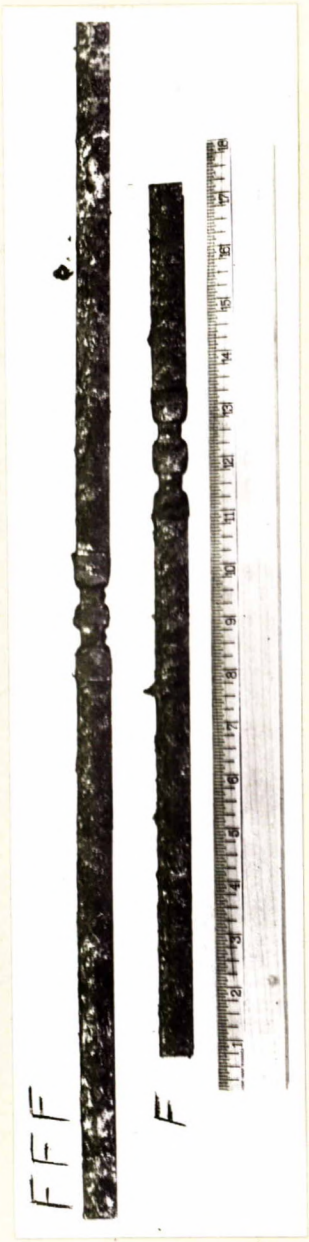
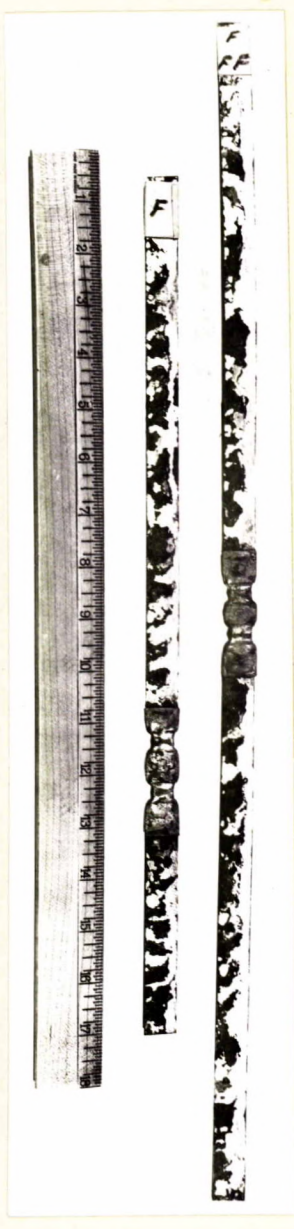
Figure 6.

SIGNODE 5/8" X 0.020" PAINTED STRAPS WITH SEALED JOINTS, AFTER 21 DAYS IN THE SALT SPRAY CABINET.

- (a) Before removal of corrosion product.
- (b) After removal of corrosion product.

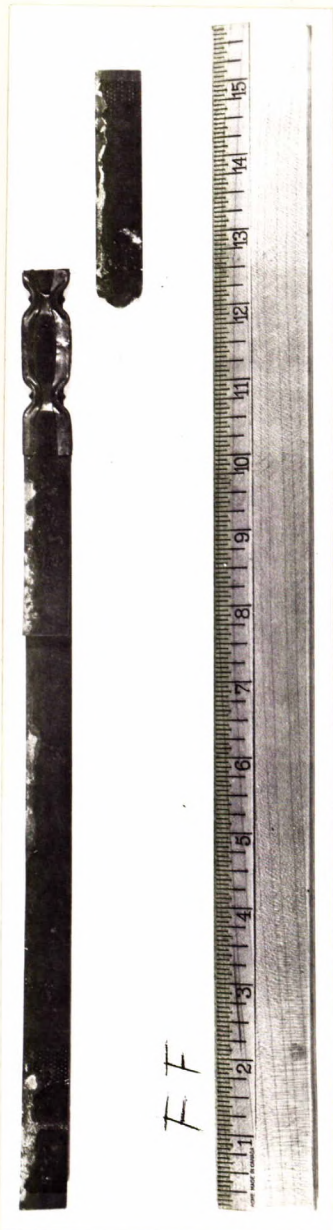
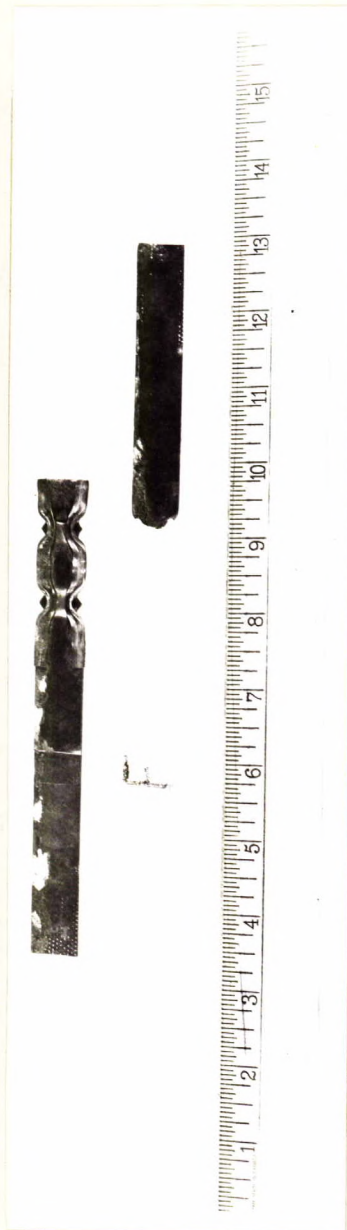
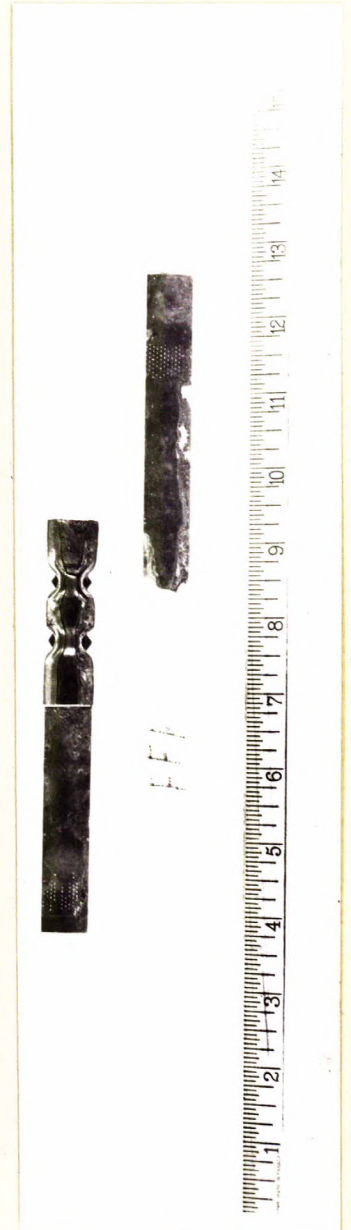
Figure 6 (cont'd)

SEALED JOINTS ON SIGMODE 5/8" X 0.020" PAINTED STRAPS AFTER REMOVAL FROM THE SALT SPRAY CABINET AND UNDERGOING BREAKING LOAD TEST.

- (c) Strap FF after 19 days in the cabinet.
- (d) Strap F)
- (e) Strap FFF) after 21 days in the cabinet.

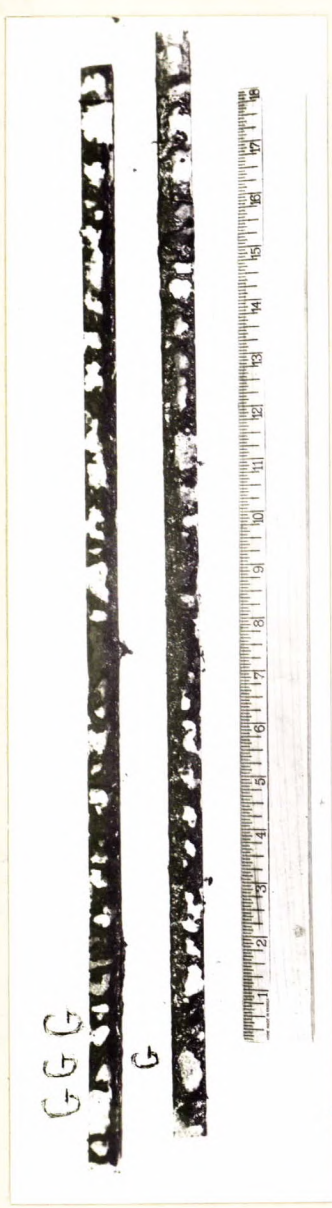
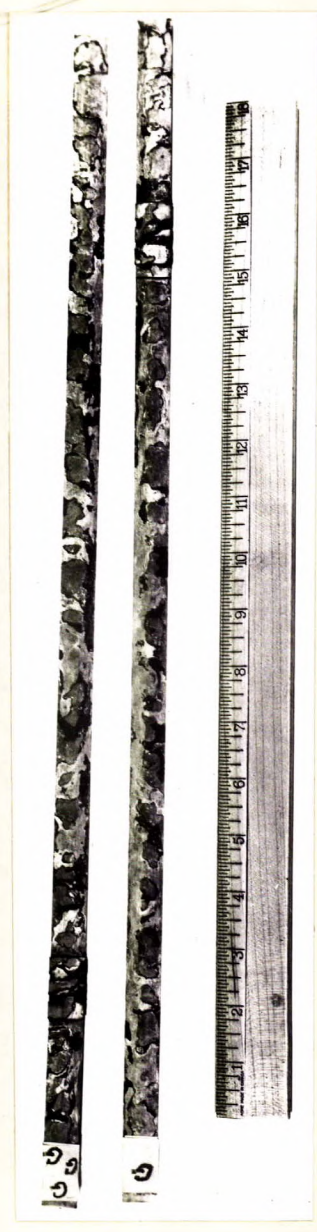
Figure 7.

ACME 5/8" X 0.018" GALVANIZED STRAPS WITH SEALED JOINTS, AFTER 21 DAYS IN THE SALT SPRAY CABINET.

- (a) Before removal of corrosion product.
- (b) After removal of corrosion product.

Note: In the case of Samples G, GG and GGG, the straps broke before the sealed joints in the breaking load test.

All G and H samples were covered with white corrosion product from the zinc coatings. In many spots iron rust was visible. The early failure of the zinc coatings was not unexpected in view of their thinness. The thickness varied between 0.00006 inch and 0.00032 inch as measured by the Aminco-Brenner Magne-Gage. See Table VII.

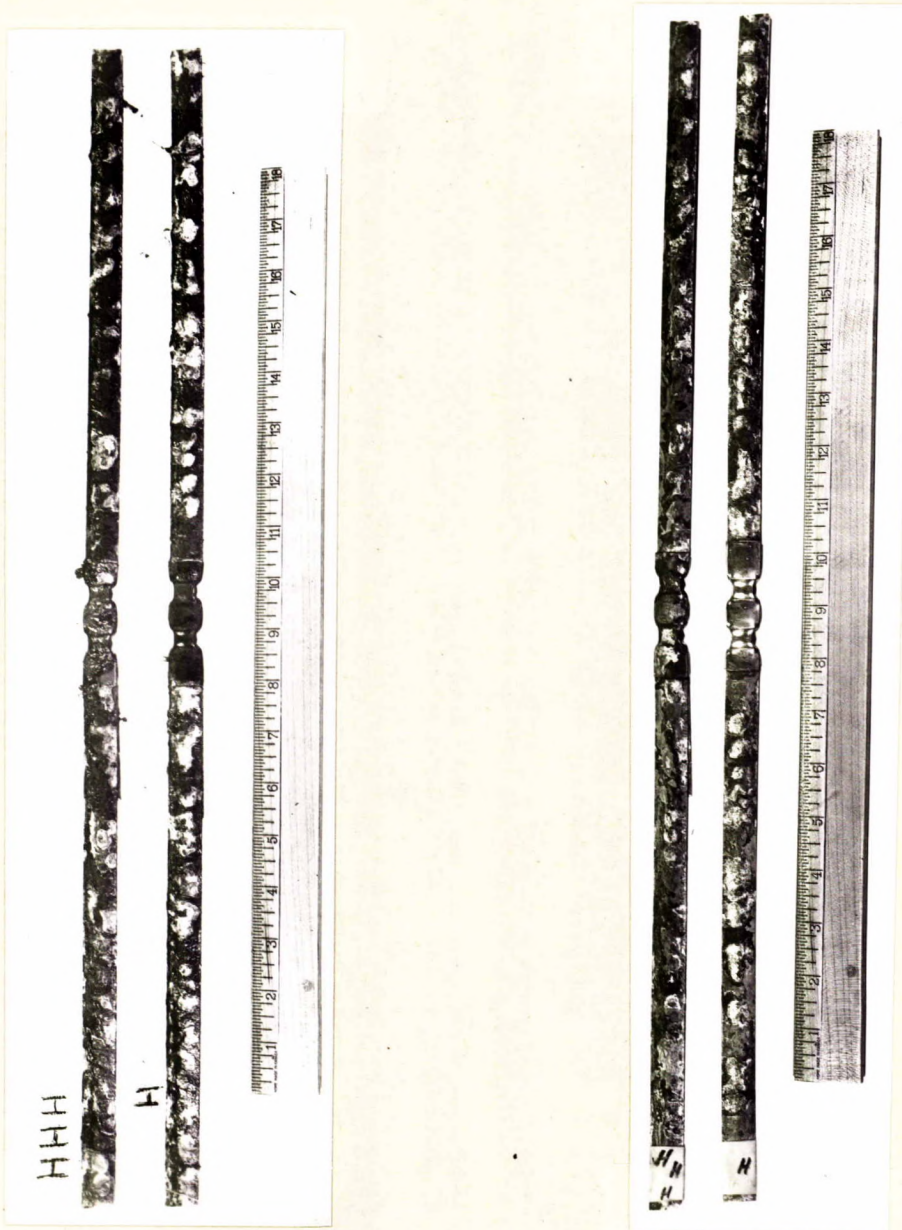
Figure 8.

SIGNODE 5/8" X 0.020" GALVANIZED STRAPS WITH SEALED JOINTS, AFTER 21 DAYS IN THE SALT SPRAY CABINET.

- (a) Before removal of corrosion product.
- (b) After removal of corrosion product.

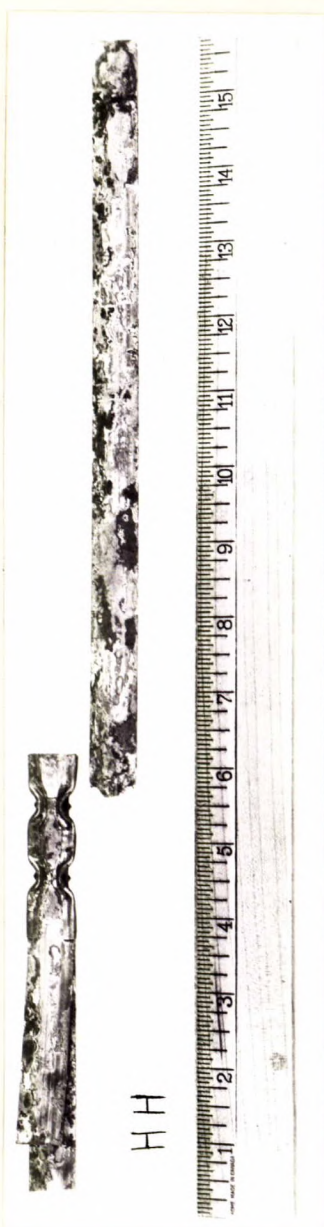
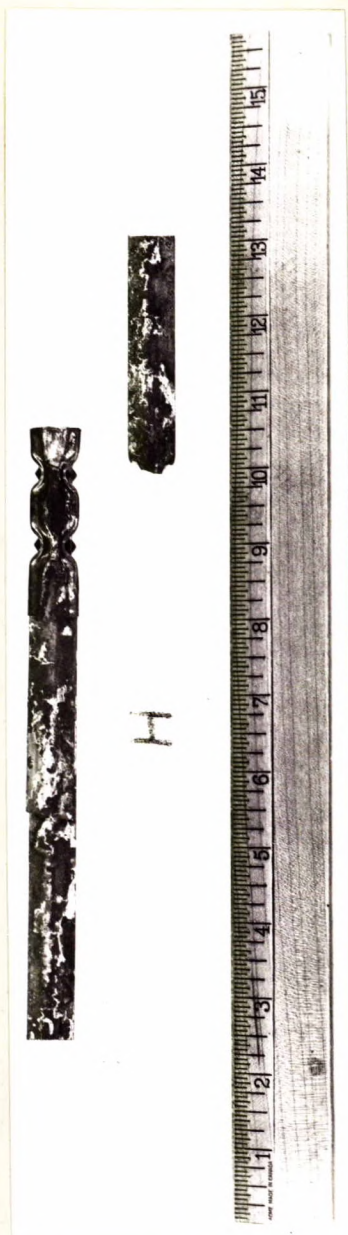
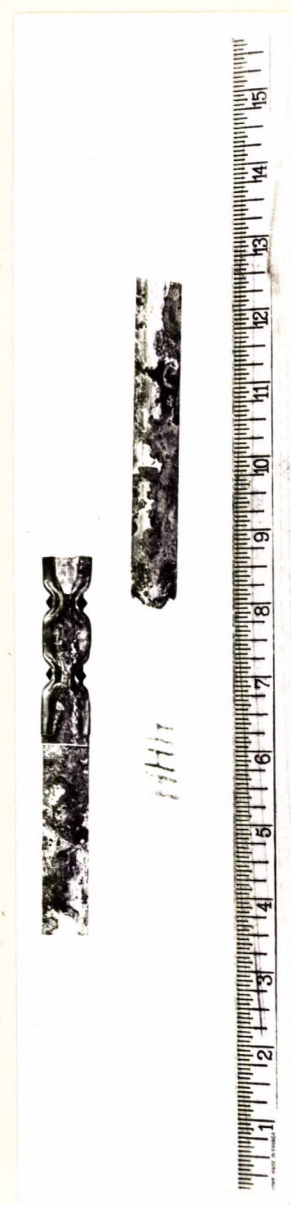
Figure 8 (cont'd)

- (c) Strap HH after 19 days in the cabinet.
- (d) Strap H) after 21 days in the cabinet.
- (e) Strap HHH)

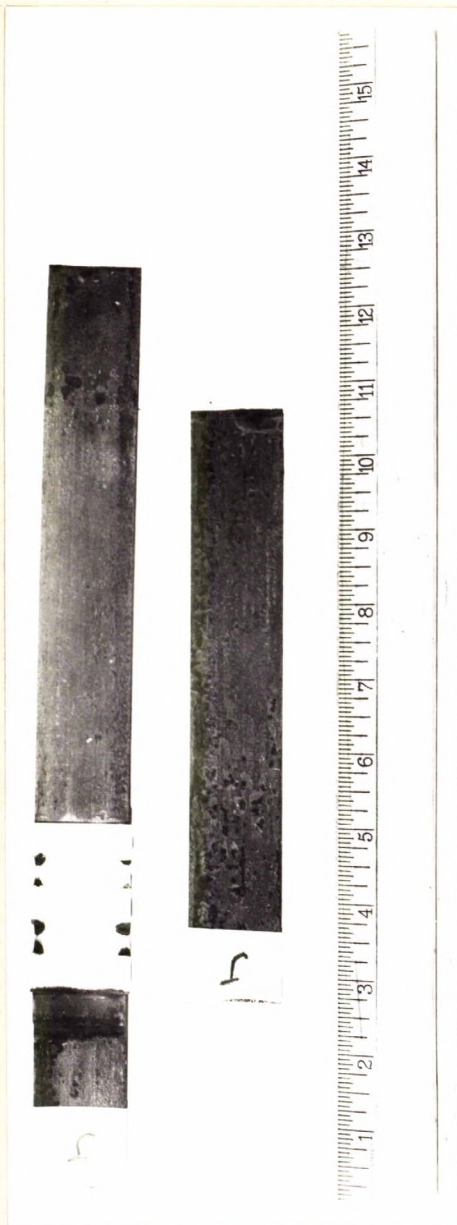
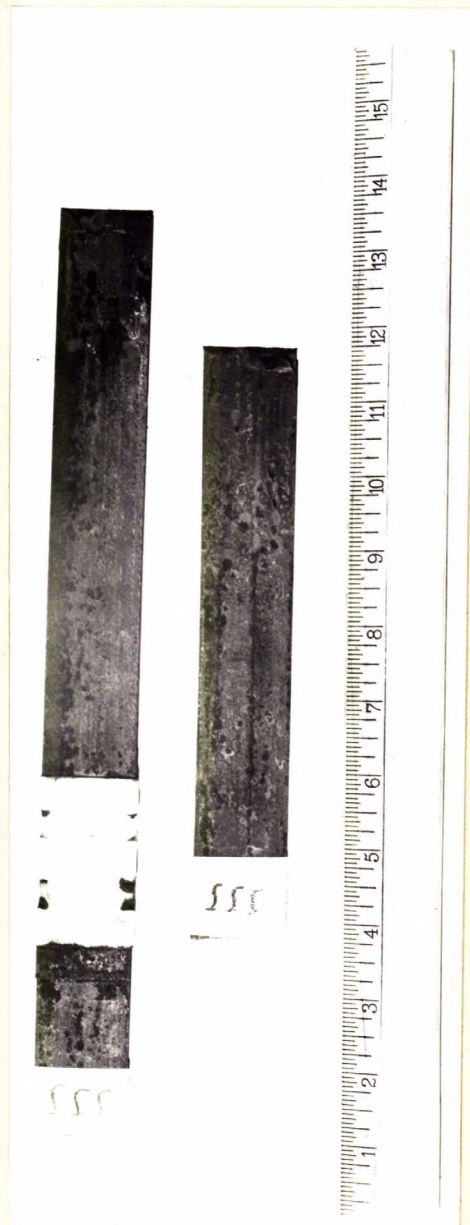
Figure 9.

ACME 1 $\frac{1}{4}$ " X 0.035" PAINTED STRAPS WITH SEALED JOINTS, AFTER 19 DAYS IN THE WEATHER-OMETER.

No corrosion product was removed.

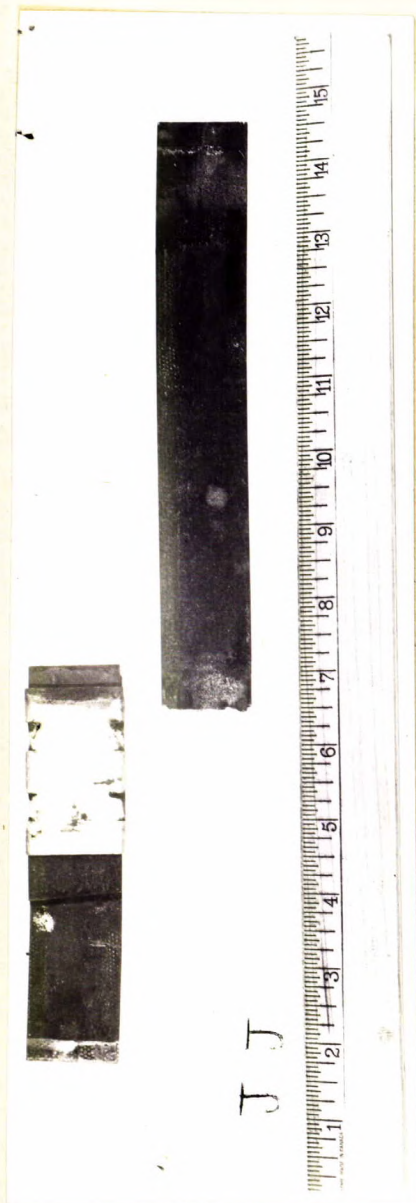
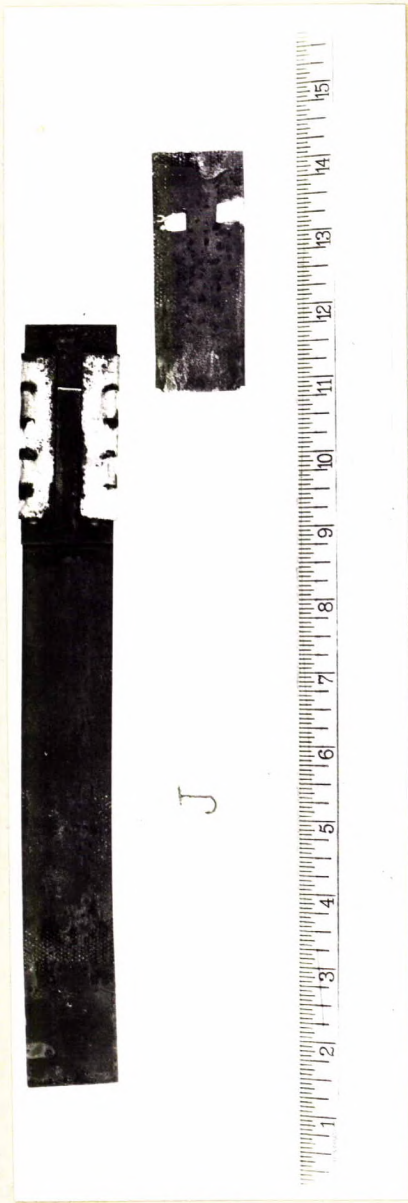
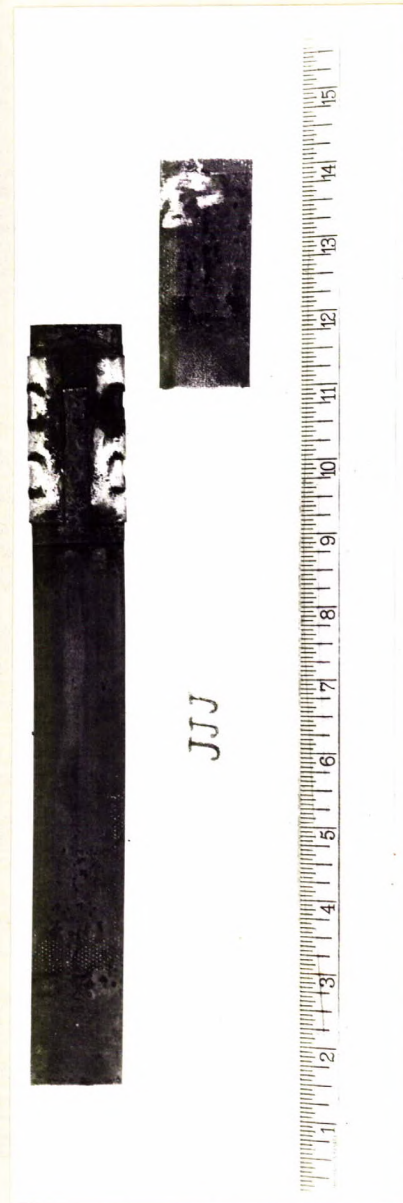
Figure 9 (cont'd)

SEALED JOINTS ON ACME $1\frac{1}{4}$ " X 0.035" PAINTED STRAPS AFTER REMOVAL FROM THE WEATHER-OMETER AND UNDERGOING BREAKING LOAD TEST.

- (c) Strap JJ after 16 days in the Weather-Ometer.
- (d) Strap J) after 19 days in the Weather-Ometer.
- (e) Strap JJJ

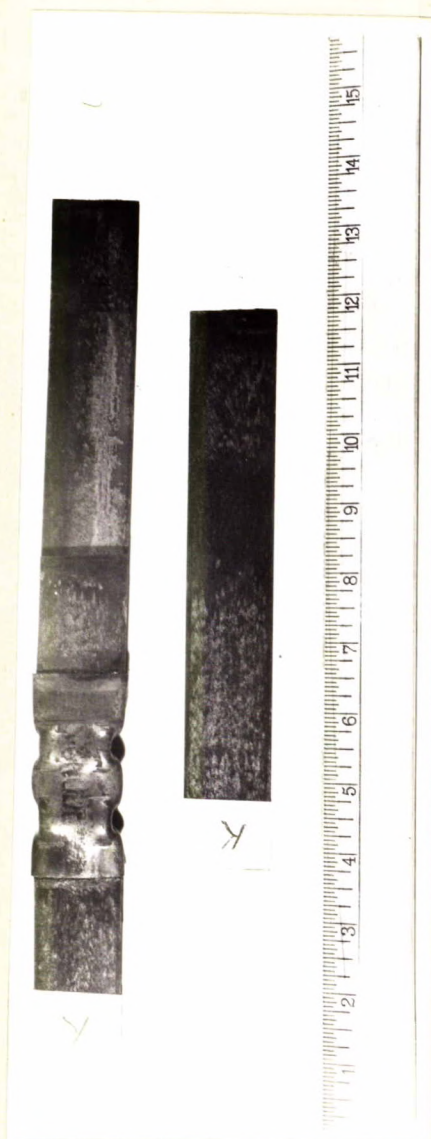
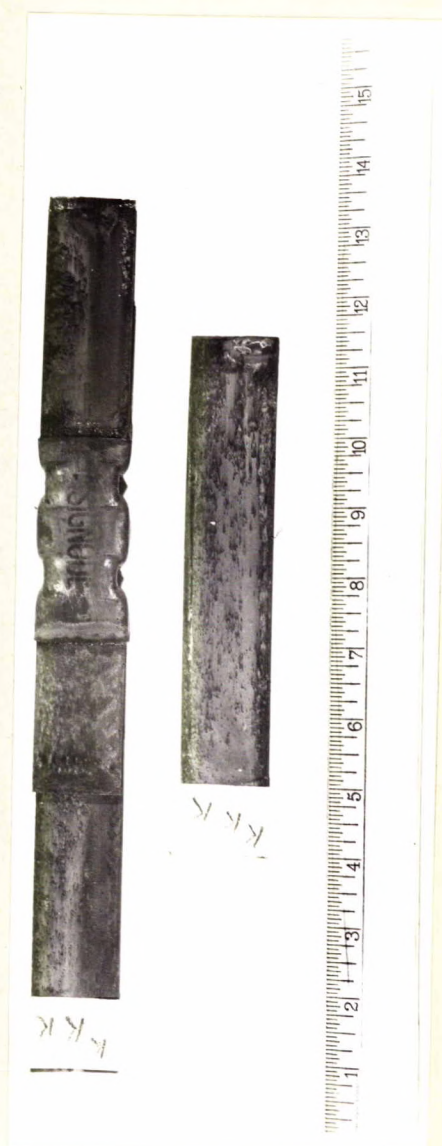
Figure 10.

SIGNODE $1\frac{1}{8}$ " X 0.035" UNPAINTED STRAPS WITH SEALED JOINTS, AFTER 19 DAYS IN THE WEATHER-OMETER.

No corrosion product was removed.

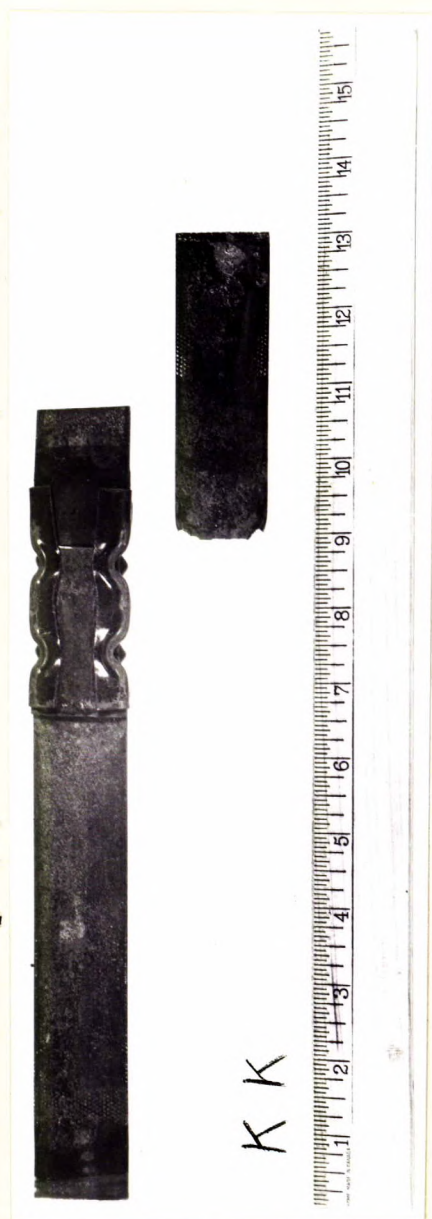
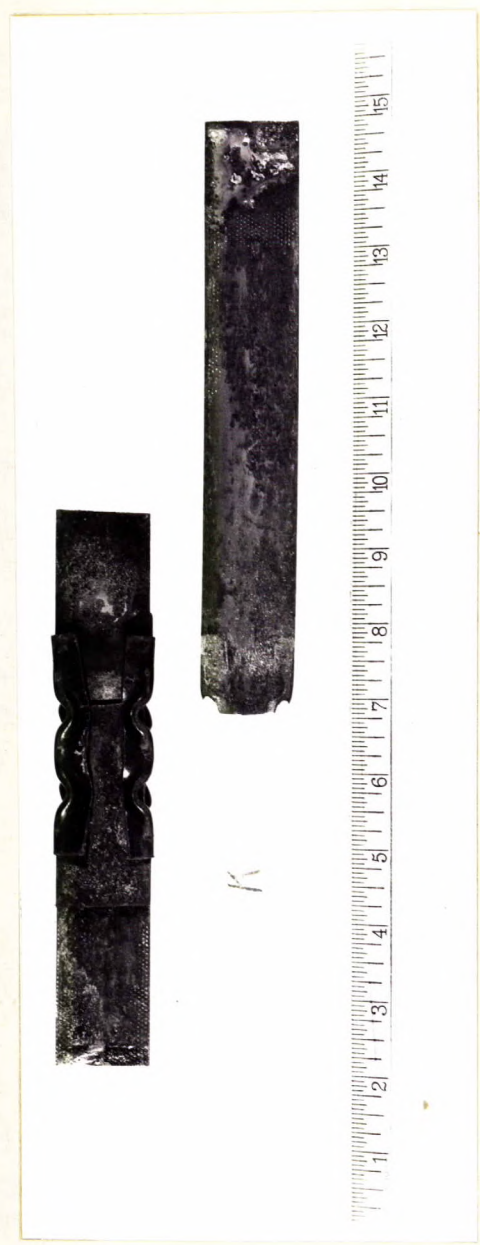
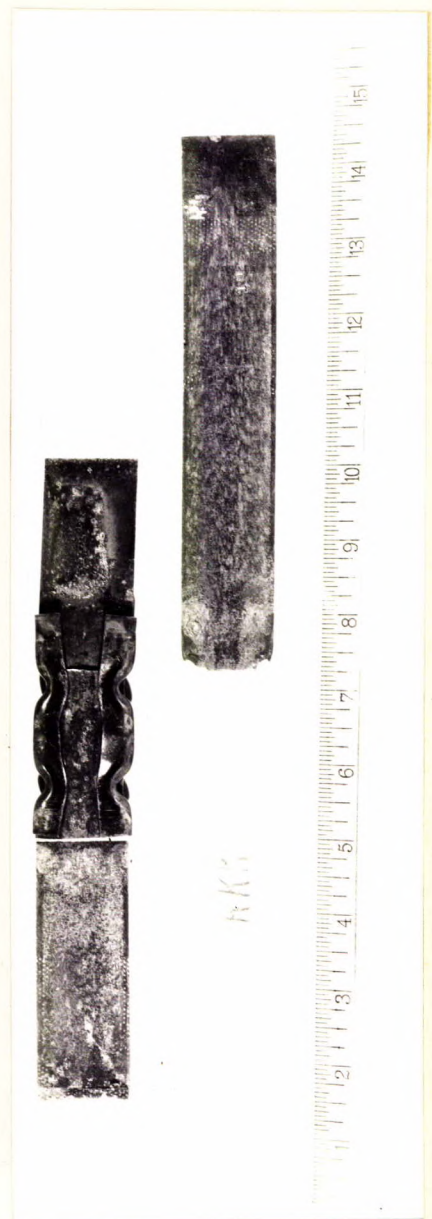
Figure 10 (cont'd)

SEALED JOINTS ON SIGNODE $1\frac{1}{4}$ " X 0.035" UNPAINTED STRAPS
 AFTER REMOVAL FROM THE WEATHER-OMETER AND UNDERGOING
 BREAKING LOAD TEST.
