ORE DRESSING AND METALLURGICAL LABORATORIES.

Investigation No. 1909.

Effect of Salt Spray and Ordinary Atmospheric
Corrosion on Coated Steel Strapping.

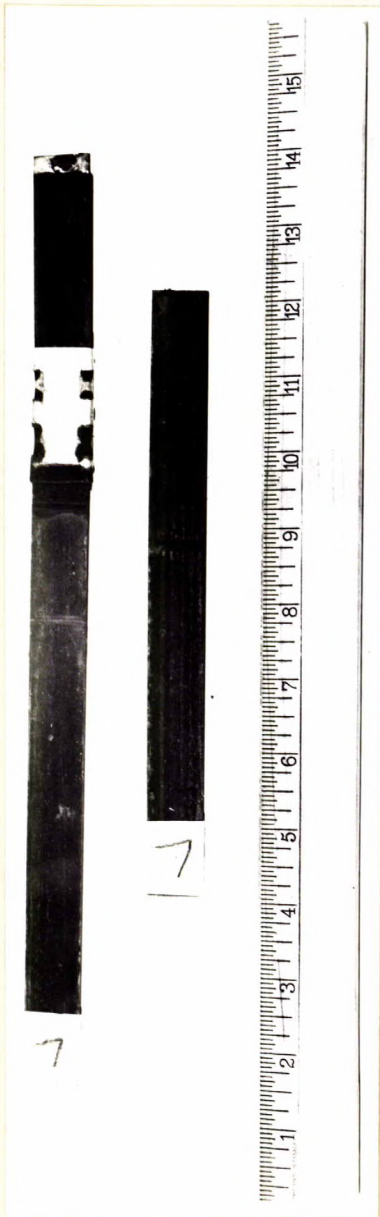
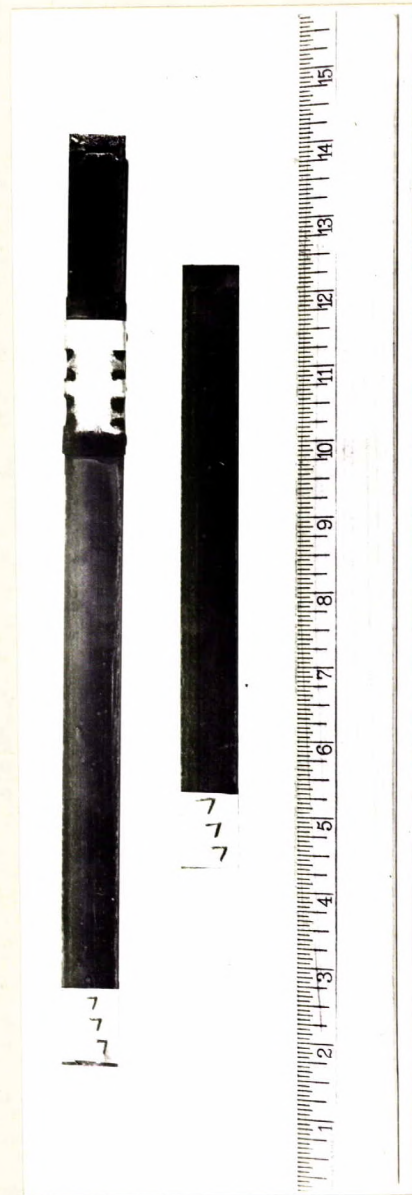
Figure 11.

ACME 3/4" X 0.035" PAINTED STRAPS WITH SEALED JOINTS, AFTER 19 DAYS IN THE WEATHER-OMETER.

No corrosion product was removed.

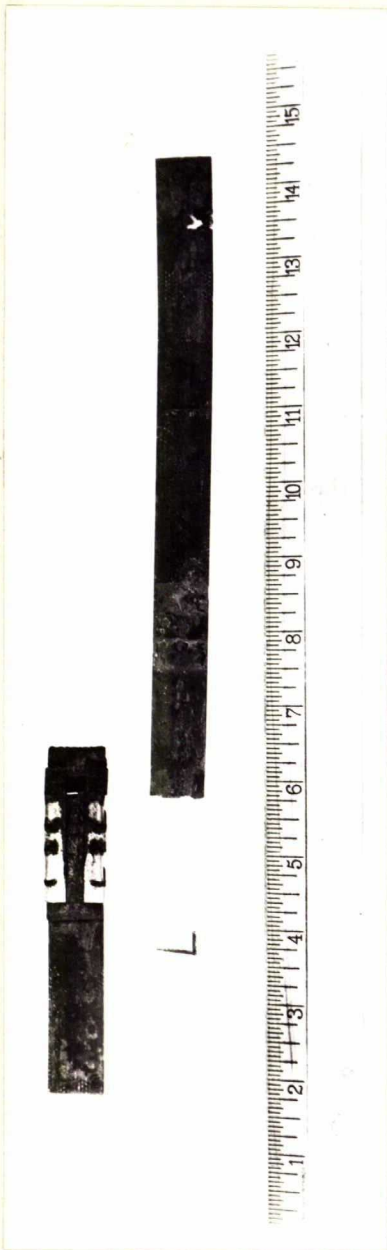
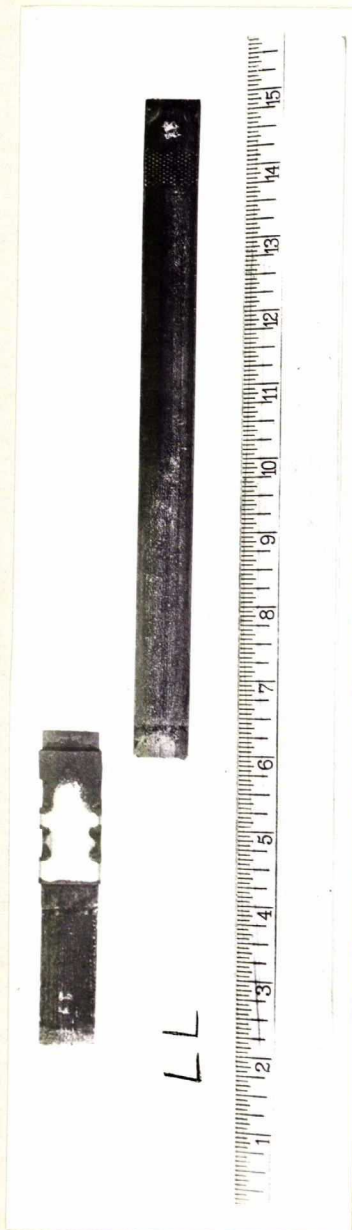
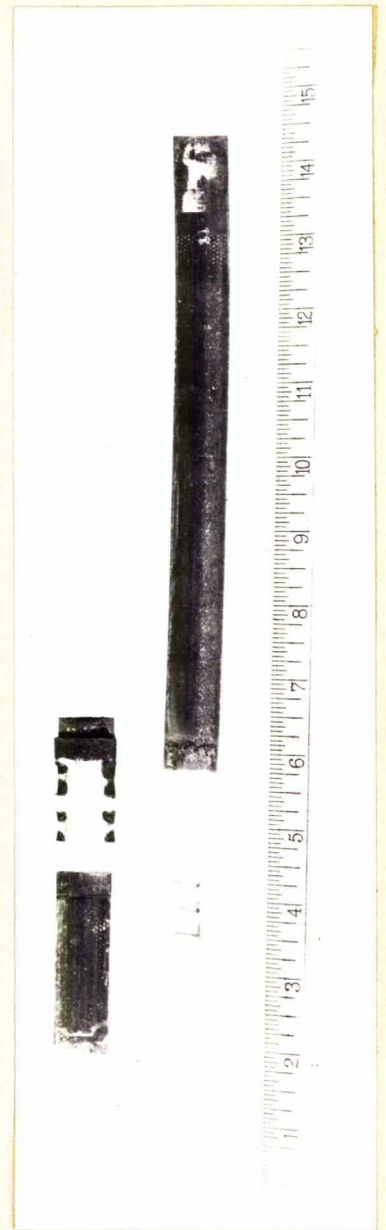
Figure 11 (cont'd)

SEALED JOINTS ON ACME 3/4" X 0.035" PAINTED STRAPS
 AFTER REMOVAL FROM THE WEATHER-OMETER AND UNDERGO-
 ING BREAKING LOAD TEST.

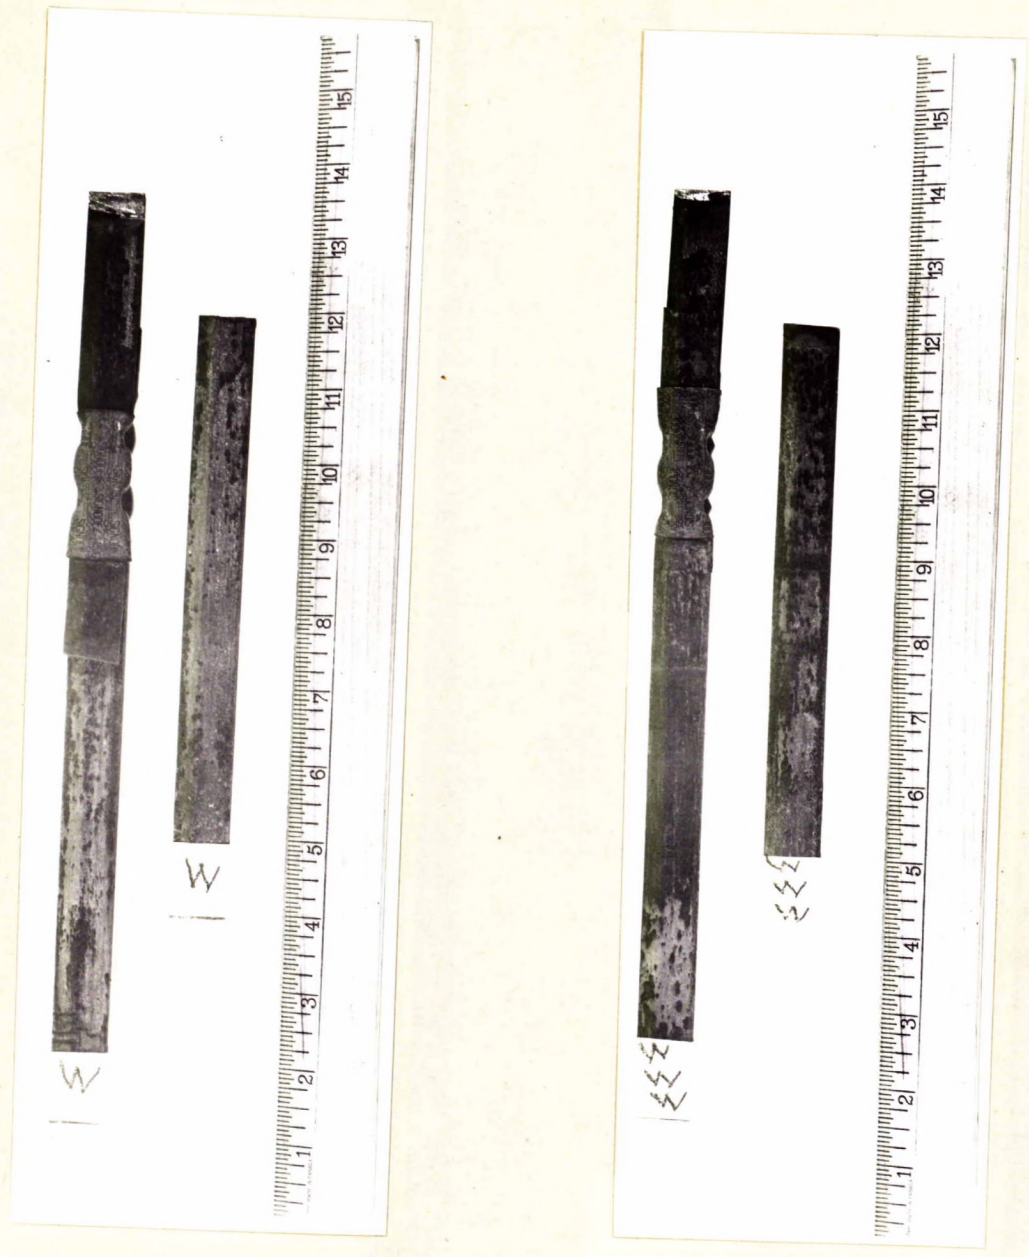
Figure 12.

No corrosion product was removed.

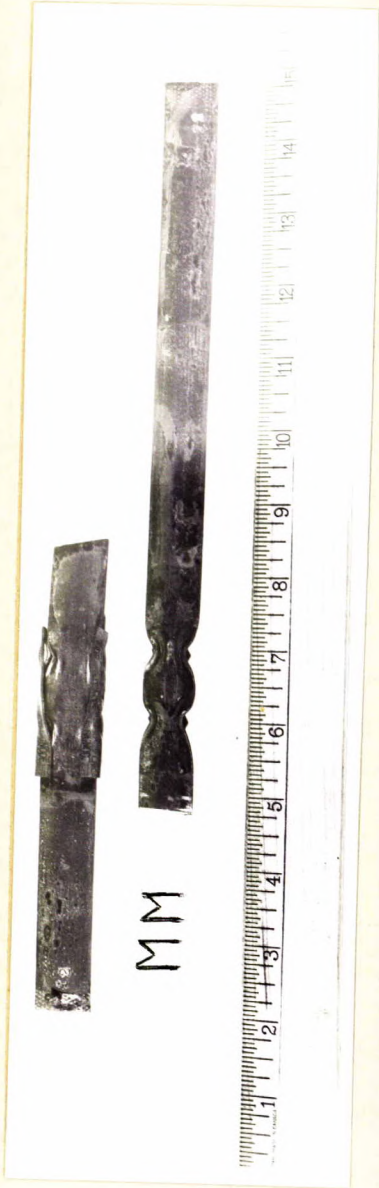
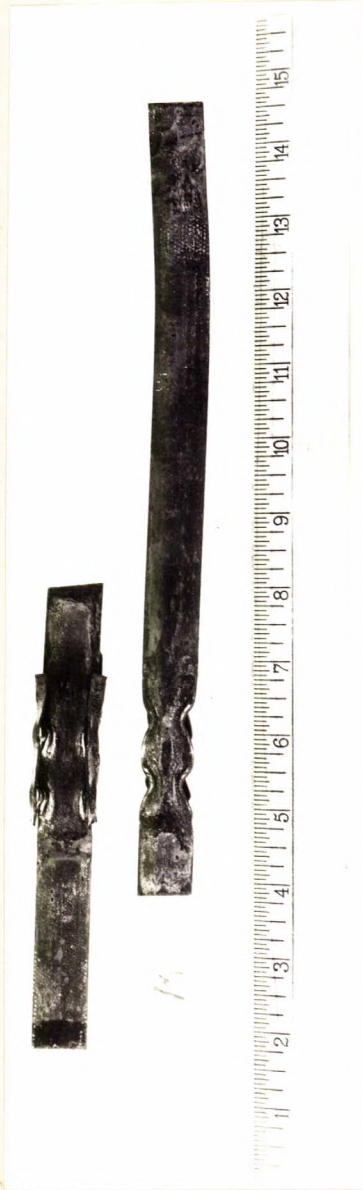
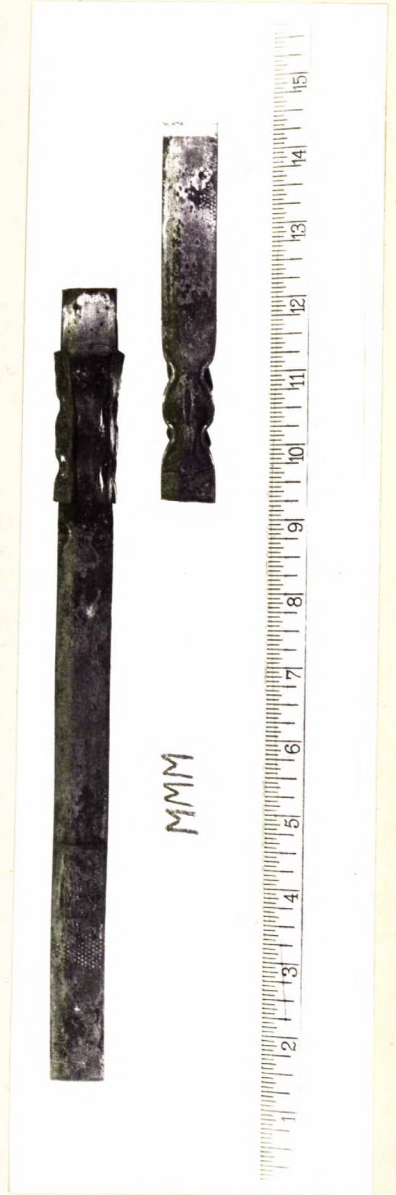
Figure 12 (cont'd)

SEALED JOINTS ON SIGNODE 3/4" X 0.035" PAINTED STRAPS
 AFTER REMOVAL FROM THE WEATHER-OMETER AND UNDERGOING
 BREAKING LOAD TEST.

- (c) Strap MM after 16 days in the Weather-Ometer.
- (d) Strap M)
- (e) Strap MMM) after 19 days in the Weather-Ometer.

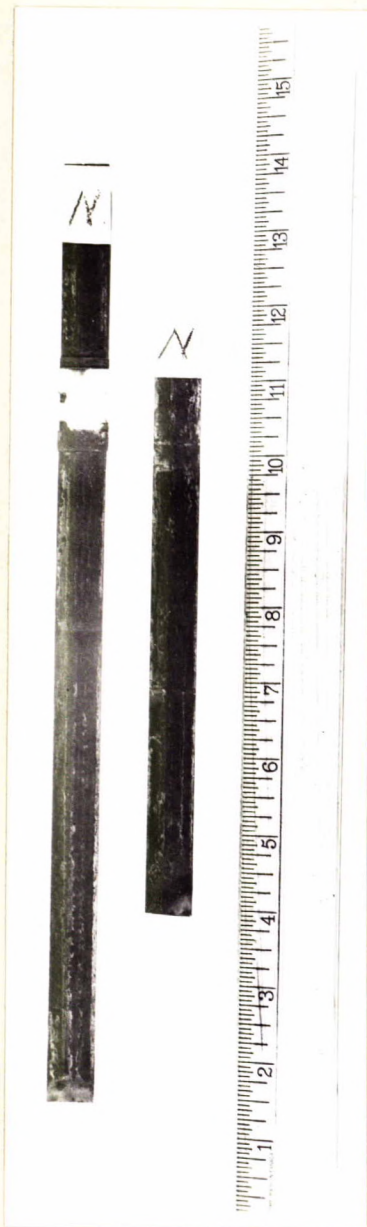
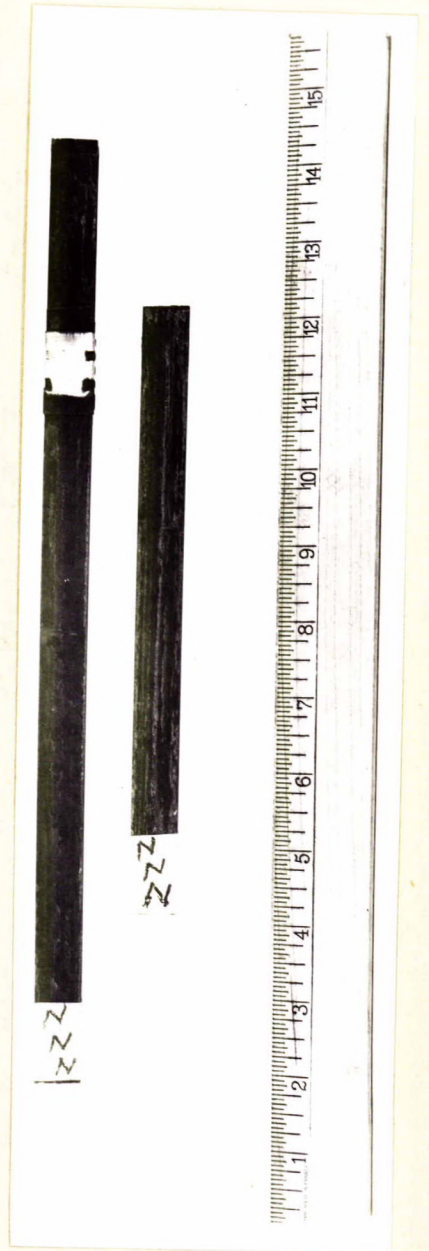
Figure 13.

ACME 5/8" X 0.020" PAINTED STRAPS WITH SEALED JOINTS, AFTER 19 DAYS IN THE WEATHER-OMETER.

No corrosion product was removed.

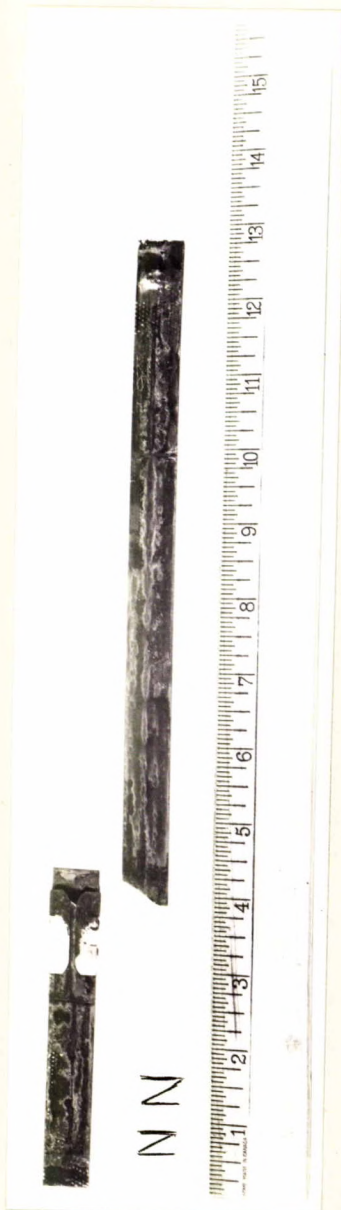
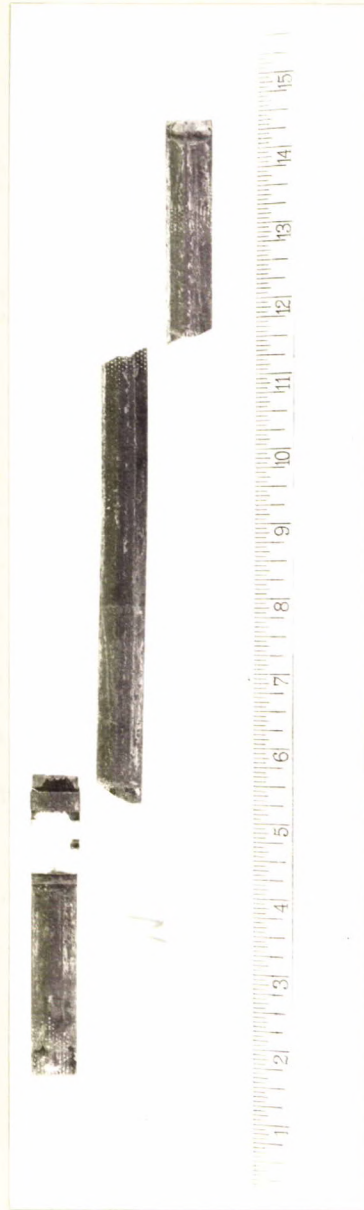
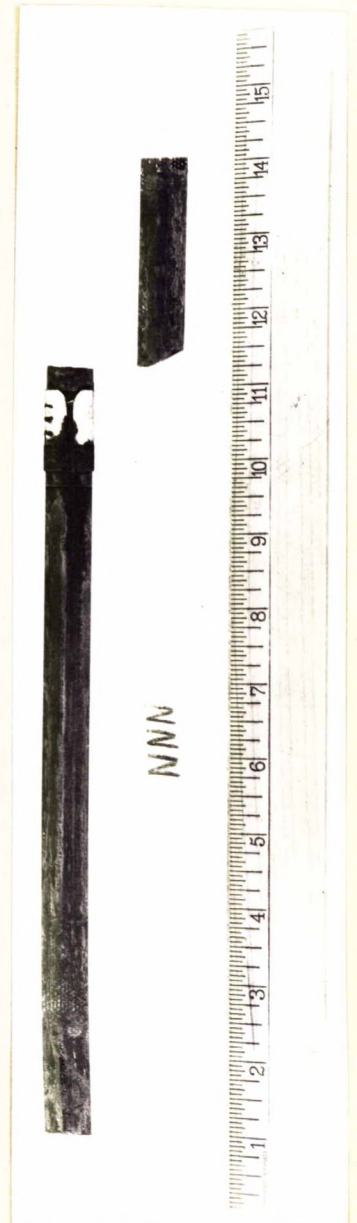
Figure 13 (cont'd)

SEALED JOINTS ON ACME 5/8" X 0.020" PAINTED STRAPS
AFTER REMOVAL FROM THE WEATHER-OMETER AND UNDERGO-
ING BREAKING LOAD TEST.

- (c) Strap NN after 16 days in the Weather-Ometer.
- (d) Strap N)
- (e) Strap NNN) after 19 days in the Weather-Ometer.

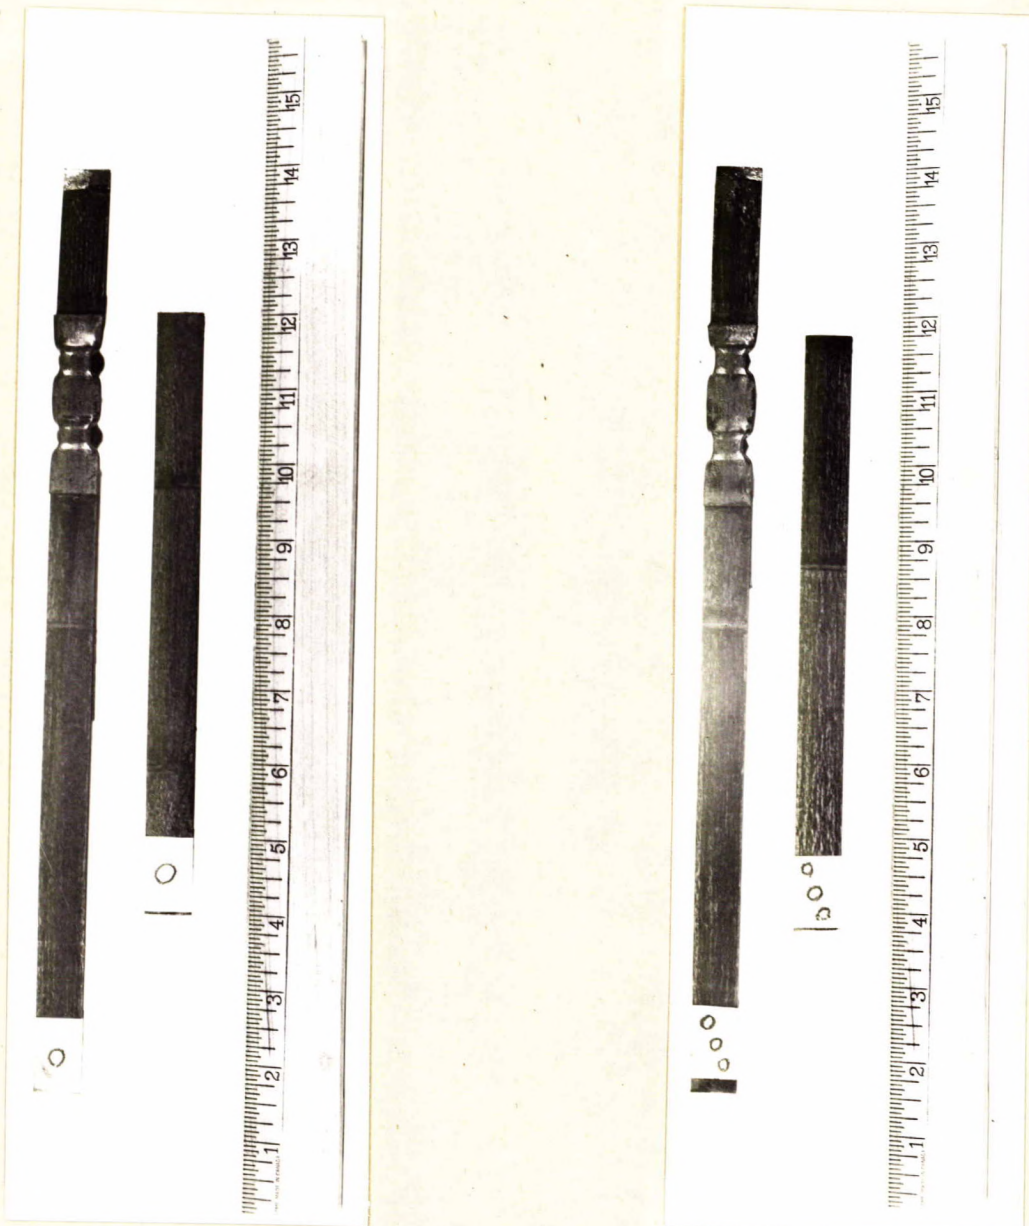
Figure 14.

No corrosion product was removed.

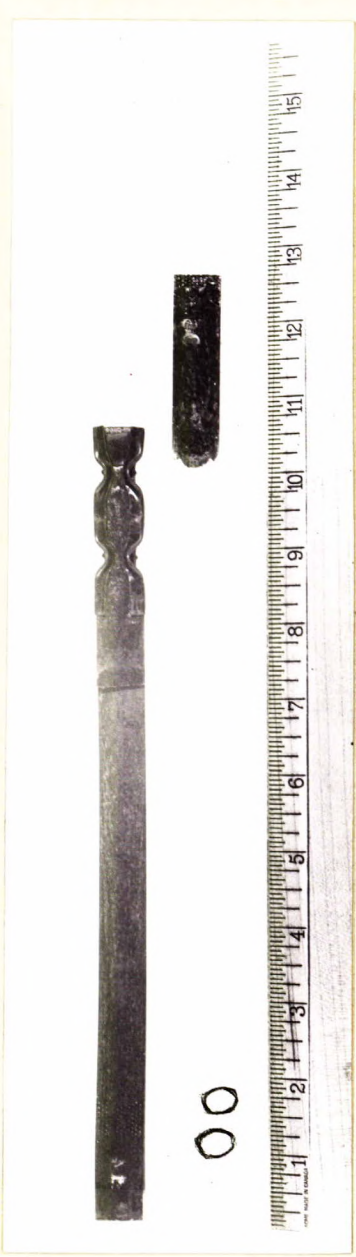
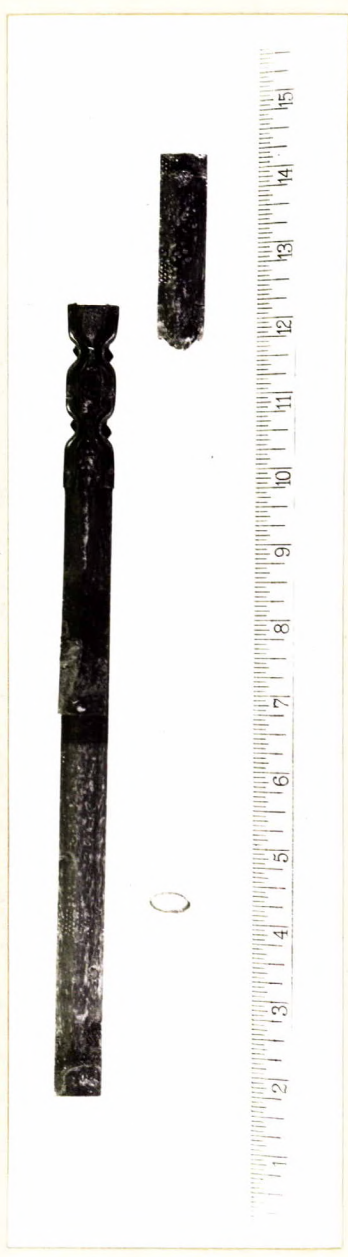
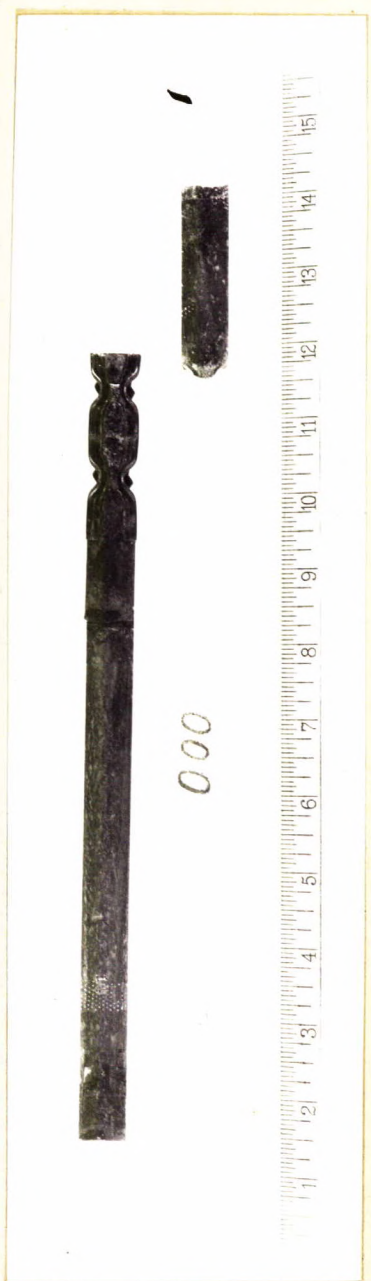
Figure 14 (cont'd)

SEALED JOINTS ON SIGNODE 5/8" X 0.020" PAINTED STRAPS
 AFTER REMOVAL FROM THE WEATHER-OMETER AND UNDERGOING
 BREAKING LOAD TEST.

- (c) Strap 00 after 16 days in the Weather-Ometer.
- (d) Strap 0) after 19 days in the Weather-Ometer.
- (e) Strap 000)

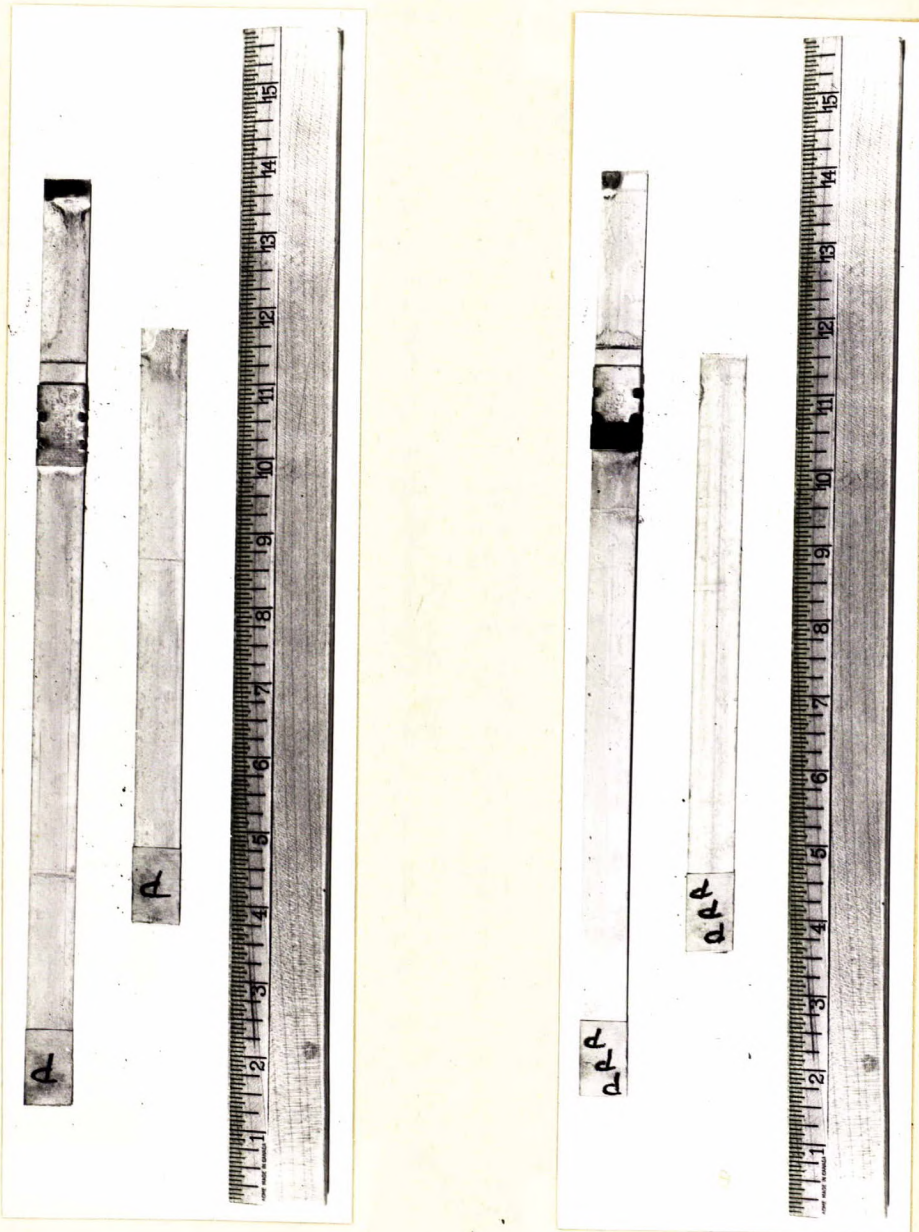
Figure 15.

No corrosion product was removed.

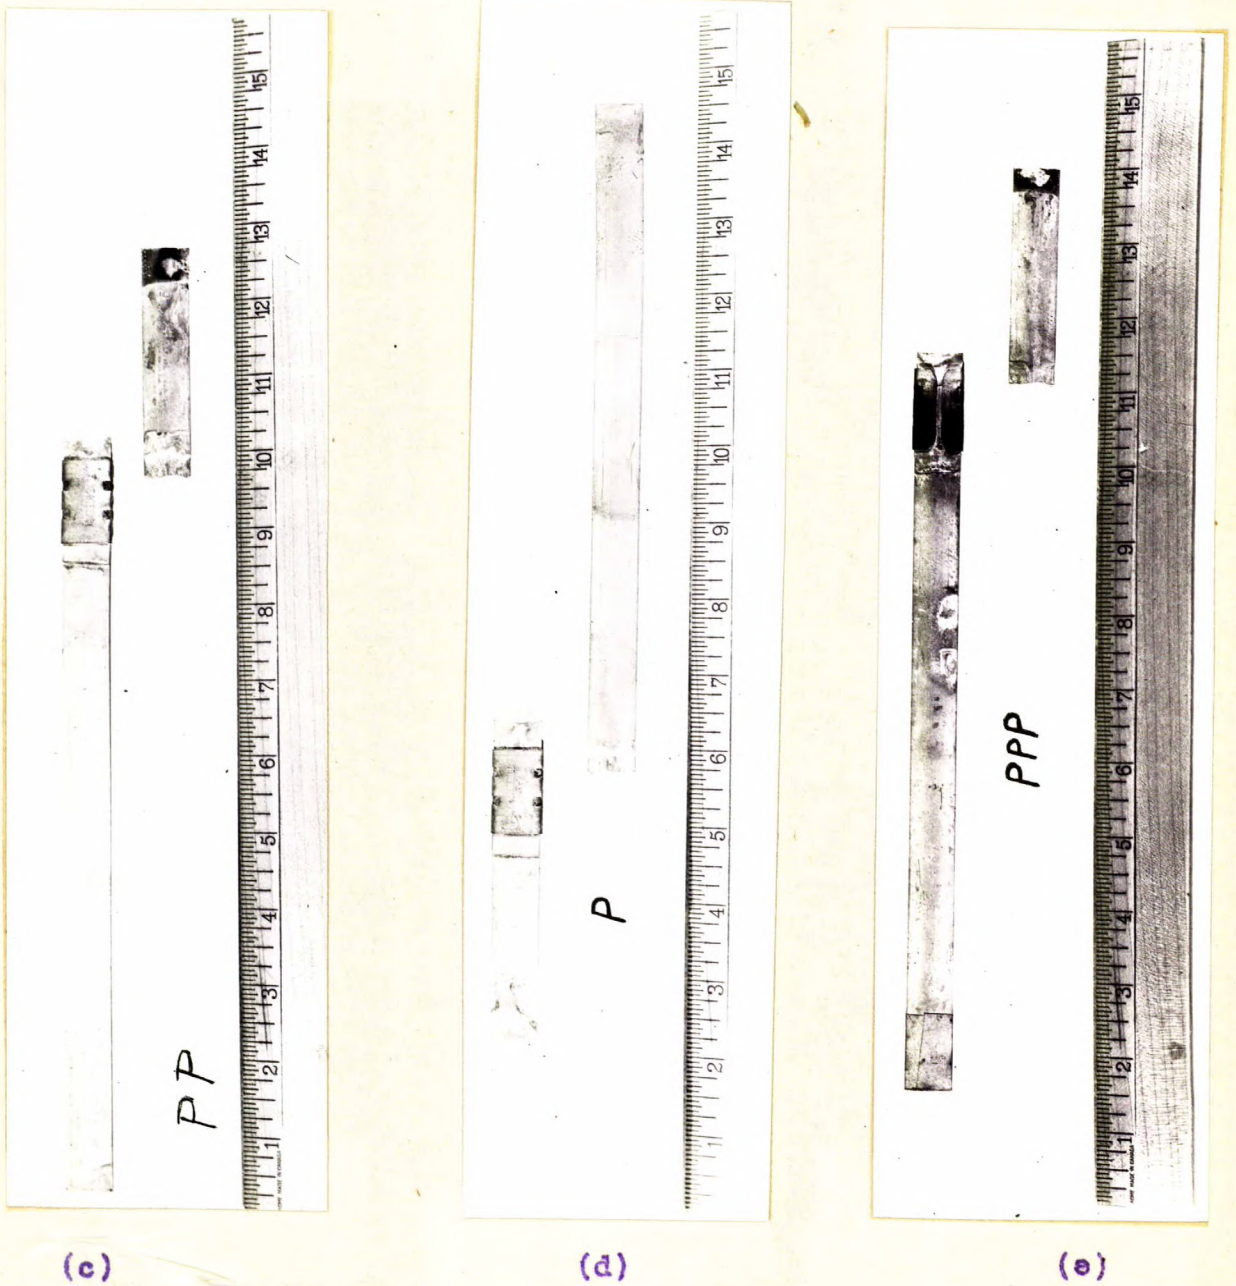
Figure 15 (cont'd)

SEALED JOINTS ON ACME 5/8" X 0.018" GALVANIZED STRAPS
AFTER REMOVAL FROM THE WEATHER-OMETER AND UNDERGOING
BREAKING LOAD TEST.

- (c) Strap PP after 16 days in the Weather-Ometer.
- (d) Strap P) after 16 days in the Weather-Ometer.
- (e) Strap PPP)

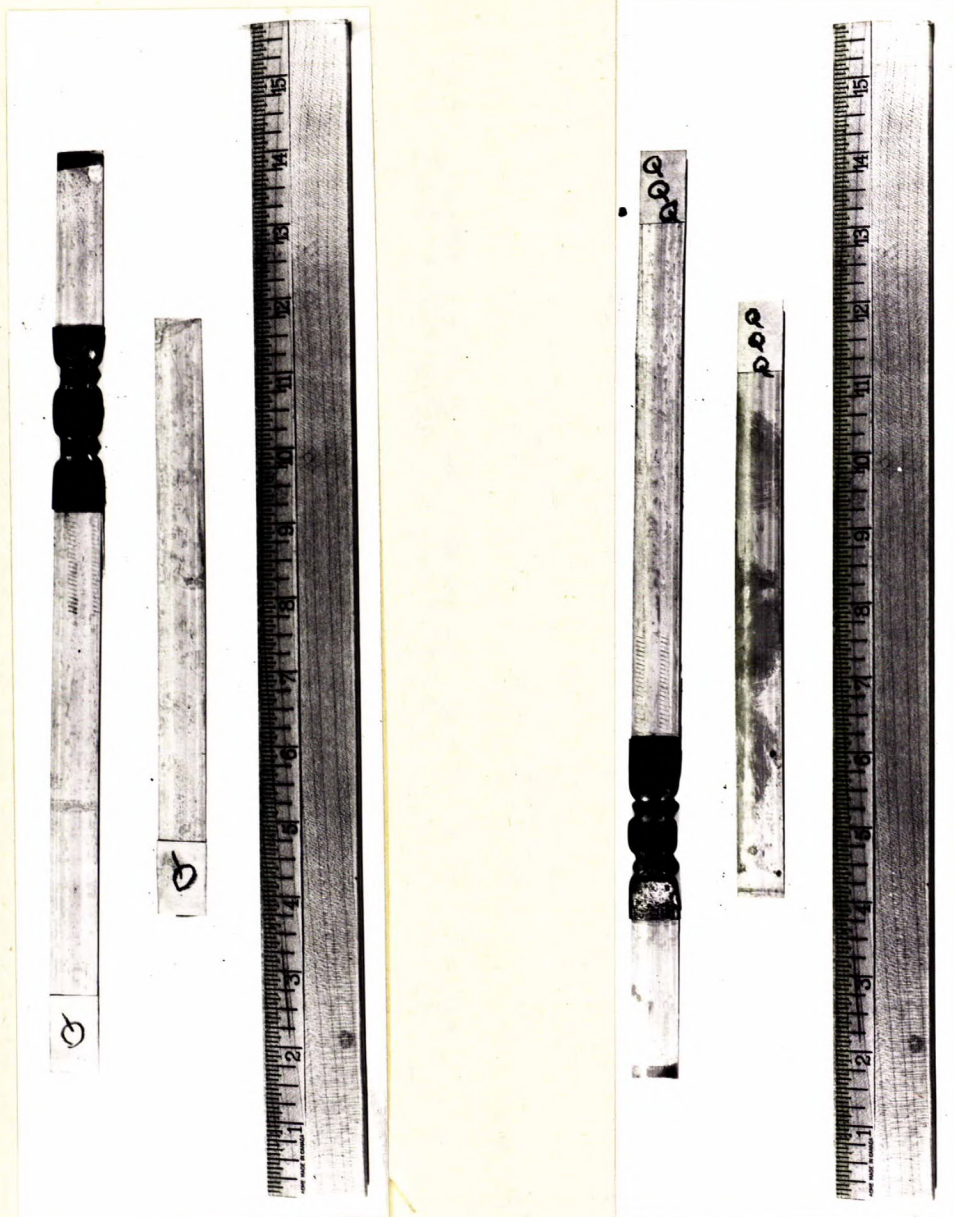
Figure 16.

No corrosion product was removed.

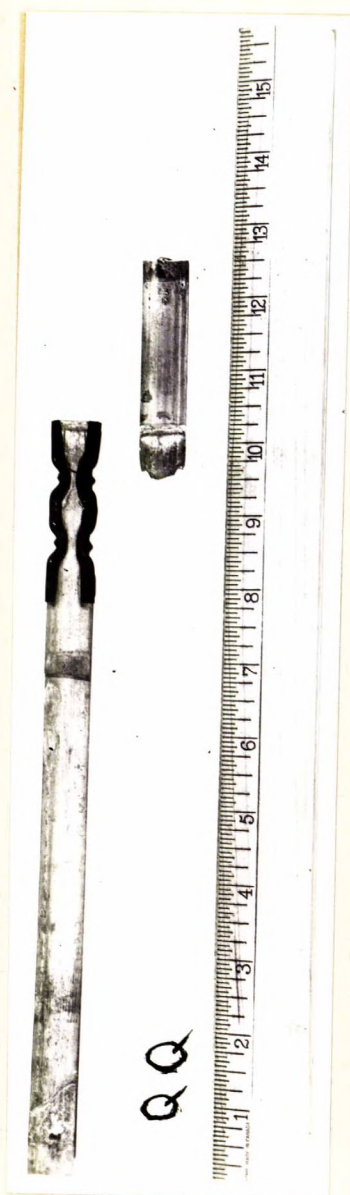
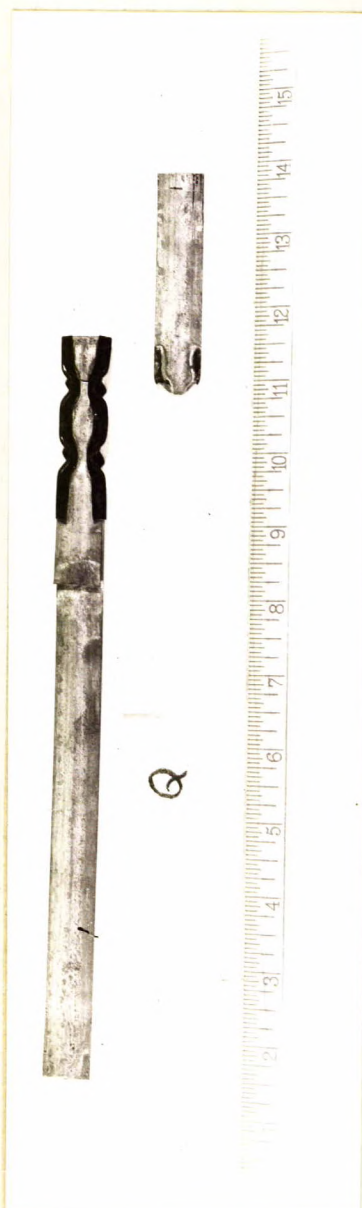
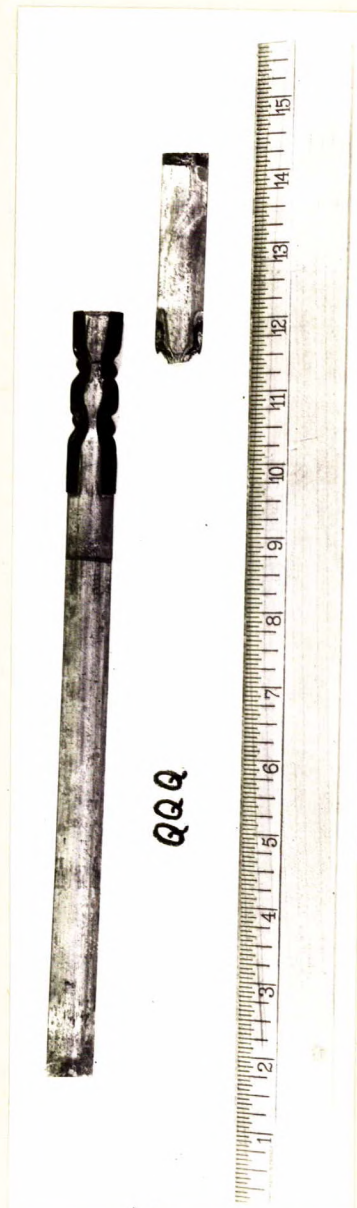
Figure 16 (cont'd)

SEALED JOINTS ON SIGNODE 5/8" X 0.020" GALVANIZED STRAPS
AFTER REMOVAL FROM THE WEATHER-OMETER AND UNDERGOING
BREAKING LOAD TEST.

- (c) Strap QQ after 16 days in the Weather-Ometer.
- (d) Strap Q)
- (e) Strap QQQ) after 16 days in the Weather-Ometer.

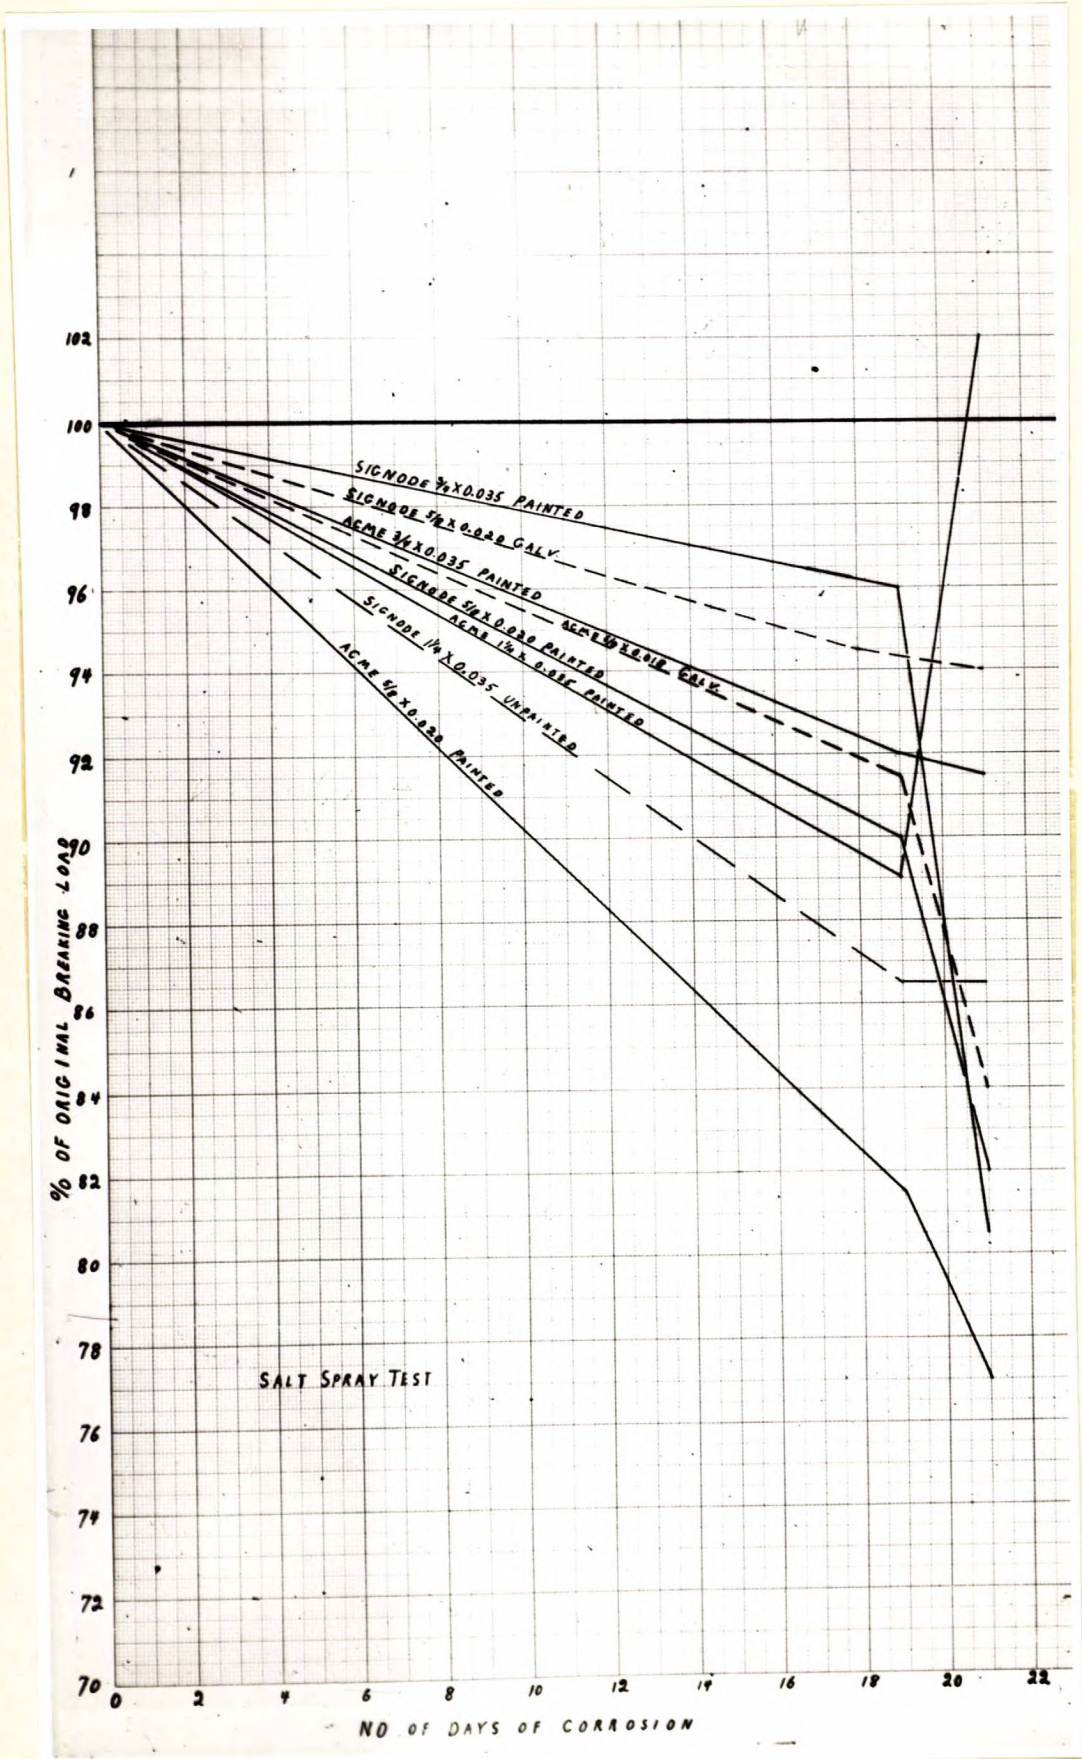
Figure 17.

EFFECT OF SALT SPRAY CORROSION ON THE BREAKING LOAD OF VARIOUS TYPES OF COATED STEEL STRAPPING.

The breaking load of the uncorroded straps is taken to be 100 per cent.

Note: The values of "% of Original Breaking Load" at 0 and 21 days are more likely to be accurate than those at 19 days, because the former are averages based on two individual measurements while the latter are based on single measurements only.

In Figure 17 the breaking load of the various straps is plotted against the number of days of corrosion in the Salt Spray Cabinet.

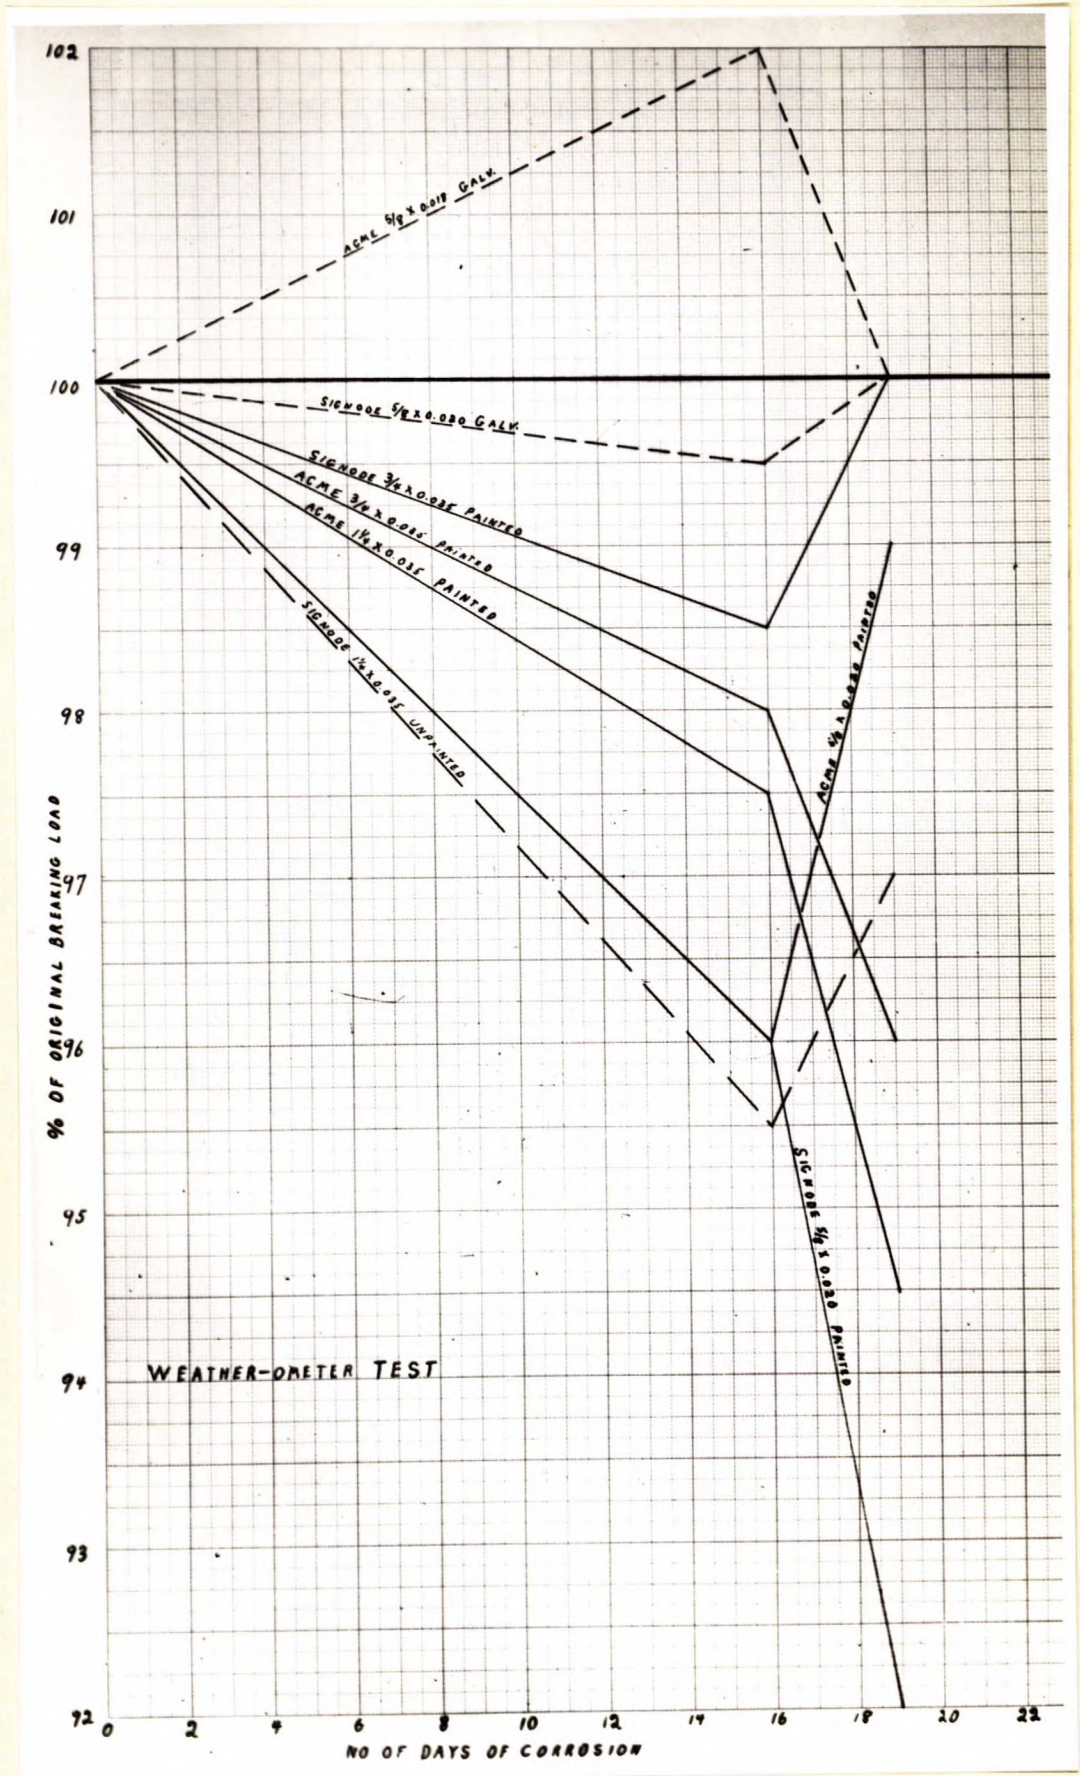
Figure 18.

EFFECT OF WEATHER-OMETER CORROSION ON THE BREAKING LOAD OF VARIOUS TYPES OF COATED STEEL STRAPPING.

The breaking load of the uncorroded straps is taken to be 100 per cent.

In Figure 18 the breaking load of the various straps is plotted against the number of days of corrosion in the Weather-Ometer.
