ORE DRESSING AND METALLURGICAL LABORATORIES.

Investigation No. 1910.

Investigation of Striations in Welded Ice-Breaker
Ship Plate.

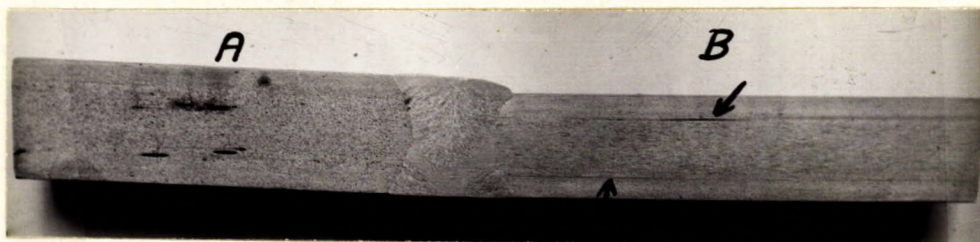
Figure 1.

Striations were observed in the plate designated B (see arrows, Figure 1) and a request was made to determine the cause of their presence.

WELDED ICE-BREAKER SHIP PLATE,
SHOWING STRIATIONS.

Etched in hot 50 per cent HCl.

The plate sample was etched in hot 50 per cent hydrochloric acid for $\frac{1}{2}$ hour, and striations in Plate B were brought up more clearly (see Figure 1). The appearance of the union weld after etching is shown in Figure 2.

The striations observed in Plate B are due to a concentration of pearlite extending throughout the metal. This concentration was probably caused by segregation in the ingot which had subsequently been rolled. Hence the appearance of the high-carbon areas as lines or striations.

The mechanical properties of the plate containing the striations are practically unaffected by their presence, and the plate is considered quite satisfactory.

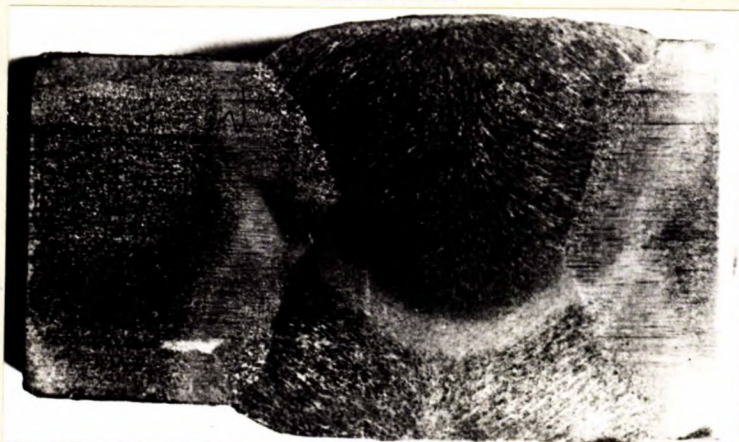
Figure 2.

X2, etched in hot
50 per cent HCl.

UNION WELD.

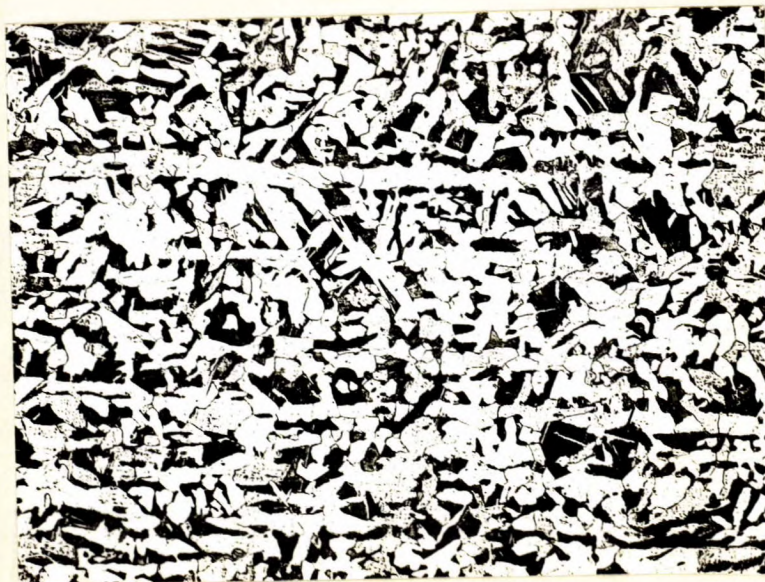
Figure 3.

X100, nital etch.
NORMAL STRUCTURE OF PLATE "A".

Figures 3, 4, 5 and 6 are photomicrographs taken at X100 magnification. Figures 3 and 4 show the normal structures of plates A and B respectively.

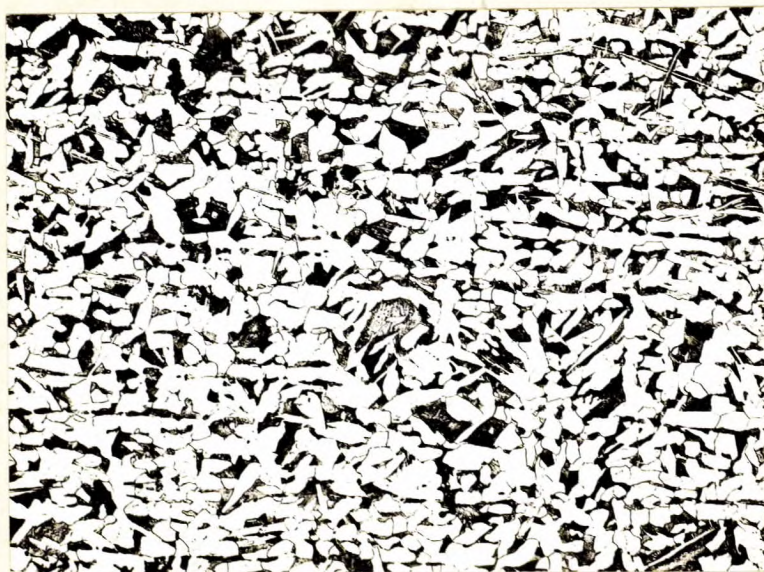
Figure 4.

X100, nital etch.
NORMAL STRUCTURE OF PLATE "B".

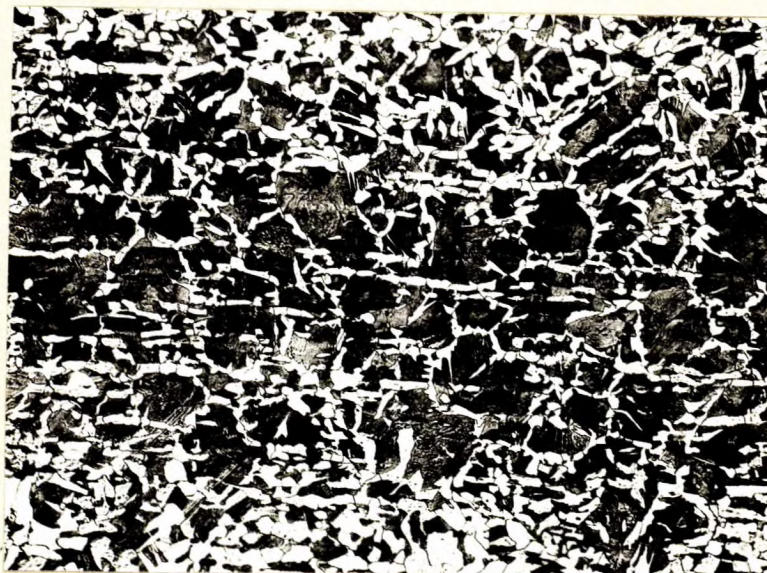
Figure 5.

Figure 5 shows the concentrations of pearlite occurring in Plate B, resulting in the striations.

X100, nital etch.
CONCENTRATION OF PEARLITE IN PLATE
"B", CAUSING STRIATIONS.

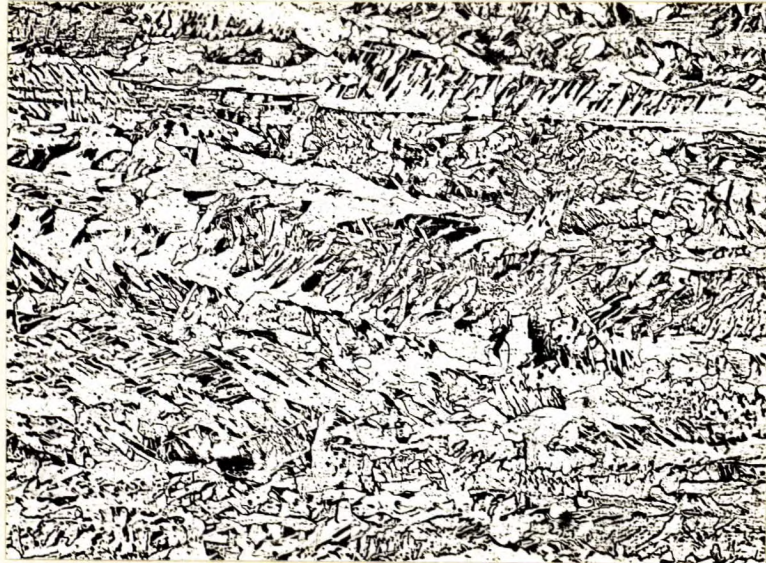
X1100, nital etch.

STRUCTURE OF WELD METAL.

The structure of the weld metal is revealed in Figure 6.
