ORE DRESSING AND METALLURGICAL LABORATORIES.

Investigation No. 1933.

Relationship of Paint Thickness and Steel
Microstructure to Corrosion Resistance
of Painted Steel Sheets.

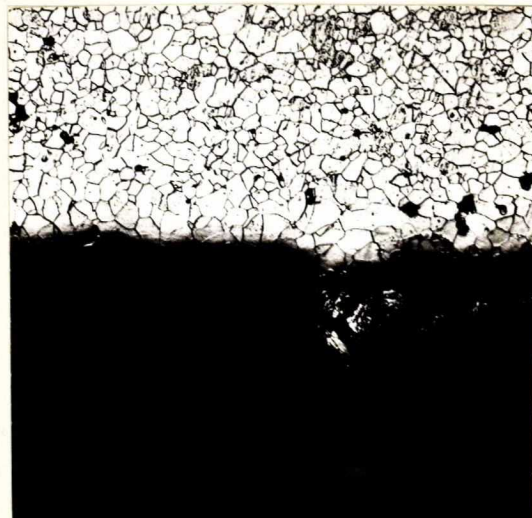
Figure 6.

X100, etched in
2 per cent nital.

CROSS-SECTION OF PANEL AT SURFACE,
SAMPLE FROM GOTTFREDSON LTD.

Figure IV shows the cross-section of one of the panels from the Border Cities Wire and Iron Works which was one of the more resistant samples to salt spray corrosion. Figure V shows the cross-section of one of the panels from Gotfredson Limited which was one of the least resistant to salt spray corrosion. Little difference can be seen in the microstructures of these two samples, although they were very different in their resistance to the action of salt spray.
