ORE DRESSING AND METALLURGICAL LABORATORIES.

Investigation No. 1941.

Metallurgical Examination of a Cast Iron Mould.

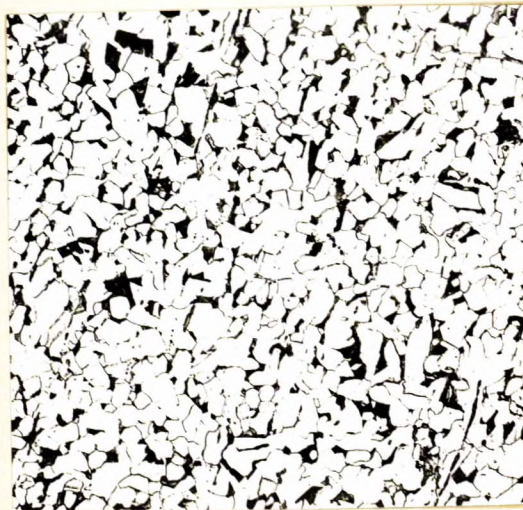
Figure 5.

The structures of the stock sample and the fractured steel bar are shown in Figures 5 and 6 respectively. The former has a structure of a normalized and the latter of an annealed low carbon steel. The structure in each consists of pearlite, the iron-iron carbide constituent, the dark etching material, and ferrite, the iron constituent, the light etching material.

X100, etched in  
2 per cent nital.

STRUCTURE OF STEEL BAR "AS RECEIVED".

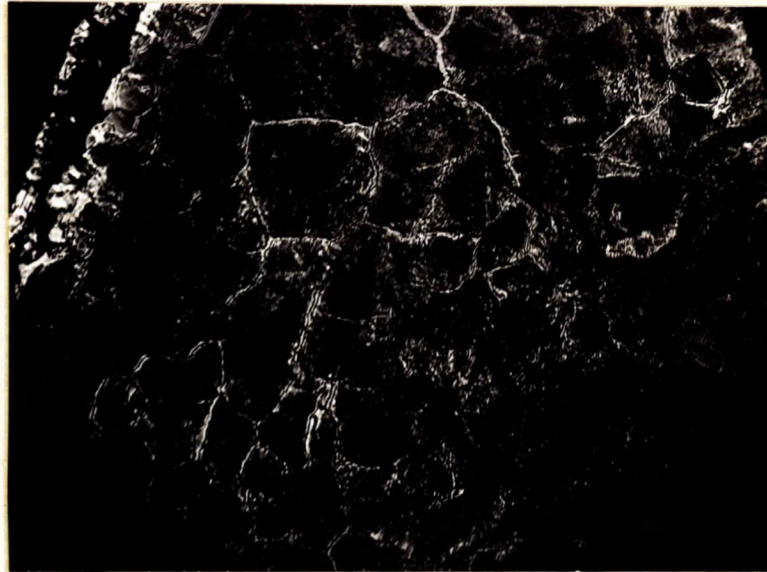
The grain size as determined by the McQuaid-Ehn method is shown in Figure 7. The grain size is rated as 2.

X100, etched in  
2 per cent nital.

SHOWING COARSE-GRAINED STRUCTURE OF STEEL  
AFTER CARBONIZING AT 1700° F. AND  
COOLING IN THE BOX.

The steel used in the cast iron mould had a chemical composition similar to that of an SAE 1020 steel. The composition of the mould was similar to that of a high phosphorus grey iron and contained no alloying additions. The microscopic examination showed the stock sample of the steel reinforcing rod to be in the normalized condition and coarse-grained. However, the structure was altered after casting the cast iron around it. The high temperature of the molten cast iron in contact with the steel bar caused grain growth, and on slow cooling the steel became annealed. Coarse-grained steels are more subject to grain growth at temperatures above the upper critical than fine-grained steels. For this service

a fine-grained, aluminium-killed, low carbon steel or a high-purity iron, such as Armco iron, is recommended. The carburization of steel bar noted at the point of contact with cast iron can be greatly reduced by tinning, or by painting the steel bar with red lead. Some consideration should be given to the use of alloy additions to the iron to improve the physical properties, such as resistance to growth, etc. In this connection, chromium additions of 0.60 to 1.25 per cent are generally recommended.
