ORE DRESSING AND METALLURGICAL LABORATORIES.

Investigation No. 1979.

Metallurgical Examination of a Broken
Grey Iron Casting.

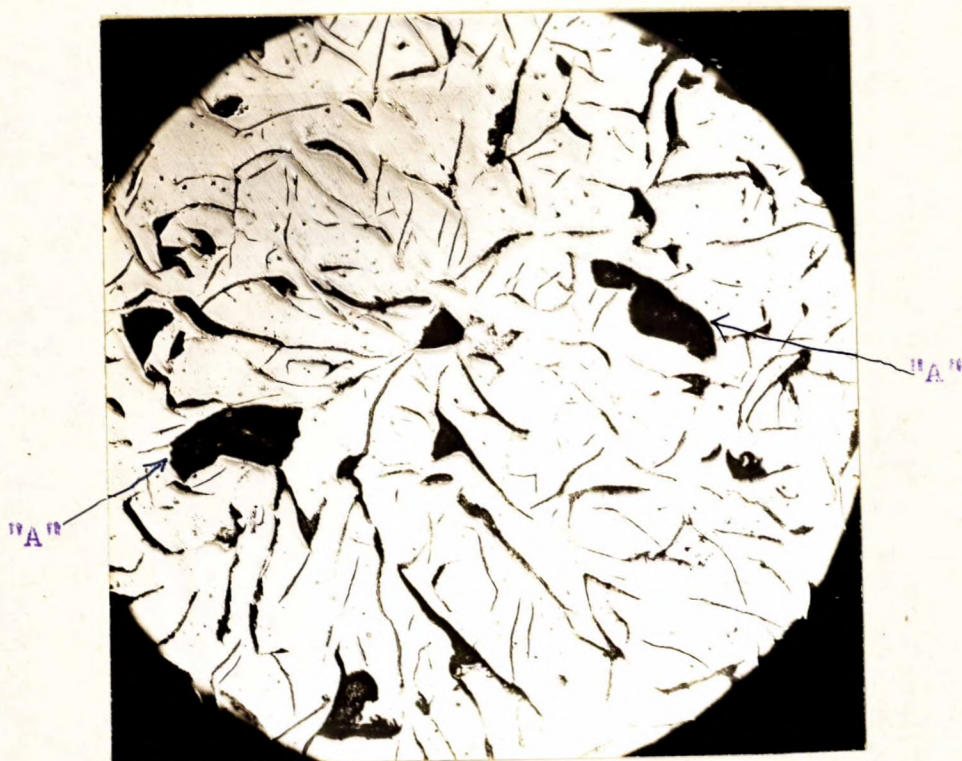
Figure 2.

A specimen of the casting adjacent to the fracture was mounted in bakelite, polished, and examined in the unetched condition under the microscope. Figure 2 is a photomicrograph, at X100 magnification, showing the coarse structure of the graphite flakes in the iron. Some microporosity can also be observed (at "A") in this photomicrograph.

SHOWING GRAPHITE FLAKES
IN UNETCHED SPECIMEN.

The casting was found to be an alloy cast iron containing nickel and a small addition of chromium. The amounts of silicon and nickel in this iron are considered to be too great. Both elements are graphitizing agents and therefore tend to produce large graphite flakes in the iron. This condition can be controlled by lowering the addition of either element. The coarseness of the fracture observed in this casting is generally associated with large graphite flakes and low tensile strength. This was confirmed by a microscopic examination of the iron and a determination of its tensile properties.

It is recommended that these castings be made from an iron with a properly balanced nickel-silicon content, which would produce a metal with superior mechanical properties.

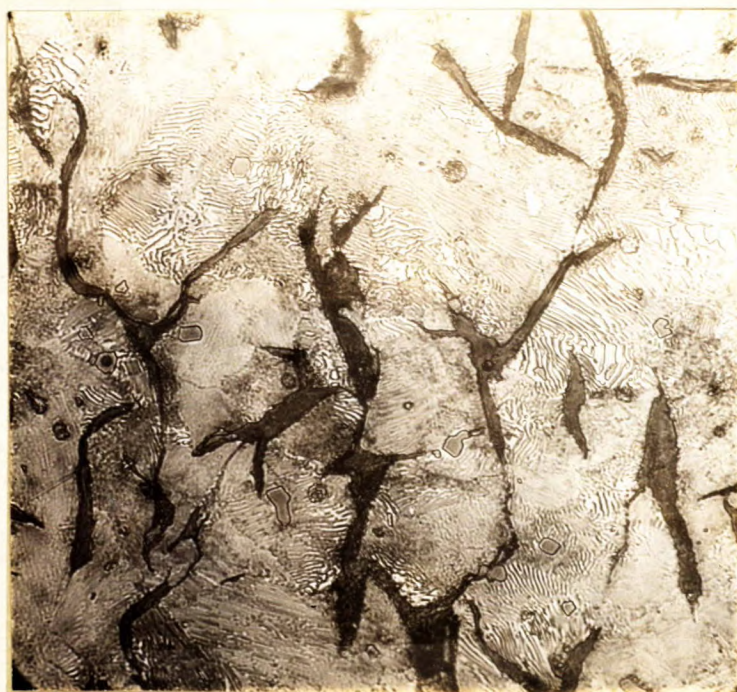
Figure 3.

Figure 3 shows the nital-etched structure of the iron at X500 magnification. The matrix consists of pearlite.

SHOWING THE NITAL-ETCHED STRUCTURE.
