ORE DRESSING AND METALLURGICAL LABORATORIES.

Investigation No. 2005.

Metallurgical Examination of Austenitic Steel  
Sample from Mantle of a Symons Cone Crusher.

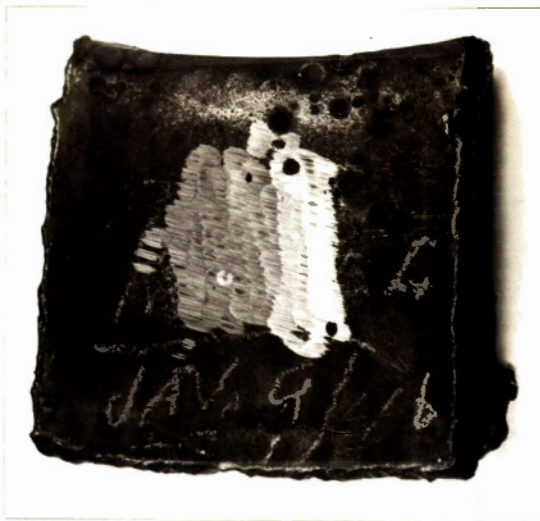
Figure 1.

On January 12, 1946, a piece of austenitic manganese steel casting (see Figure 1), cut from the mantle of a Symons 5 $\frac{1}{2}$ -ft. Short Head Cone Crusher, was submitted by the Sorel Steel Foundries Limited, Sorel, Quebec, per H. M. Brownrigg, Metallurgist.

The covering letter, dated January 10, 1946, stated that the mantle had been removed, broken in three places, after 37 per cent normal service life. A complete metallurgical examination was requested in order to determine the cause of the failure.

SAMPLE OF AUSTENITIC STEEL CUT FROM  
MANTLE OF SYMONS CONE CRUSHER.

(Dimensions, 4 in. x 4 in. x 2 in.).

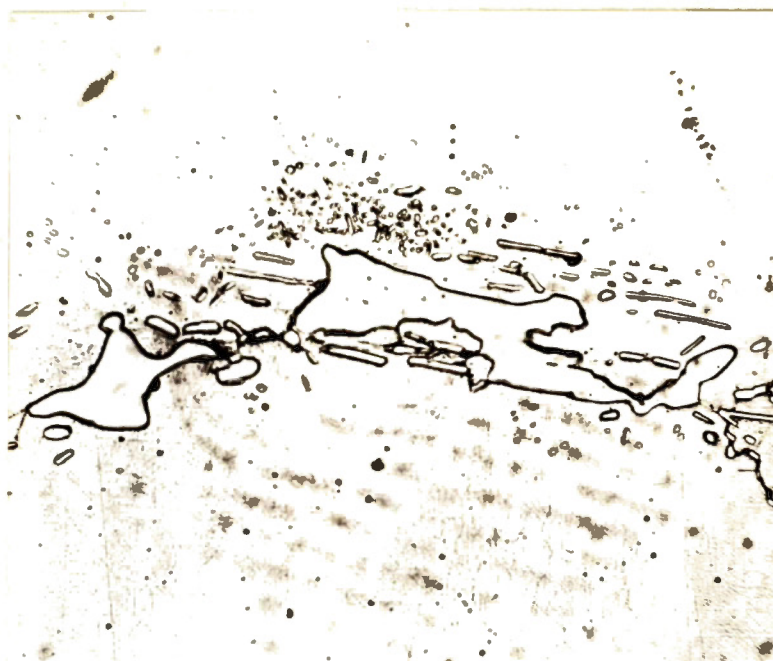
Figure 4.

Figures 4 and 5, taken at X100 and X500 respectively, show the microstructure after the heat treatment described in (4). It will be noticed that the carbides are still evident, although in smaller quantities.

carbides. It was found, however, that considerable quantities of free carbides persisted after this heat treatment (see Figures 4 and 5), thus indicating that the usual methods of heat treatment will not eliminate the carbides in austenitic manganese steels of this carbon content.

X100, nital etch.

X500, nital etch.

SMALL SECTION HEATED TO 1900° F.  
AND QUENCHED IN WATER.

Note presence of large carbides still  
evident.

In order to prevent similar failures it is recommended that the carbon content be kept within the range 1.00 to 1.40 per cent, and the silicon content 0.25 to 1.0 per cent.
