ORE DRESSING AND METALLURGICAL LABORATORIES.

Investigation No. 2013.

Metallurgical Examination of Austenitic Manganese
Steel Ball Mill Liner Reported to have given
Double Normal Service Life.

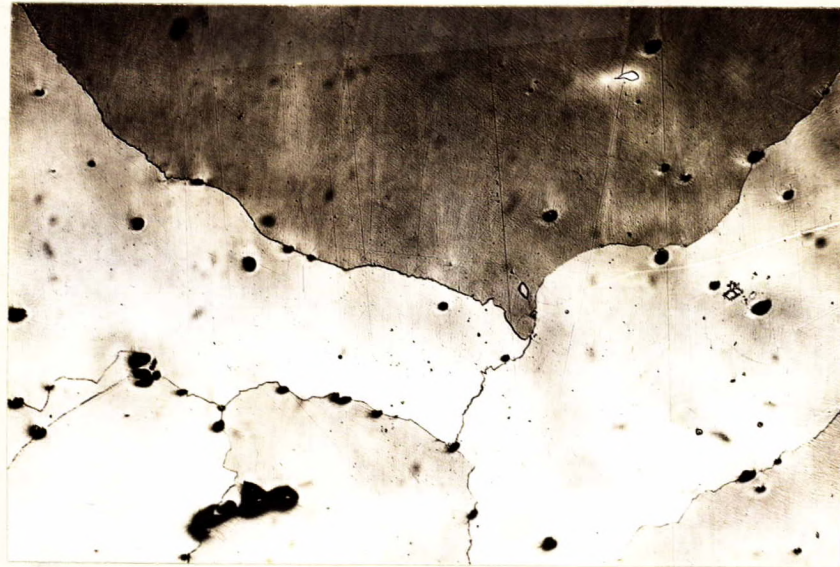
Figure 1.

X100, nital etch.

Note large grain size, indicating high-pouring temperature.

Figures 1 and 2 show the normal microstructure of the steel at X100 and X500 magnifications, respectively. The large grain size indicates high pouring temperature, whereas the absence of carbides at the grain boundaries signifies correct heat treatment.

The microscopic examination revealed that the steel had a large grain size (see Figures 1 and 2) resulting from high-pouring temperature. It is common knowledge that the pouring temperature has a marked effect upon the tensile strength of austenitic manganese steel. Hence it may be safe to conclude that the low tensile strength recorded (70,000 p.s.i.) is a direct result of the large grain size and the presence of cracks (see Figure 4). It is also thought that the cracks were induced, probably in the latter part of service life, as a result of the pounding action on a steel already weakened because of the large grain size.

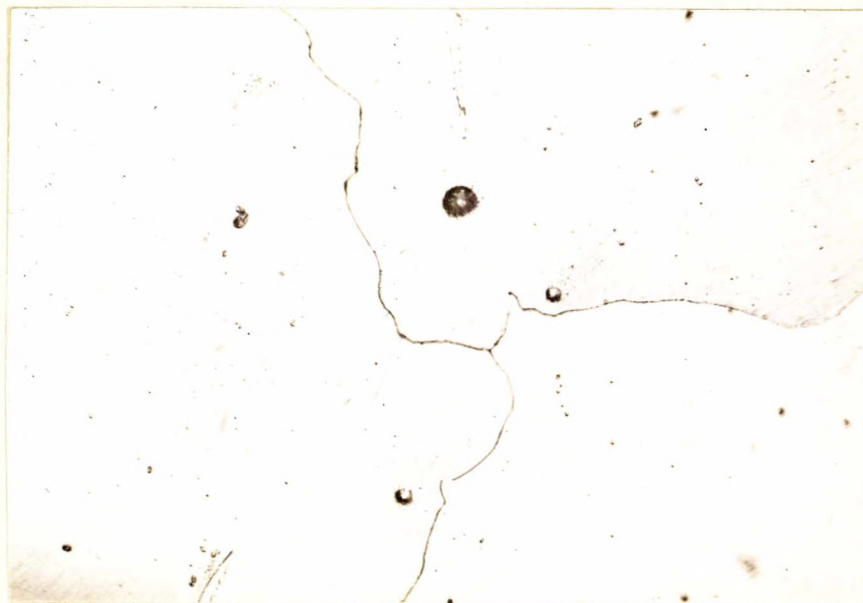
Figure 2.

X500, nital etch.

Note absence of carbides at the grain boundaries, indicating correct heat treatment.

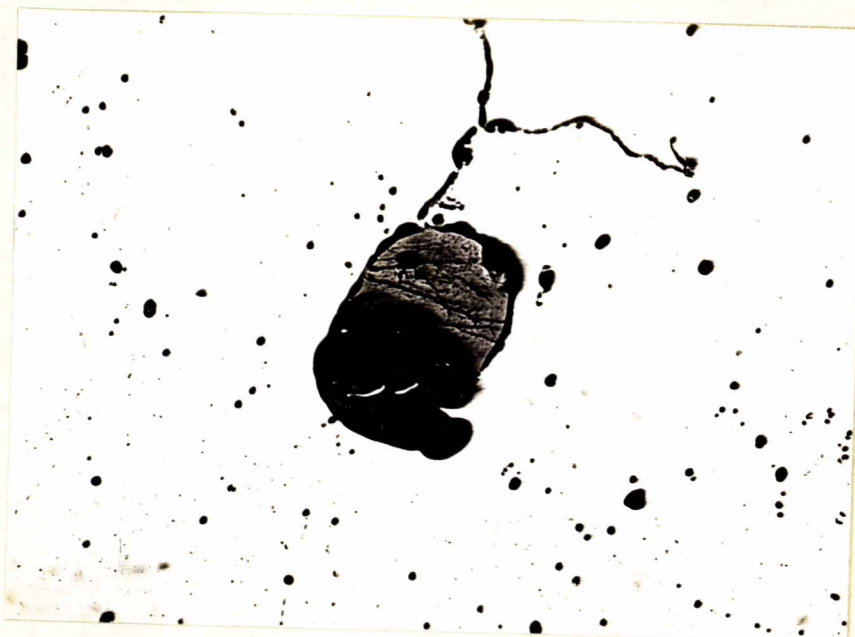
Figure 3.

X100, nital etch.
Showing large inclusions.

Figures 3 and 4, taken at X100 magnification, indicate the presence of large inclusions and cracks in the steel.
