### ORE DRESSING AND METALLURGICAL LABORATORIES.

Investigation No. 2034.

Metallurgical Examination of Worn Austenitic  
Manganese Steel Casting.

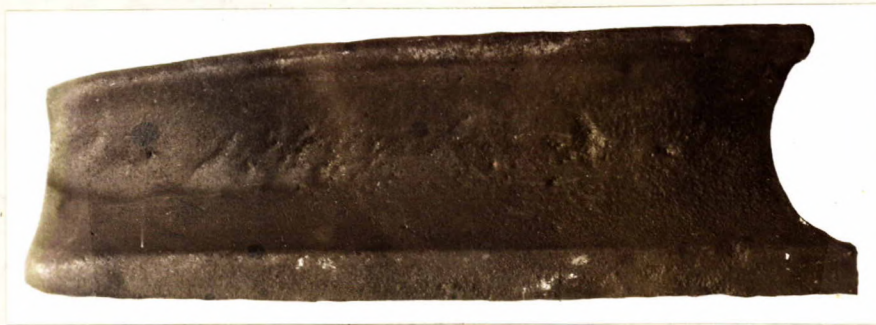
Figure 2.

MANGANESE STEEL CASTING, SHOWING  
WORN INSIDE SURFACE.

Note also casting defects.

Visual examination of the worn inside surface revealed some casting defects in addition to the evidence of wear.

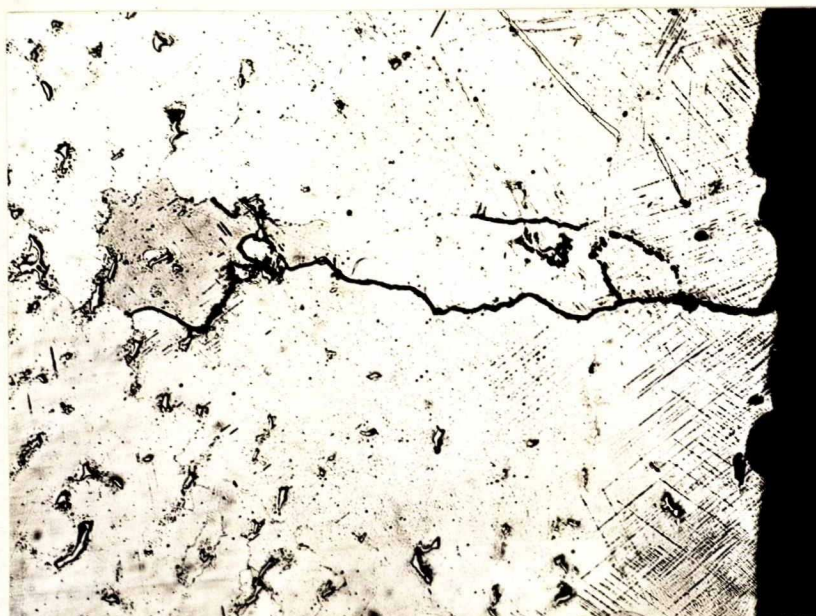
Figure 5.

Figure 5, taken at X100 magnification, illustrates a crack extending inward from the wearing surface. This crack is typical of a great number found in the metal. Note, also, evidence of work hardness at the wearing surface.

X100, nital etch.

Note crack at wearing surface, characteristic of many found in the metal. Note, also, indications of work hardening.

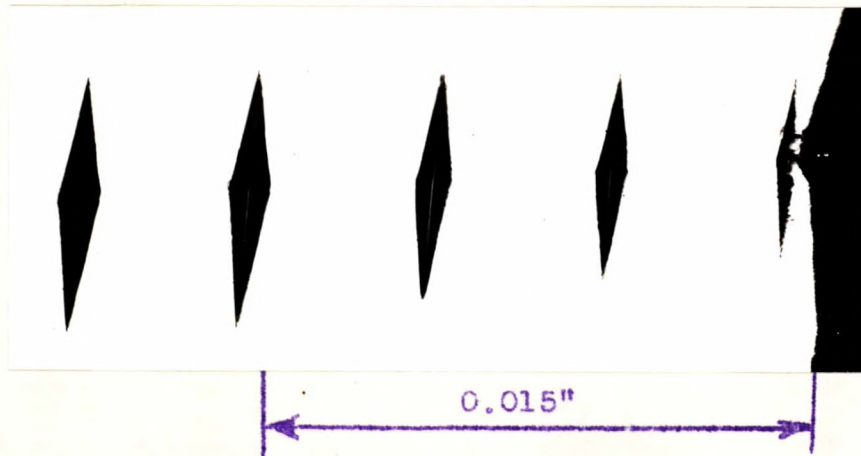
Figure 8.

<u>Distance from Wear Surface, inches</u>	<u>HARDNESS NUMBER</u>	
	<u>Knoop</u>	<u>Rockwell "C" (Converted)</u>
Nil	- 490	47
0.005	- 361	32
0.01	- 303	25
0.015	- 246	17
0.02	- 246	17

Figure 8, taken at X200 magnification, illustrates the extent of the work hardness. Impressions were made with a Tukon hardness tester, using a 500-gram load.

The results of the hardness test and microscopic examination prove conclusively that some work hardening has taken place. However, the fact that the hardened surface extends to a distance of only 0.015 inch proves that the impact loads are not very great. It should be noted that the hardened layer is so shallow that the Vickers hardness tester failed to disclose the presence of work hardness.

ROCKWELL "C"

17            17            25            32            47

X200.

HARDNESS READINGS MADE WITH A TUKON HARD-  
NESS TESTER, SHOWING MAGNITUDE AND DEPTH  
OF SURFACE WORK HARDNESS.
