ORE DRESSING AND METALLURGICAL LABORATORIES.

Investigation No. 2089.

Investigation of Hard Drawn Spring Wire  
As Used in the Twin Pin Clothes Pin

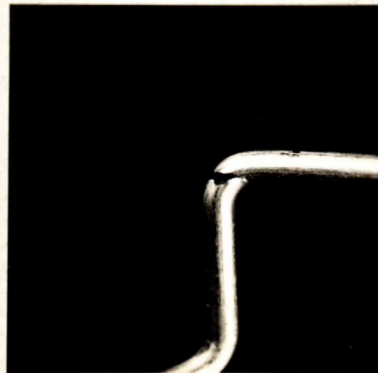
Figure 5.

THE FRACTURE AT POINT A,  
(Note deformation on inside of the bend)

(See Figure 4.)

The stress analysis of this type of clothes pin was determined. Assuming 14 gauge hard drawn spring wire conforming to A.S.T.M. Spec. A-227-41 it can be shown that the maximum safe working stress with intermittent loading is approximately 48,000 p.s.i. This is a torsional shear stress acting at the critical point where the wire passes under the pin. The actual working stress which is developed at this point was found to be approximately 200,000 p.s.i., almost four times greater than the safe allowable stress. (See Appendix X) Attention is also called to the sharp right angle bends at points A and B (see figs. 1, 4) and the resulting deformation on the inside of the bend (fig. 5)

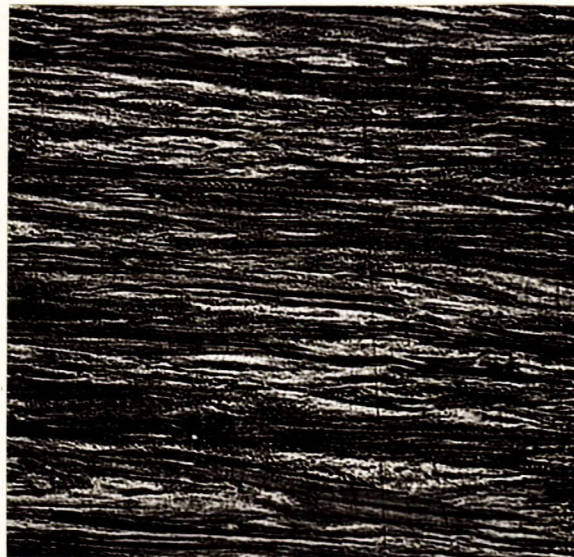
Figure 7.

Transverse and longitudinal sections were taken from both satisfactory and unsatisfactory spring wire, mounted, etched and examined under the microscope. Figure 6 is a photomicrograph of the normal sorbitic structure of the transverse area. Figure 7 is a photomicrograph of the longitudinal area showing the elongated grains of a typical hard drawn structure. No differences were noted in the microstructure between the satisfactory and unsatisfactory wire examined.

X500, nital etch.

TYPICAL LONGITUDINAL AREA (elongated  
grains are characteristic of a cold  
drawn structure).

No differences were noted in the microstructure between satisfactory and unsatisfactory wire. The wire has a normal patented and cold drawn structure.
