R E P O R T  
of the  
ORE DRESSING AND METALLURGICAL LABORATORIES.

Investigation No. 2144.

Examination of a Hair-Line Crack  
on a Malleable Iron Casting.

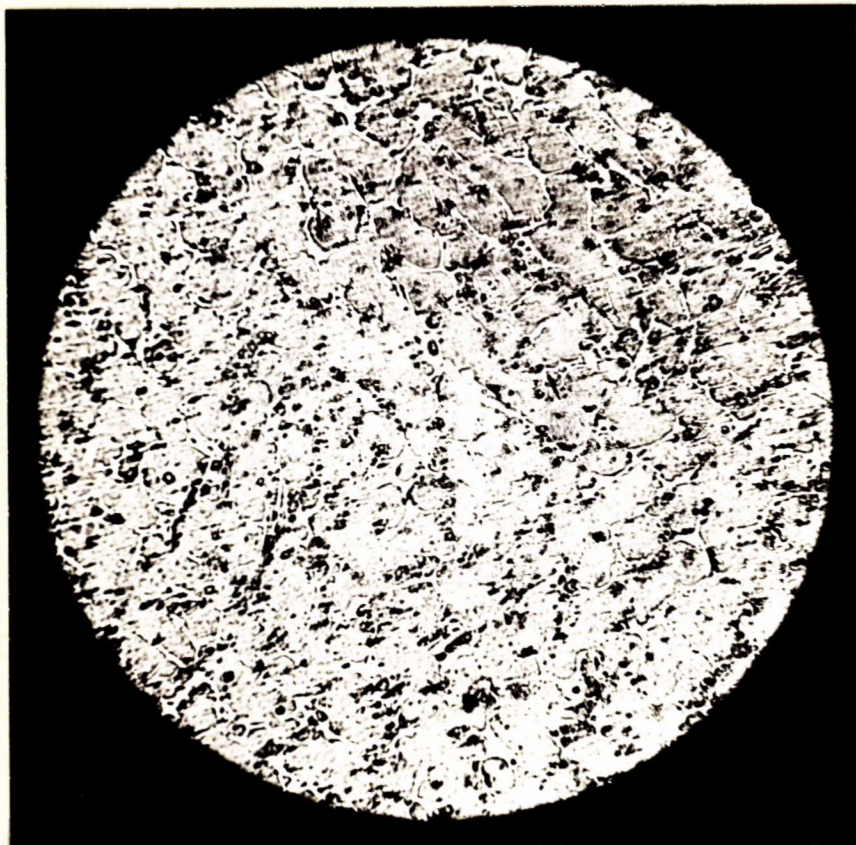
Figure 3.

A section was cut through the oxidized area of the fractured surface and examined under the microscope after it had been polished. Figure 3 (X100) illustrates the unetched surface of the specimen. Figure 4 (X300) was taken of the nital-etched sample. This shows the pearlite-cementite structure normally associated with white iron.

X100.  
UNETCHED SPECIMEN.

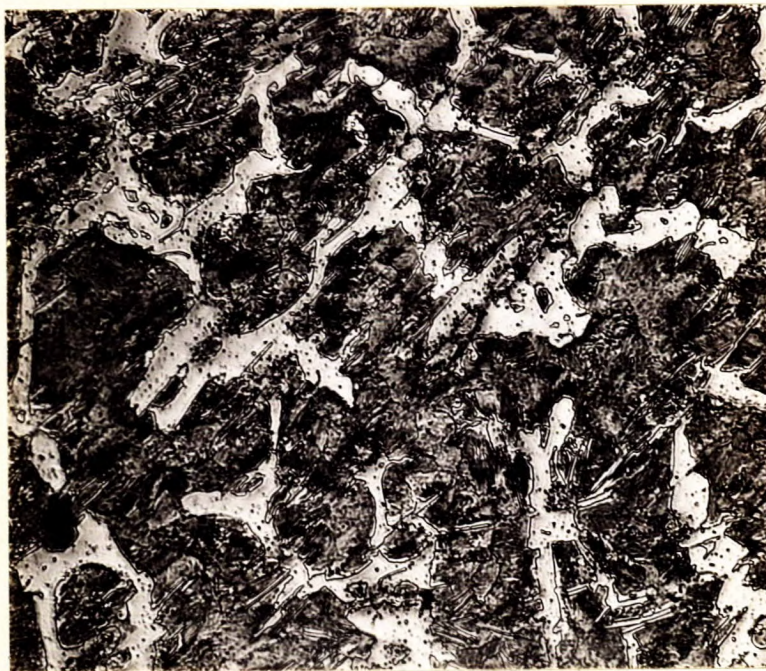
Figure 4.

X300, etched in 2  
per cent nital.

PEARLITE AND CEMENTITE.

Metallurgically the metal appears to be normal white iron, the microscopic examination having revealed the characteristic structure of pearlite and cementite.
