Ottawa, February 14, 1947.

R E P O R T  
of the  
ORE DRESSING AND METALLURGICAL LABORATORIES.

Investigation No. 2177.

Metallurgical Examination and Stress Analysis  
of a Compressed Air Reservoir.

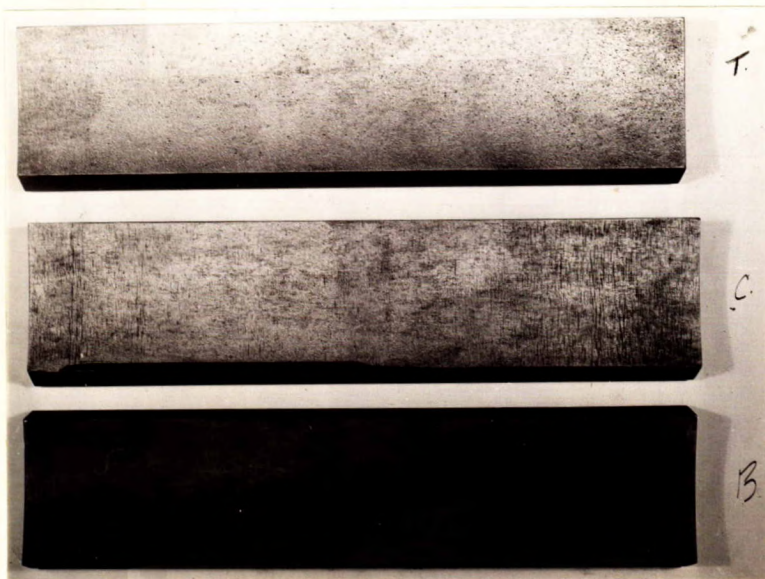
Figure 1.

The three samples of steel plate, cut from the top (T), centre (C) and bottom (B) sections of the steel air reservoir, are shown in Figures 1 and 2 after a macro etch in 50 per cent hydrochloric acid solution. The metal was observed to be quite sound.

MACRO-ETCHED 30 MINUTES IN  
50 PER CENT HCl AT 180° F.  
(Approximately 1/3 actual size.)

The macro-examination showed that the steel reservoir had been made from sound metal.

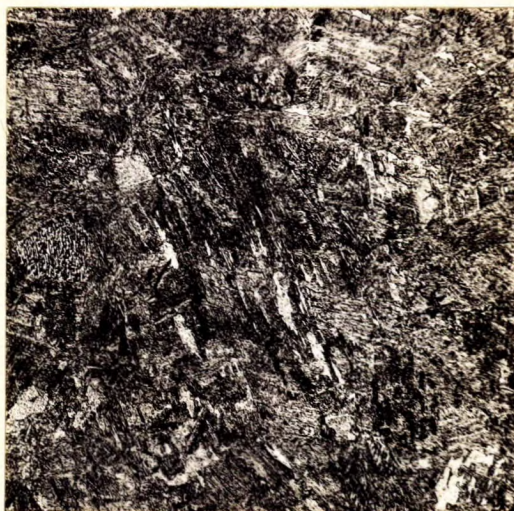
Figure 3.

X100, etched in  
2 per cent nital.

TOP SECTION.

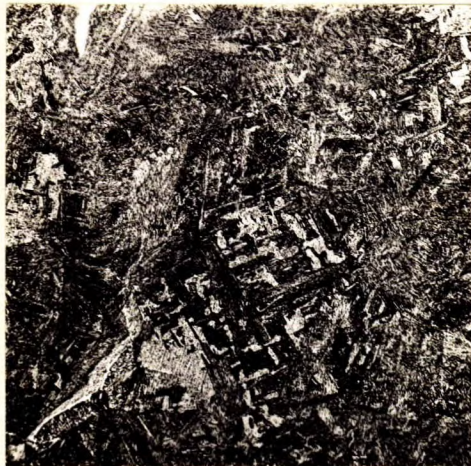
Figure 5.

X100, etched in 2  
per cent nital.

CENTRE SECTION.
