MINES BRANCH INVESTIGATION REPORT IR 66-84

**EXAMINATION OF PNEUMATIC CAPSULES
FOR CONTAINING COBALT 60**

EXAMINATION OF PNEUMATIC CAPSULES
FOR CONTAINING COBALT 60

SUMMARY OF RESULTS

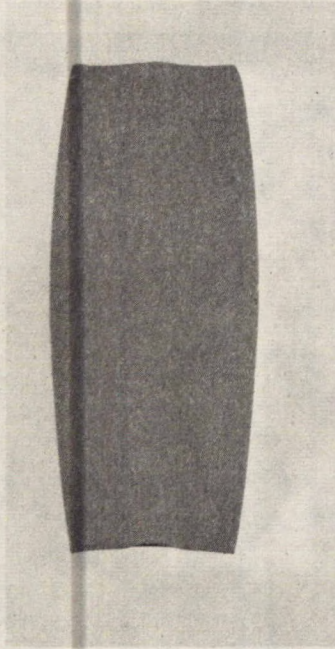
Figure 5. Cross-Section of Exhibit No. 4.

Figure 5 shows a longitudinal cross-section of the carbon steel dummy capsule which had been service tested. The profile of the ends indicate the severity of hammering in service.

Carbon steel dummy capsule, service tested for
an unknown period. Etched in nital. (X1.6)

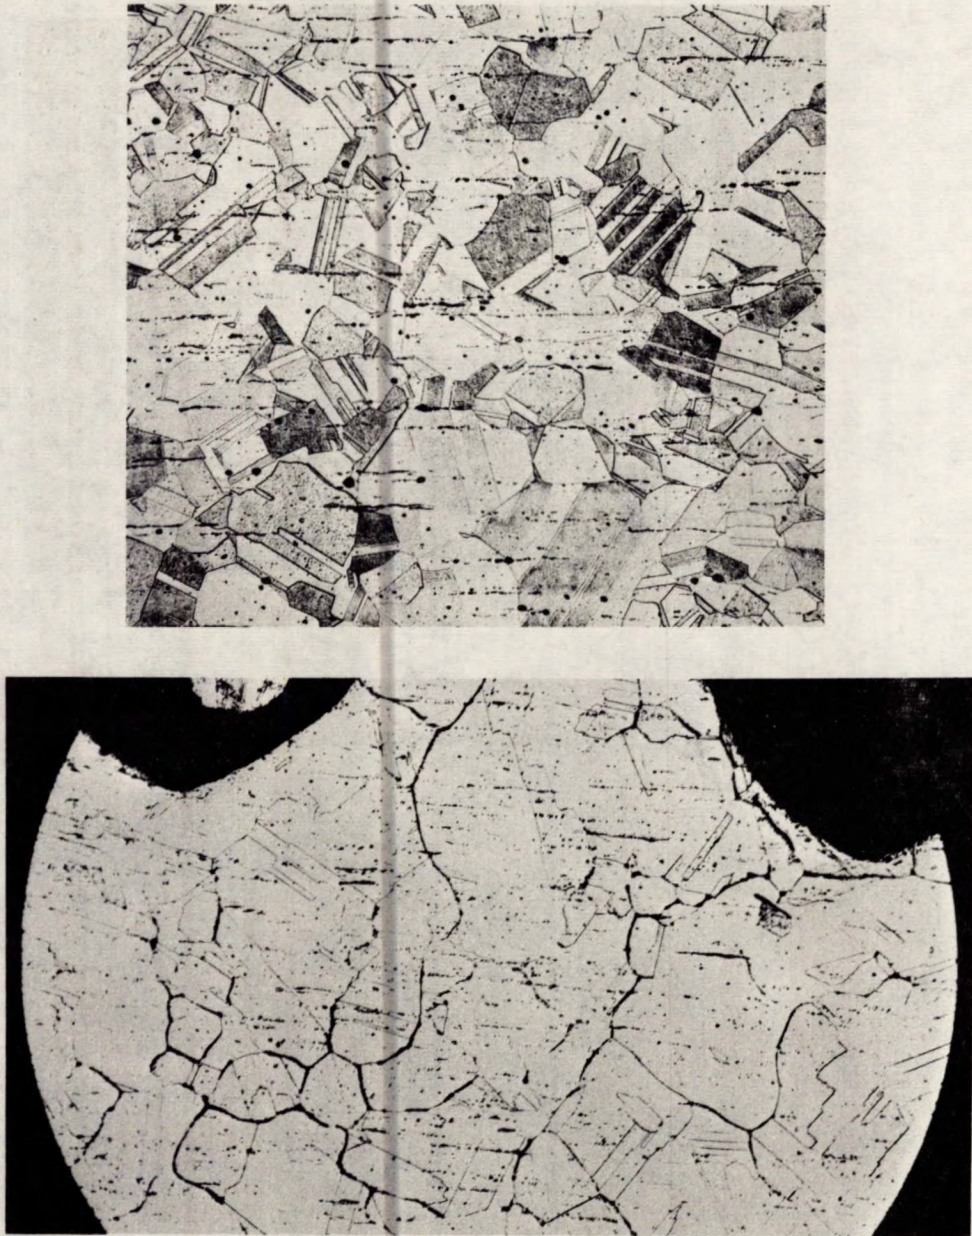
Figure 7. Structures of Inner Capsule No. 5. Electrolytic oxalic etch. (X100)

Figures 6 and 7 show features of the structure of the inner capsule from the capsule of Design #3 which had been service tested for 100,000 cycles. The end plugs of the inner capsule were in the quench-annealed condition. The walls of the inner capsule were of quench-annealed austenite; however, the end lengths showed intergranular carbide precipitation in the vicinity of welds "A" and "B". Small underbead cracks were also observed in sections of weld "B".

Upper: Annealed structure of the main part of the inner capsule.

Lower: Sensitized structure of the end-length of the body ("A" - "B" in Figure 6) near weld "A".
