MINES BRANCH INVESTIGATION REPORT IR 70-16

# A STUDY OF THE CAUSE OF DETERIORATION OF AN EXPANDED SHALE IN MOIST, CYCLIC FREEZING AND THAWING CONDITIONS

SUMMARY OF RESULTS

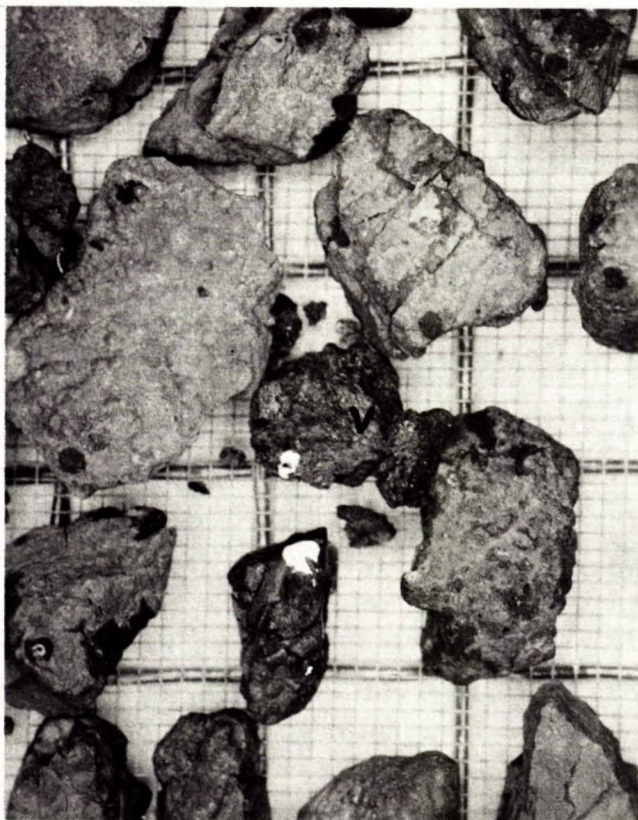
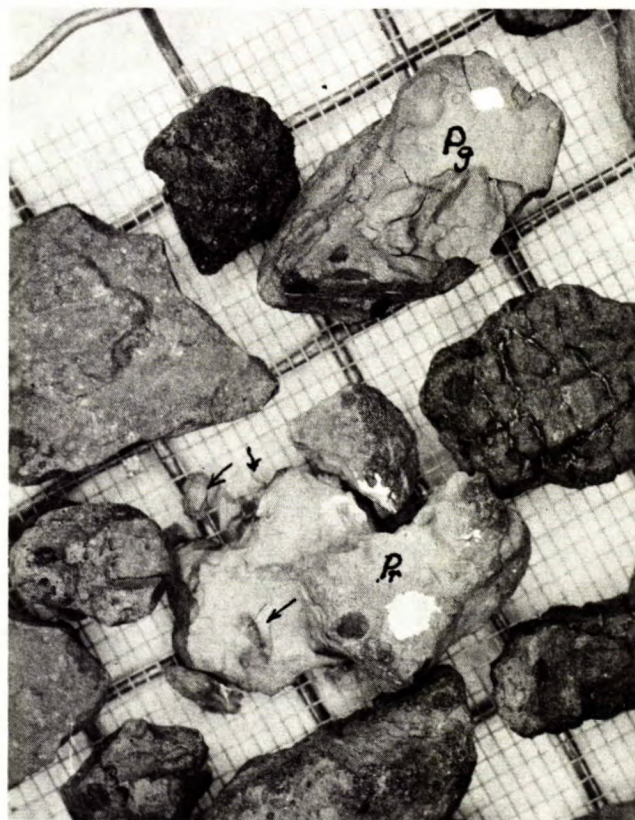
Figure 1. Photographs of mounted semi-coated Haydite aggregate after exposure to 194 cycles of freezing and thawing. Magnification 1.5X.

- A: Vesicular dark particle (V), broken apart and crumbling into shards in the friable interior;
- B: Platy reddish (Pr) and grey (Pg) particles split parallel to original shaly parting. Small flakes ( ← ) have broken from fresh surfaces.

Exposure of the mounted aggregate particles to cyclic freezing in air and thawing in water produced a gradual breakdown of several particles of the three types noted to have caused spalling in Wilson's concrete specimens. The results of the tests are summarized in Table 1. The deterioration progressed from early splitting along laminations and random cracks to piecemeal spalling, either of flakes from freshly exposed surfaces of laminated particles, or of glassy shards from highly vesicular aggregate particles. Figures 1 and 2 show examples of the deterioration products.

Although no absorptive, deleterious minerals are present, the tests show that the freezing and expansion of absorbed or trapped water does effect the breakdown of the aggregate. Primary rupture takes place along major cracks related to laminations in the particles, and later disruption proceeds either by piecemeal spalling of flakes from the fresh rupture surfaces of flat aggregate, or by crumbling of the highly vesicular centers of well-bloated particles. It appears from these observations that some major cracks are loci of refractory,
