**DEPARTMENT OF MINES AND TECHNICAL SURVEYS**

**MINES BRANCH INVESTIGATION REPORT IR 62-53**

**THE COMPOSITION OF PRODUCTS FROM  
THE GOLD-REFINING PROCESS OF  
MACASSA MINES LIMITED,  
KIRKLAND LAKE, ONTARIO**

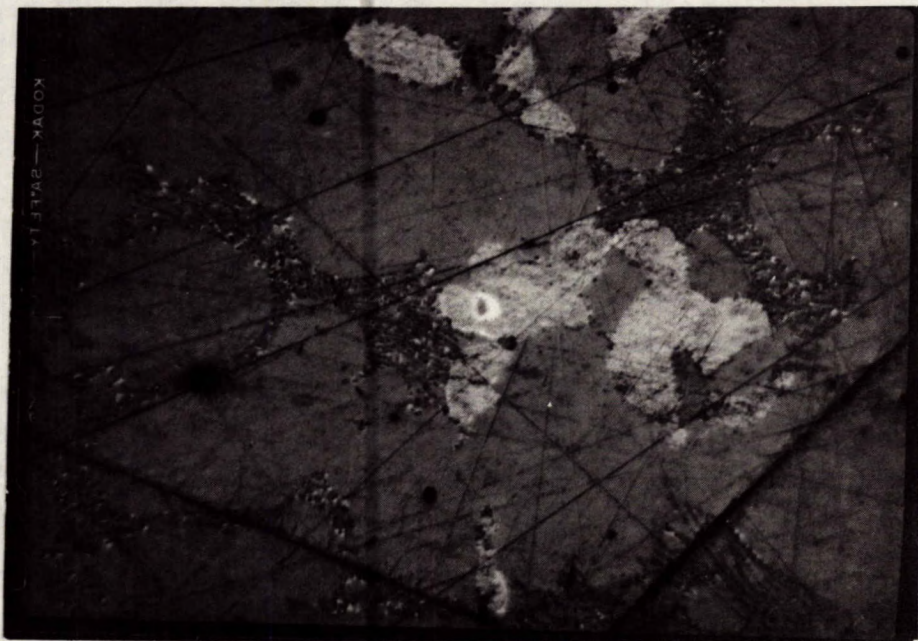
**Figure 1. Polished Section of Macassa Bar**  
**Magnification: 350 X**  
**(Straight lines are polishing scratches)**

Figures 1 and 2 show two photomicrographs of polished sections of a portion of the Macassa bar. Only four of the phases described in Table 2 can be discerned here. The background mass seen in Figure 1 is phase (A). The large light islands are phase (B), while the dark intergranular material is phase (C). Phase (D) is seen as light-coloured flecks distributed throughout phase (C). Figure 2 shows phase (C) in more detail and at higher magnification. It is seen to consist of very small worm-like, dark islands packed close together. Phases (E) and (F) can be detected only by their colour and hence are not distinguishable on these photomicrographs.

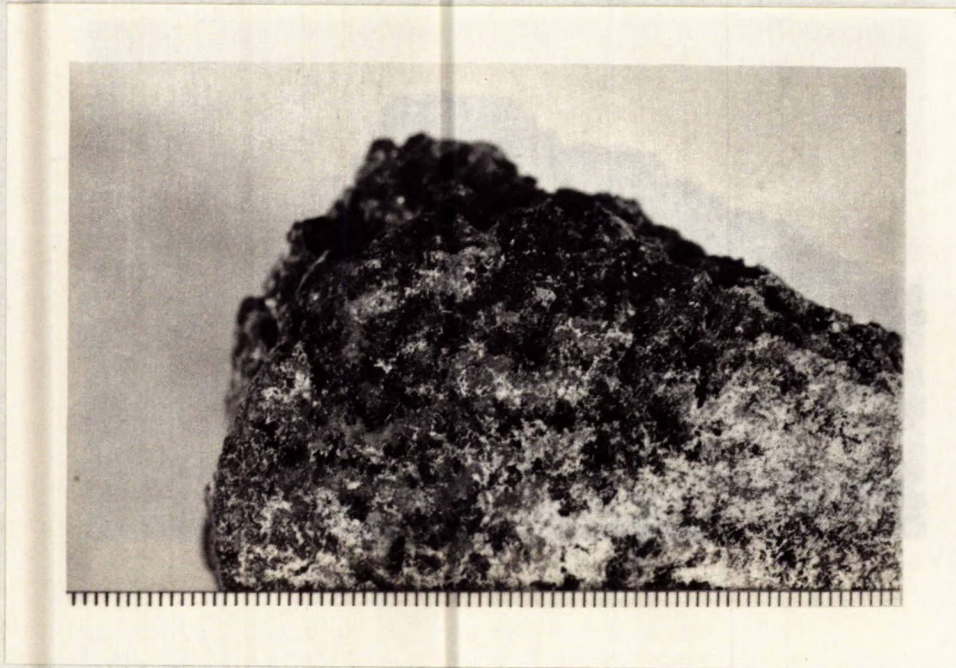
Figure 3. Photograph of Portion of Macassa Slag  
(Scale at lower edge of photograph is in millimetres)

- (a) Black, shiny material that was very hard and vitreous and formed the main body of the slag;
- (b) brownish-grey material that coated certain areas of the surface of the slag, almost with the appearance of a mould-growth;
- (c) white, powdery material, deposited on certain surface areas;
- (d) black, brittle, needle-like crystals formed in hollows and irregularities in the surface of the slag.

These phases can be seen in Figure 3, which is a photograph of a portion of the slag taken at low magnification.

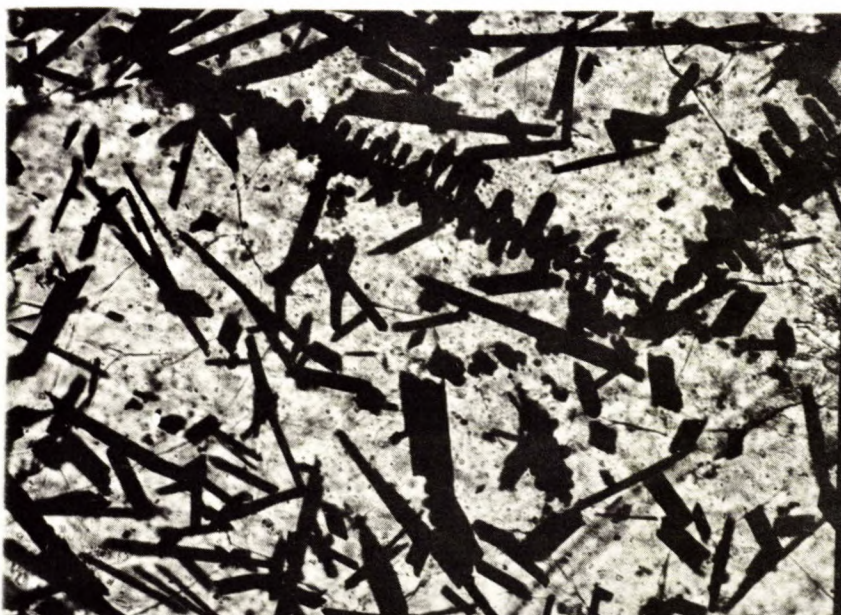
Figure 4. Photomicrograph of Thin Section of Macassa Slag  
Magnification: 270 X

A thin section of the slag was prepared. A photomicrograph of this section is shown in Figure 4.

The dendritic formations visible in Figure 4 will, therefore, be the cuprite,  $\text{Cu}_2\text{O}$ , phase. The optical properties of this material, again,

Thus it has been possible to identify the crystalline components associated with this slag to a reasonable degree of completeness. The material which forms the matrix visible in Figure 4 is, presumably, the amorphous material referred to in Table 3. From the spectrographic data given in Table 4, it would appear likely that the slag and the crystals obtained from it are of essentially the same composition. It is thus likely that the slag is a copper-manganese-rich oxide in the glassy or amorphous condition. This slag also contains significant amounts of Na, Ca, Zn, B and Si. It is therefore entirely likely that, included in this glassy phase, are certain complex borates and silicates, both of which types of compound are known to be strongly glass-forming materials.
