MINES BRANCH INVESTIGATION REPORT IR 63-22

**METALLURGICAL EXAMINATION OF
SAMPLES RELATING TO RESEARCH ON
THE RESISTANCE WELDING OF
GALVANIZED COATINGS**

J. J. SEBISTY

MARCH 4, 1963

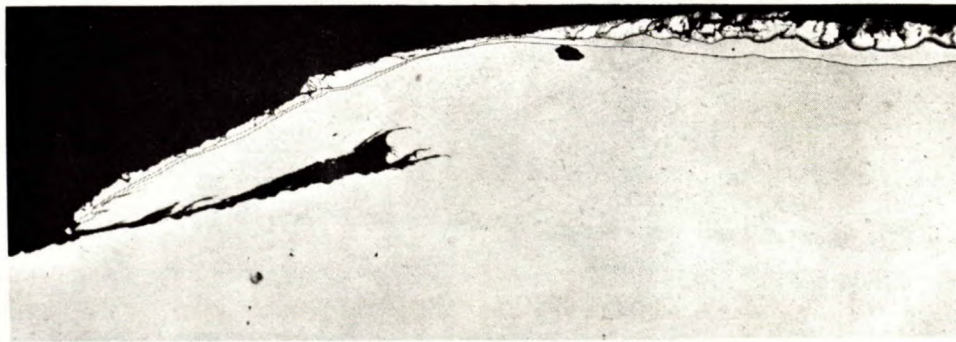
(b) X500

Figure 5. Microstructures of Electrode KAGA showing, (a) mushrooming at edge of contact surface and thick beta phase growth in this area; (b) uniformly thin beta layer and cracking of gamma phase layer in an area remote from the periphery. Ammonia-hydrogen peroxide etch.

A prominent feature of Electrodes KAGA and KAGC, which had given poor service with electroplated sheet, was the marked mushrooming at the tip edges as shown in Figures 5 and 6. Such deformation suggests excessive surface heating of the electrode which in turn could be expected to increase the rate of alloying of the tip and to affect the nature of the alloying products. Evidence of such effects were observed. As illustrated in Figures 5(a) and 6, beta phase formation for some distance in from the periphery as well as in the vicinity of craters was much thicker than elsewhere. Also, despite the relatively limited welding service, the gamma phase layer was relatively thick and was characterized by severe cracking and break-up as shown in Figure 5(b). No explanation for the apparently aggravated heating operation of these electrodes could be found. However, this must be related to the nature and properties of the electroplated zinc coating, particularly as these affect the welding conditions and the availability of zinc for the electrode alloying process.

On this electrode also, there was little evidence of mushrooming of the type shown in Figures 5(a) and 6(a). Its exceptional service performance with galvanized sheet was reflected in marked and complex development of thick layers of the copper-zinc diffusion phases and welding residues. Typical microstructures are given in Figures 9 and 10. It is to be noted that in this case only was evidence found of the alpha Cu-Zn phase, as indicated in Figure 9. By comparison with the other four electrodes, the contour of the KAHB tip was very irregular as well as being grossly contaminated. In view of this condition it can only be concluded that welding of galvanized sheet is much less dependent than normal galvanized or electroplated sheet on the state of the electrode tip surface. The inherently different structure, surface characteristics and other properties of this type of coating, and the reduced amount of zinc available for reaction with the copper alloy electrode, must account for this different response.

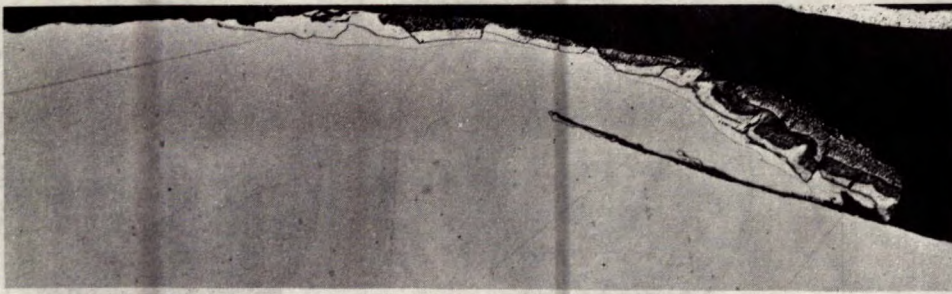
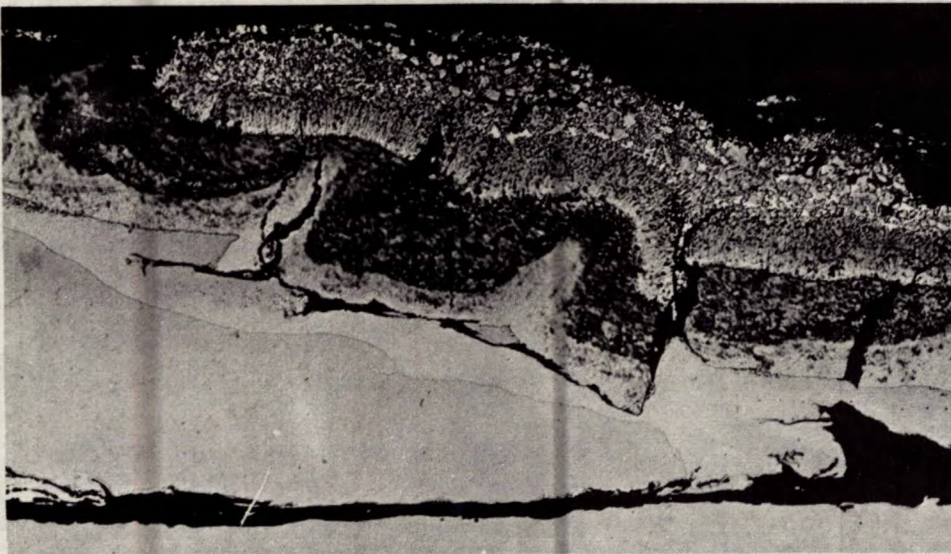
Figure 6. Microstructures of Electrode KAGC showing typical mushrooming at edge of contact surface in (a) and parts of this field enlarged in (b) and (c). An unusual beta phase formation adjacent to a cavity located elsewhere on the electrode surface is shown in (d). Ammonia-hydrogen peroxide etch.

A characteristic feature of all sections examined was the occurrence of a distinct brass layer, identified as the beta copper-zinc phase, adjacent to the copper body of the electrode. Overlying this was a much thicker grey-coloured layer, tentatively identified as the gamma copper-zinc phase. This layer was usually extensively cracked and was locally exposed to the surface because of break-up and tearing away during separation of electrode and work piece at the last weld made. Some of the bright patches evident in Figure 4 presumably represent such exposure of the gamma phase. Elsewhere on the tip surfaces (with exceptions noted later) the gamma layer was covered by what appeared to be a layered mechanical mixture of unidentified welding products including particles of zinc (Figures 6, 9 and 10).

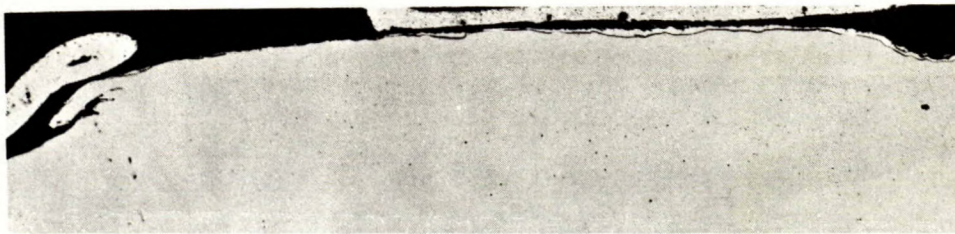
Figure 7. Microstructure of electrode KAAB showing relatively minor mushrooming at edge of contact surface. X100, Ammonia-hydrogen peroxide etch.

In the metallographic sections of Electrodes KAAB and KAB8A, mushrooming was much less pronounced despite the excessive wear apparent on the latter as shown in Figure 4(d). A typical area on KAAB is illustrated in Figure 7. On these two samples, both of which had given intermediate welding life, the beta phase

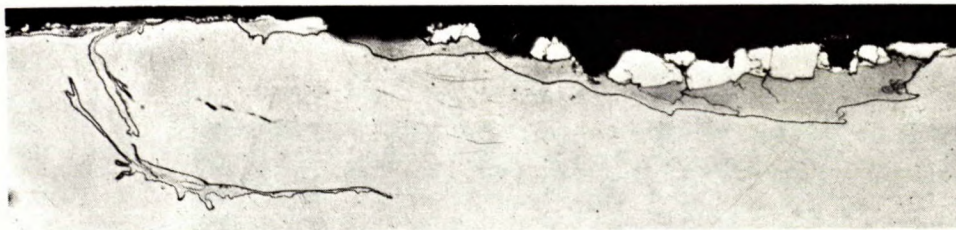
Figure 8. Microstructures of Electrode KABSA illustrating, (a) beta phase penetration and irregular growth in an adjacent shallow depression; (b) cross section through gross pit shown in Figure 4 (d); (c) characteristic growth of beta, gamma and an unidentified outer layer in areas remote from surface irregularities. Ammonia-hydrogen peroxide etch.

layer was uniformly thin except in the vicinity of gross surface depressions and pits such as shown in Figures 8(a) and 8(b). Another feature contrasting these samples from the pair described above was the thin, uniform and compact growth of the gamma phase layer. Cracking and break-up in this layer was minimal as shown in Figure 8(c). The absence of adhering secondary welding products apart from a thin outer shell of a third unidentified phase, also to be seen in Figure 8(c), was another dissimilarity. These various features of Electrodes KAAB and KAB8A suggest significant differences in the rate and mechanism of alloying of the tips, presumably, again, because of the nature and properties of the particular type of zinc coating welded. By comparison with Electrodes KAGA and KAGC, lower temperature of operation is indicated and this is supported by the much brighter appearance of the welds on the corresponding weld panels as described earlier. The gross increase in diameter of Electrode KAB8A without any accompanying marked mushrooming also indicates gradual spreading by compression at a reduced temperature. However this is uncertain, in view of the possible influence of the gross pit which developed in this electrode.

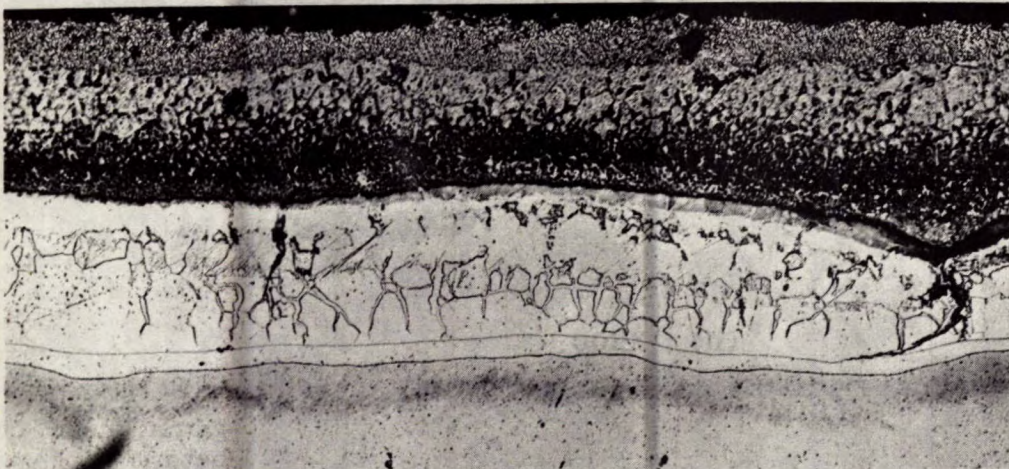
Figure 9. Microstructures of Electrode KAHB at low and high magnifications showing complex development of copper-zinc diffusion phases and layered mechanical mixture of other unidentified welding products. The presence of the alpha Cu-Zn phase is to be noted. Ammonia-hydrogen peroxide etch.
