MINES BRANCH INVESTIGATION REPORT IR 64-84

EXAMINATION OF METAL PIECE FROM THE BOTTOM OF THE ST. LAWRENCE SEAWAY

D. R. BELL

PHYSICAL METALLURGY DIVISION

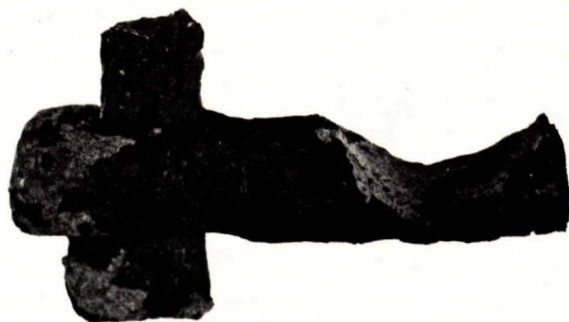
The sample, Figure 1, consisted of a cylindrical piece, approximately $3\frac{1}{2}$ in. by $\frac{3}{4}$ in. diameter, hereinafter referred to as the bolt, with a tapered split wedge driven through a slot near one end of the bolt. The sample had been cut from a longer piece, the cut being at the right of the bolt as shown in Figure 1. The large transverse groove in the bolt had penetrated slightly more than halfway through the bolt. The surface of this groove was smooth and covered with an adherent layer of iron oxide. The light coloured material shown in Figure 1 is an extremely thin layer which cannot be brushed off. It appears to be a layer of clay which has worked into the relatively porous surface of the iron oxide. When the friable corrosion products were brushed from the sample, the surface was found to have a pronounced fibrous or woody texture characteristic of corroded wrought iron.

Figure 1. Sample as-received.
(Approx. full size)

The diameter of the bolt, the split wedge, the gap between the wedge and the transverse groove, and the fact that the groove appears to have been produced by wear are consistent with the hypothesis that the sample submitted is one end of a shackle bolt. This is a standard means of connecting chains to rings, including anchor rings, and provides no information as to age.

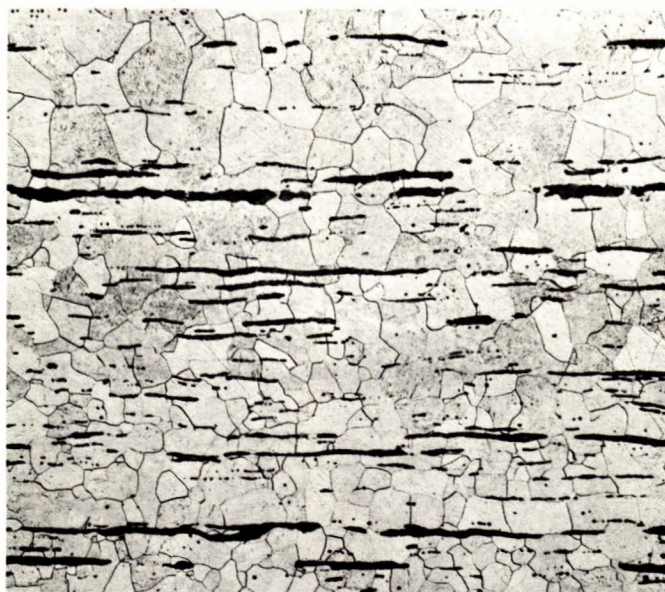
Longitudinal and transverse sections of the bolt and a longitudinal section of the wedge were examined. The microstructure consisted of polygonal ferrite grains with a considerable quantity of elongated duplex slag-type inclusions. There were also a considerable number of small round glassy inclusions. No carbides were observed. The microstructure is characteristic of good quality wrought iron. The slag inclusions were not bent around the transverse groove in the bolt, indicating that the groove was not forged.

Figure 2. Longitudinal section of pin.
(X100, etched with 2% nital)

Wrought iron has been produced from prehistoric times to the present. The process has gone through three basic changes, i.e., direct, puddled, and finally, Aston-Byers process. There have, of course, been innumerable refinements of technique. Despite time and technological change, the end product has not changed markedly in physical structure. Although the quality of early material varied widely, good quality wrought iron of the Middle Ages does not appear to differ significantly from good quality wrought iron produced in the 20th century. Hence, the structure of this sample is of no value in determining its age.
