MINES BRANCH INVESTIGATION REPORT IR 65-24

**METALLURGICAL EXAMINATION OF
THREE BROKEN LEAF SPRINGS**

D.A. MUNRO & D.E. PARSONS

PHYSICAL METALLURGY DIVISION

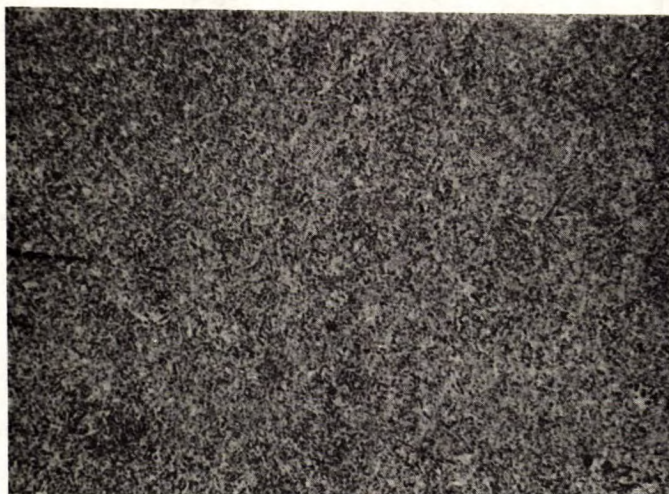
X500 - Same etch as Figure 3.

Figure 9. Sample No.1. Reheat treated; normalized 1650°F (1 hr); oil quenched from 1550°F. Tempered 700°F; water quenched - R_C 50. Shepherd grain size is No.8. The banding is eliminated or masked. No trace of grain boundary constituent was observed.

Similar areas are shown, etched in the same manner, after portions of each spring were reheat treated* by normalizing from 1650°F, reheating to 1550°F, oil quenching and tempering at 700°F (R_C 51), followed by water quenching from the tempering temperature. The grain boundary constituent has been eliminated, as illustrated in Figures 9, 10 and 11.

Reheat treatment by normalizing, austenitizing, oil quenching, tempering and water quenching was also effective in producing a much finer grain size. Broken Charpy V-notch bars after reheat treatment had a Shepherd** fracture size of No. 8, whereas the Shepherd fracture number was 5 in the as-received condition.

As demonstrated by heat treatment tests, salvage of existing material may be possible by renormalizing and rehardening to effect solution of grain boundary constituent and grain refinement, providing quench cracks are not present.

From the viewpoint of the spring manufacturer, the embrittling vanadium compound can be eliminated by resort to reheat treatment involving normalizing, hardening and tempering, followed by water-quenching. (This constitutes two additional heat treatments that may possibly be warranted from the viewpoint of quality, but are probably unnecessary with the competitor's material on account of the presence of 0.02% - 0.03% residual aluminum coupled with a considerably lower vanadium content).

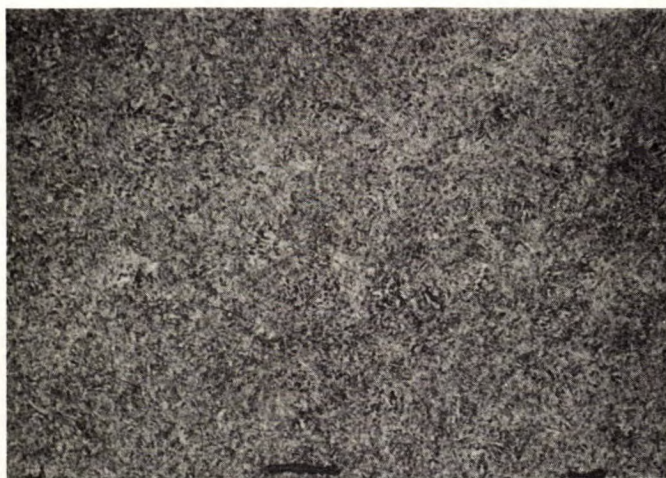
X500 - Same etch as Figure 3.

Figure 10. Sample No.2. Reheat treated as in Figure 9. (R_C 50). The banded structure and grain boundary constituent appear to have been eliminated.

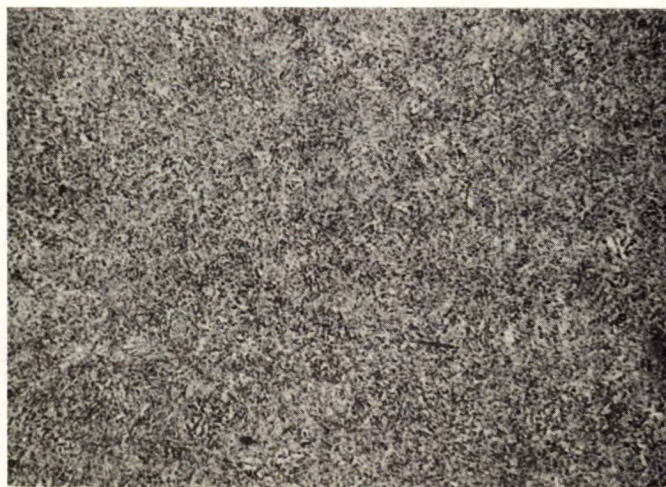
X500 - Same etch as Figure 3.

Figure 11. Sample No.3. Reheat treated as in Figure 9 (R_C 50). Charpy V-notch fractures were much finer grained than those observed in the as-received springs.

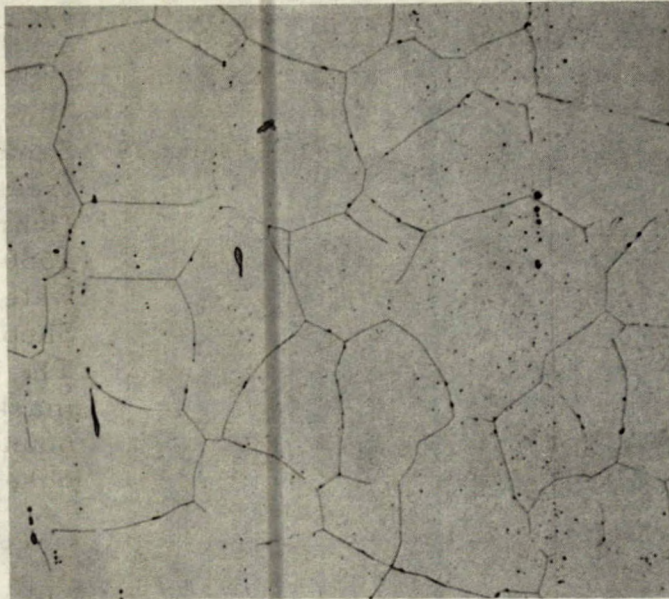
X500 - Etched in saturated aqueous picric acid + tridecylbenzene sulfonate.

Figure 12. Metal from spring No.2. Reheat treated to eliminate as-received precipitate then heated to 2000°F, slow cooled to 1600°F and water quenched. The grains are outlined with a continuous, brittle film believed to be vanadium carbide.

7. Metal from the springs was reheat treated to dissolve the grain boundary constituent, then was heated to 2000°F, held for 1/2 hr, slow cooled at 50°F per hr to 1600°F, followed by quenching. This heat treatment developed a continuous brittle film outlining austenite grains. Quench cracks were observed to preferentially follow the grain boundaries producing intergranular fracture. (Figures 12 and 13).
